Inspection Report of 6282 S. Military Trail, Lake Worth FL #705 Prepared for Muhammad A. & Nisreen Tina

6282 S. Unit 705 Military Trail Lake Worth FL 33463

Inspection Report of 6282 S. Military Tr. Lake Worth FL 33463 Unit 705 7.28.06

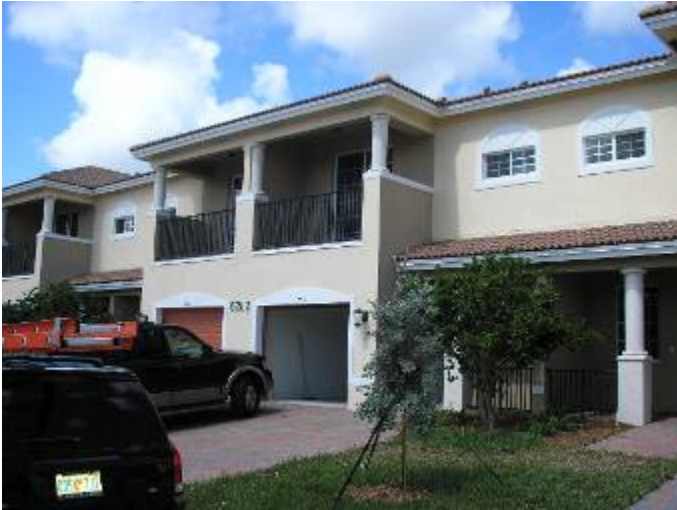
Site photo. The front of the house faces towards the east.

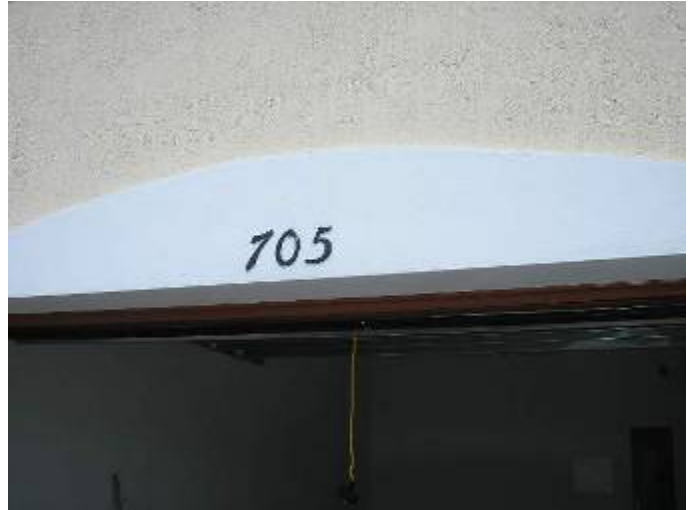
Some of the stucco work appears to be uneven, curved in & not the proper depth. ASTM C 926, §2504.2 §1403.1.3

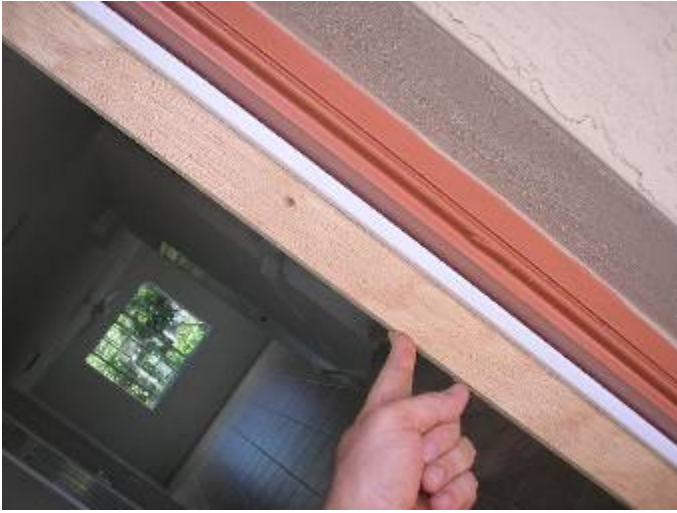
A straight edge was verified at the front door frame & used to check the exterior walls.

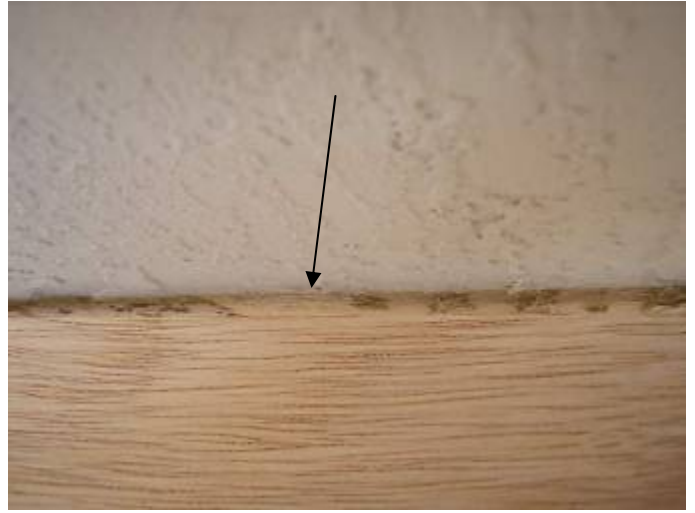
Some of the stucco work appears to be uneven, concave & not the proper depth. ASTM C 926, §2504.2 §1403.1.3

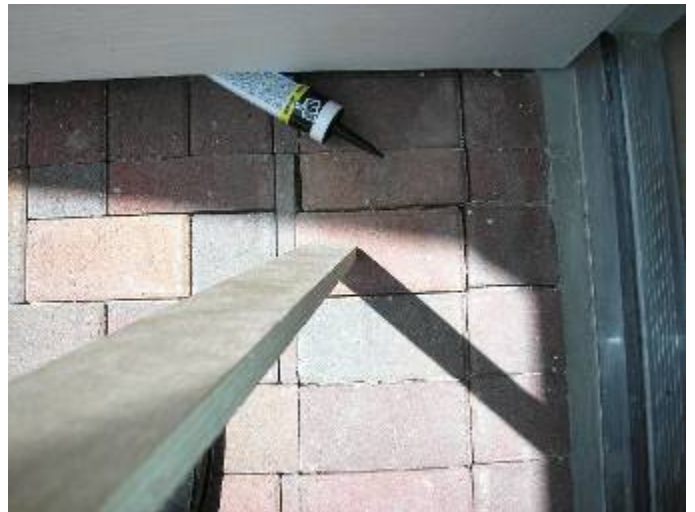
Some of the pavers were loose, damaged or out of place at the driveway & walkway.

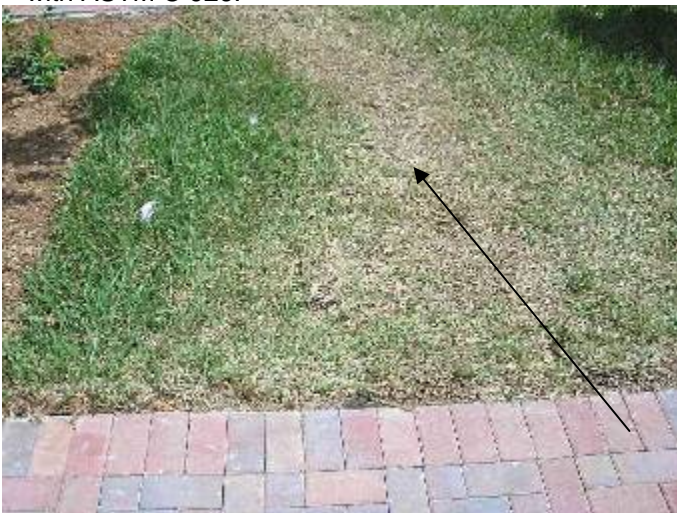
Some of the grass is brown &/or dying from what appears to be foot traffic at the front of the building.

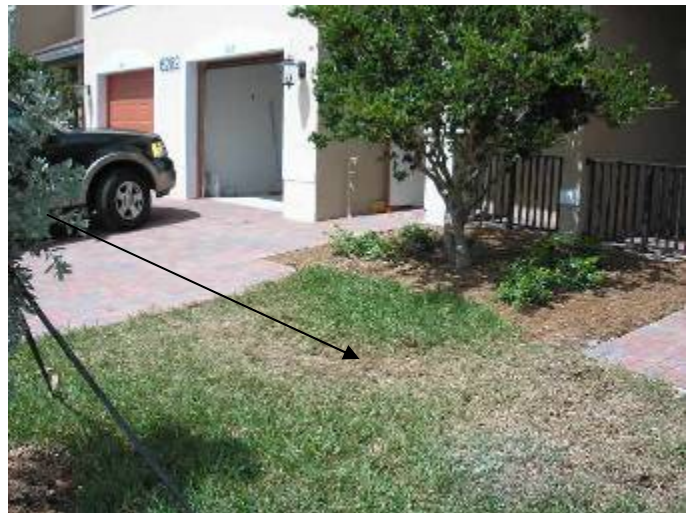
Some of the grass is brown &/or dying from what appears to be foot traffic at the front of the building.

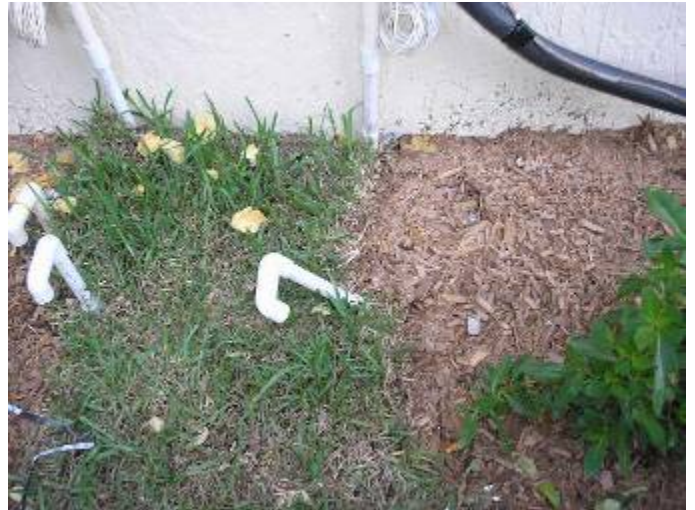
The condensate drain line is leaning over & not plumb or correctly supported.

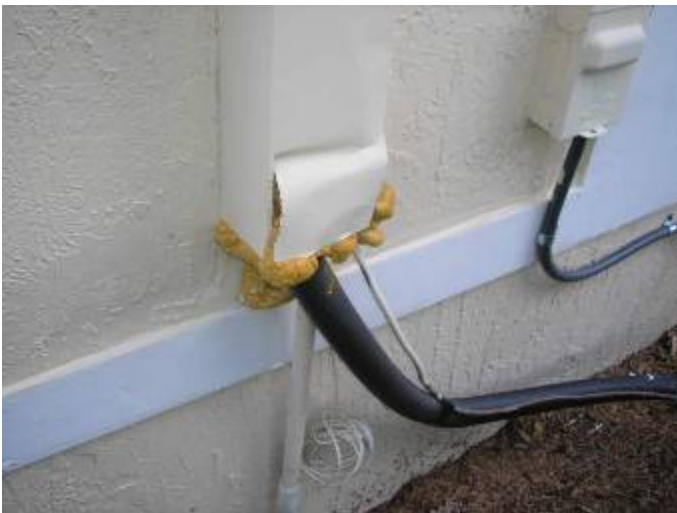
The AC line cover is damaged with sharp edges. Cement, mortar or non-corrodible metal should be used to close the opening around the refrigerant line piping.

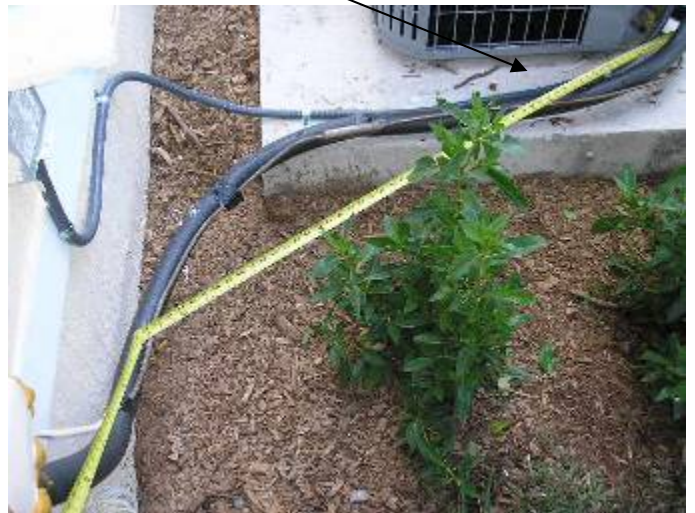
3 Anchors are required on each side of the condensing unit. M301.13.1 The AC refrigerant line piping was not correctly supported at 6 ft intervals as required. §M305.4

Obtain anchorage engineering specs or add anchors as required.

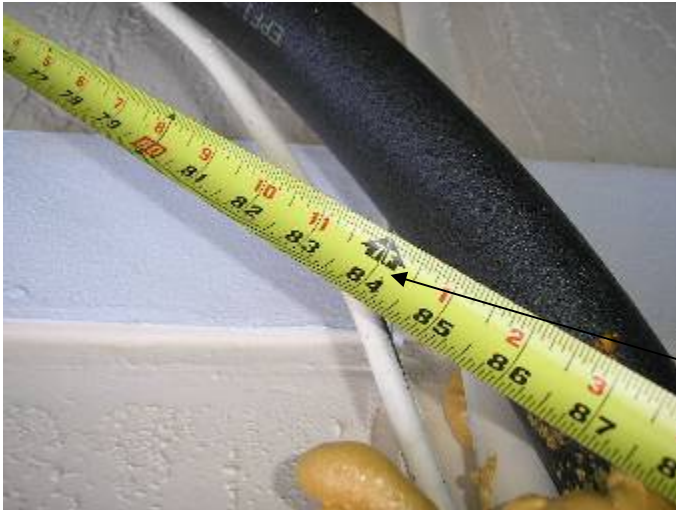
The exterior AC refrigerant line piping was not correctly supported at 6 ft intervals as required. §M305.4

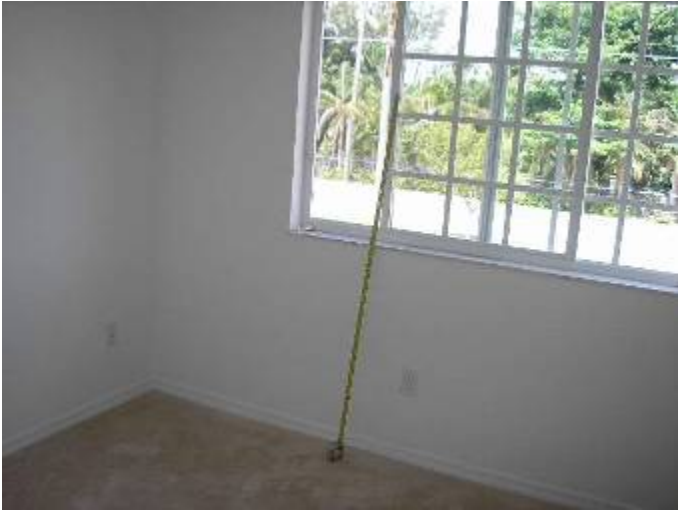
The height of the locks should not exceed 54 inches at the bedroom windows.

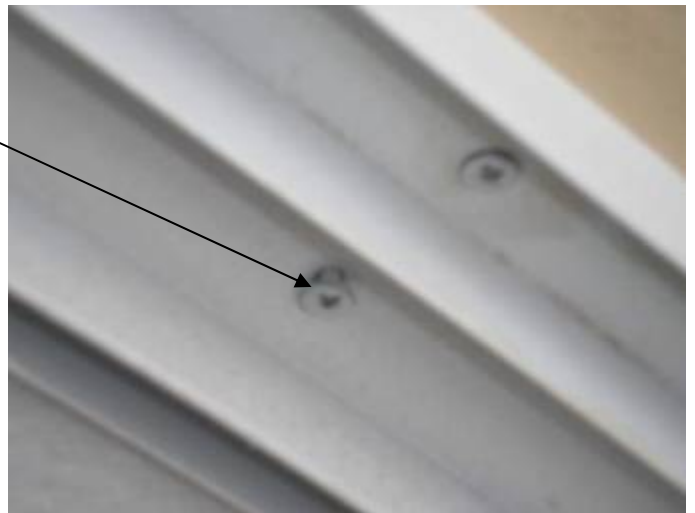
Some of the screw anchors not completely set & not sealed to prevent water & pest intrusion at the sliding glass door frame. FBC §13-606.1.ABC.1.2., §1707.4.4.1

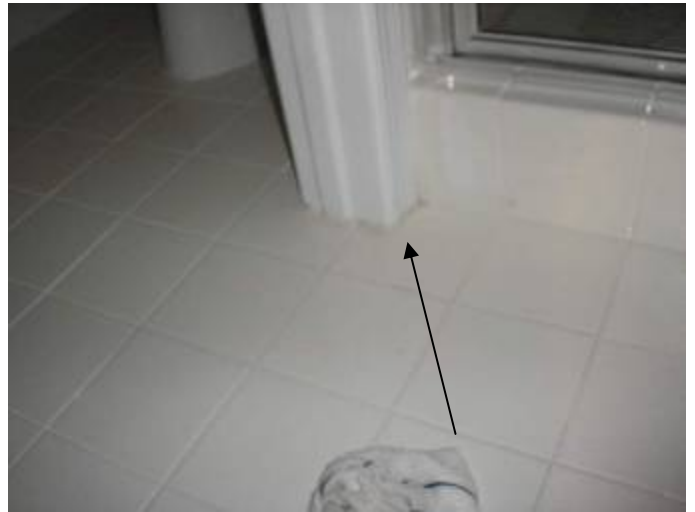
Water leaked from the shower through the wall to the master bathroom floor after about ½ hr. §P417.5.2

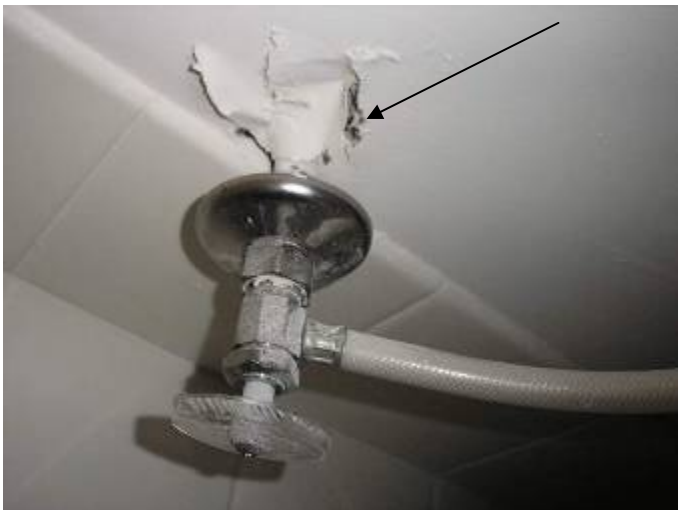
Some of the plumbing supply lines are not correctly secured or sealed at/behind the wall at the W.C. (toilets) & for the sink faucets.

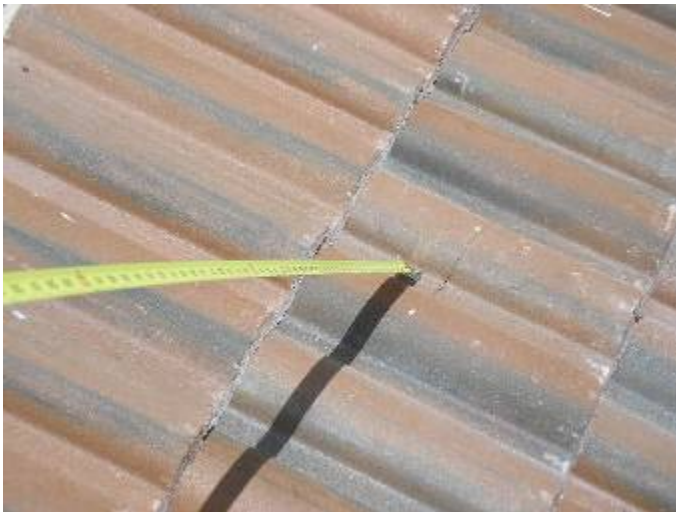
There were broken & incorrectly repaired roof tiles at several locations. The broken roof tiles should be removed & replaced, not “glued” back together.

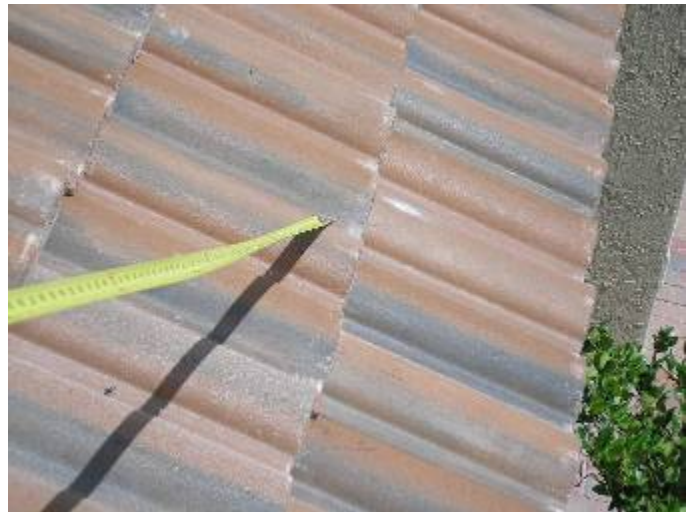
There should not be any broken tiles on the new roof. The tiles need to be removed & replaced; not “glued” back together.

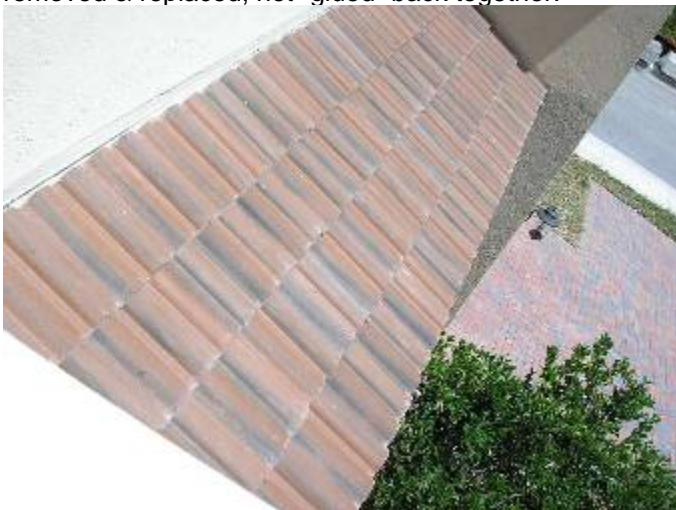
Location of the previous photo/s from the master balcony. The builder does not permit inspectors to walk on the roof.

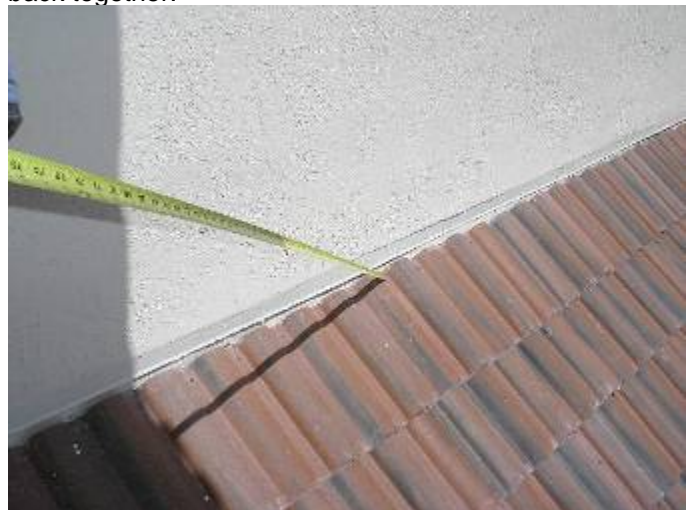
The roof wall abutments have not been correctly pointed up with mortar at the back patio. R118-3.13

R118-3.13A. Cut tile to fit approximately 1/2 in. to base of walls. Fill void with mortar and point to finish.

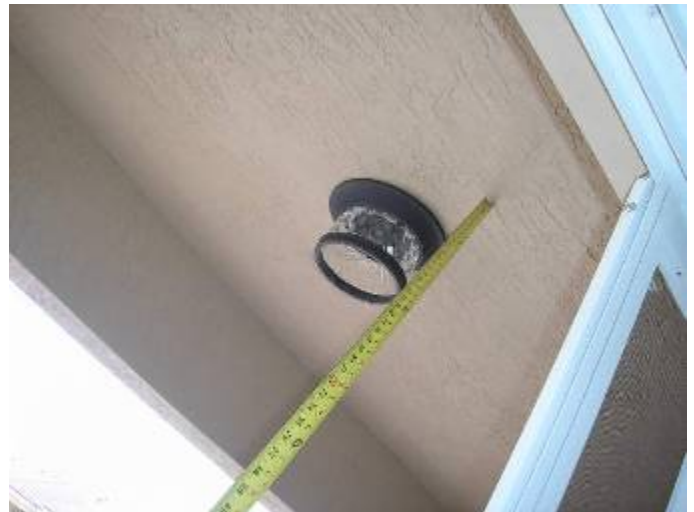
Some of the stucco work appears to be uneven, curved in/concave & not the proper depth. ASTM C 926, §2504.2 §1403.1.3

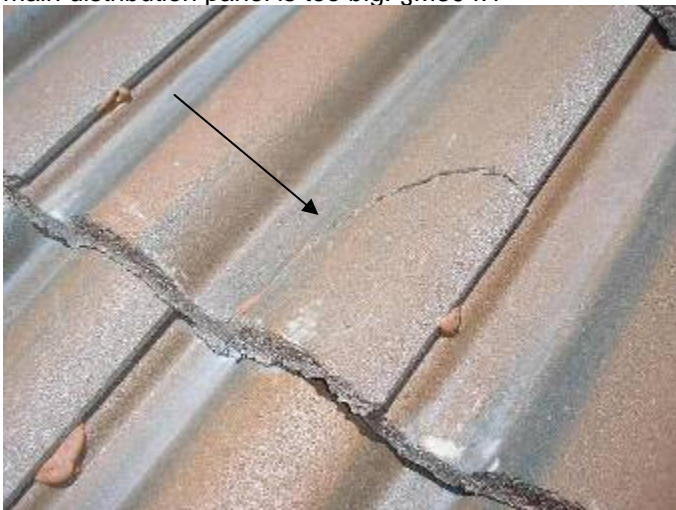
There were broken & incorrectly repaired roof tiles at several locations. The broken roof tiles should be removed & replaced, not "glued" back together.

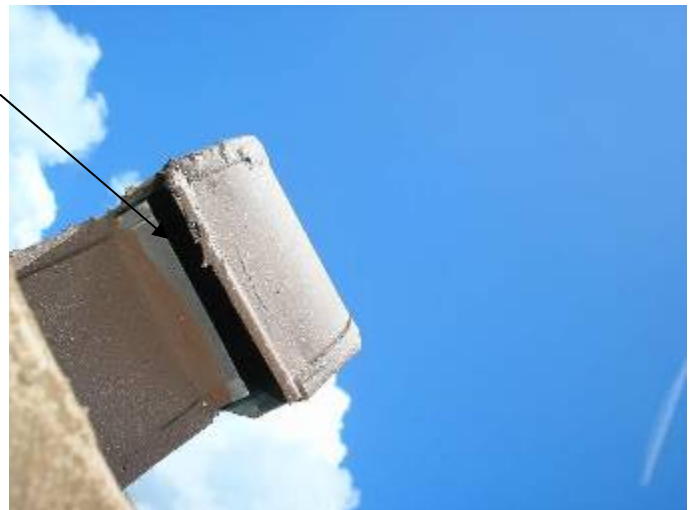
Some of the exhaust vent hoods do not appear to have the correct screening or dampers to prevent pest intrusion.

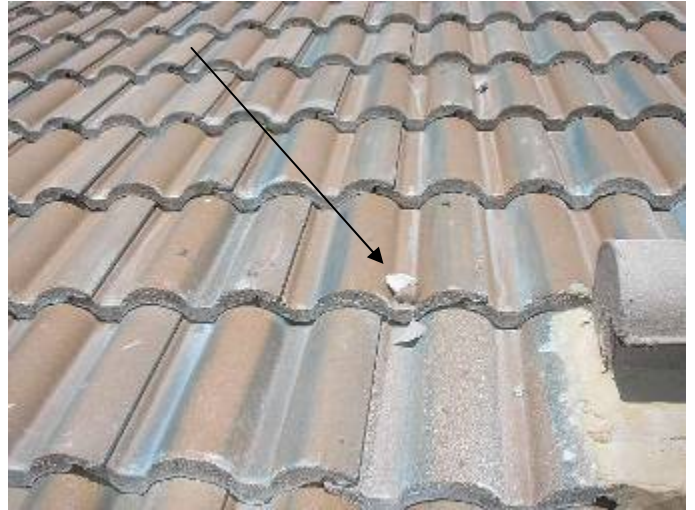
There is broken tile & debris at several locations.

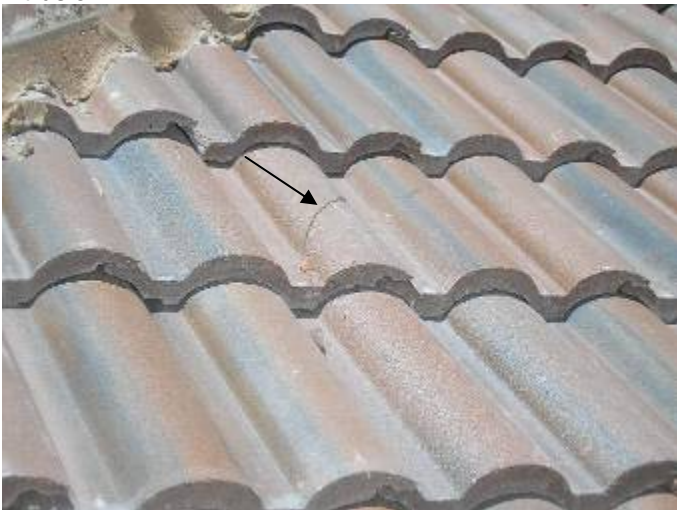
There were broken & incorrectly repaired roof tiles at several locations. The broken roof tiles should be removed & replaced, not "glued" back together.

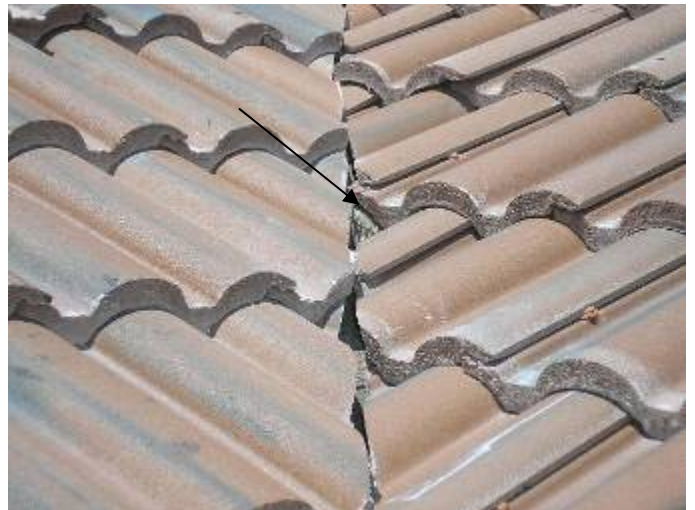
There is broken tile & debris in some valley locations.

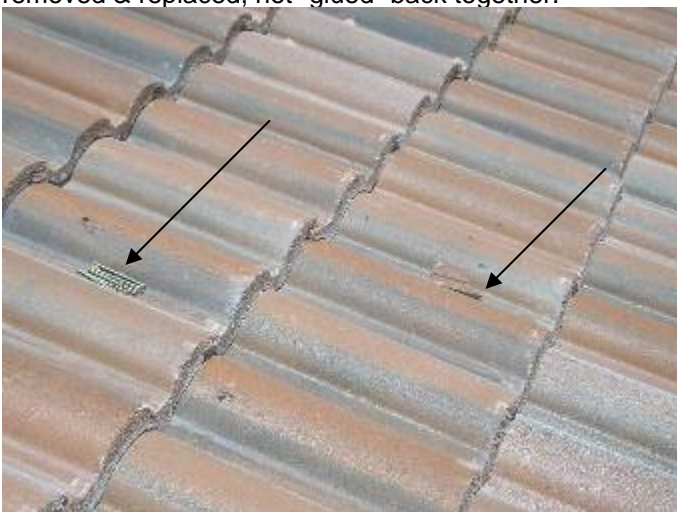
There is broken tile & debris at several locations.

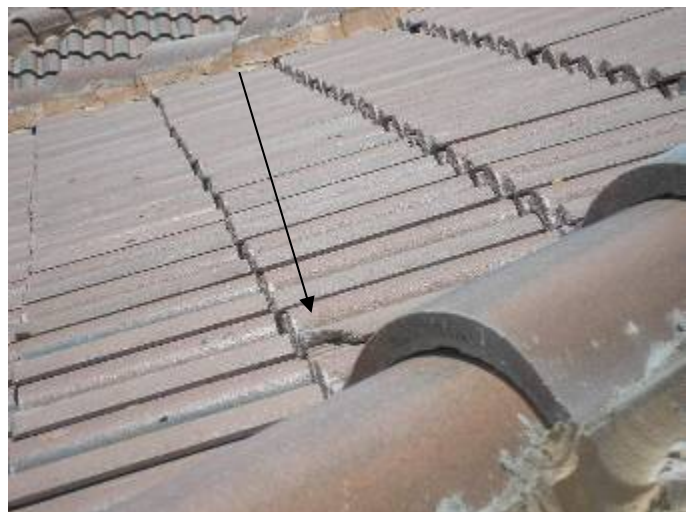
There were broken & incorrectly repaired roof tiles at multiple locations. The broken roof tiles should be removed & replaced, not "glued" back together.

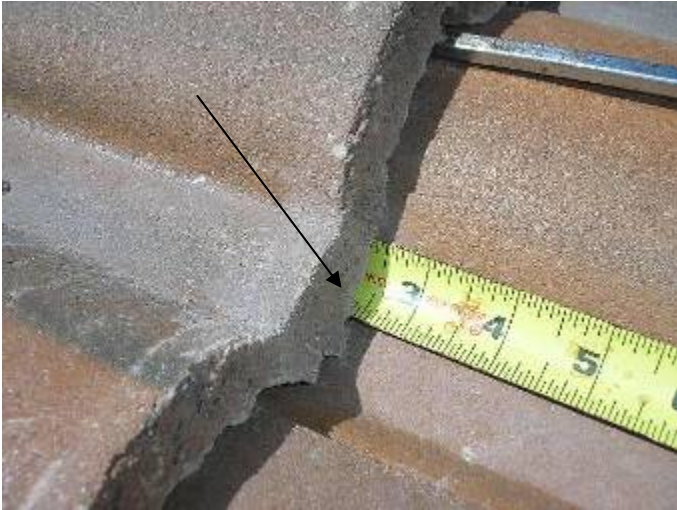
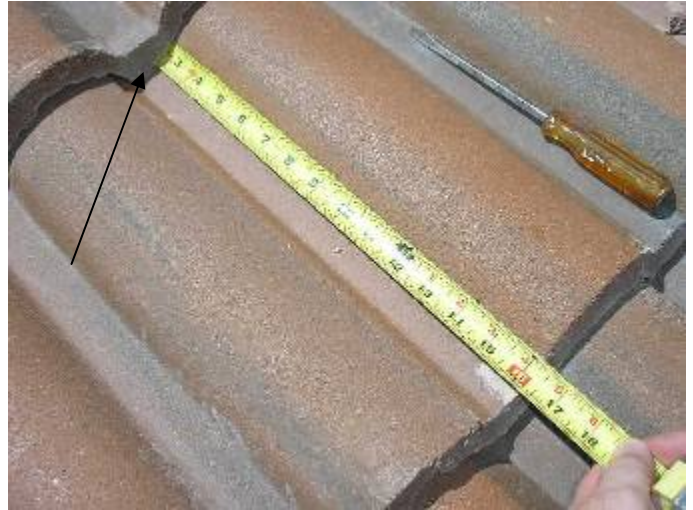
See the documentation from the builder that states the tile headlap does not need to be a minimum of 3 inches in all cases.

The roof tiles are 16 & 1/2" in length. There should be no more than 13 & 1/2 inches of exposed roof tile to allow for the correct headlap. §1518.8.11

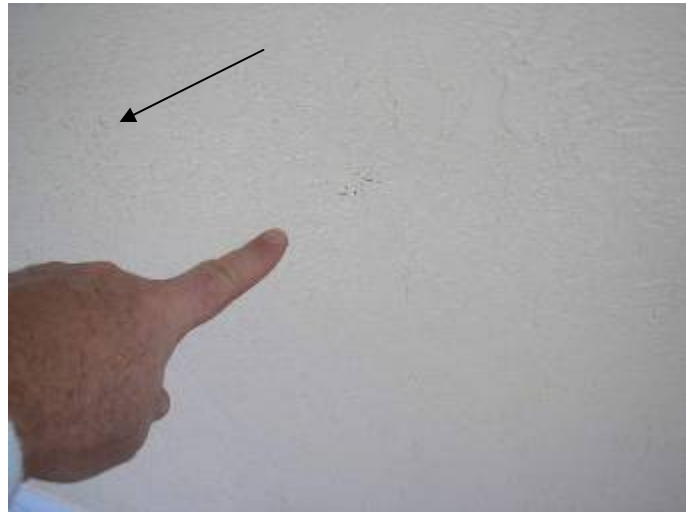
Some of the stucco is visible indicating there is not enough paint on the exterior walls.

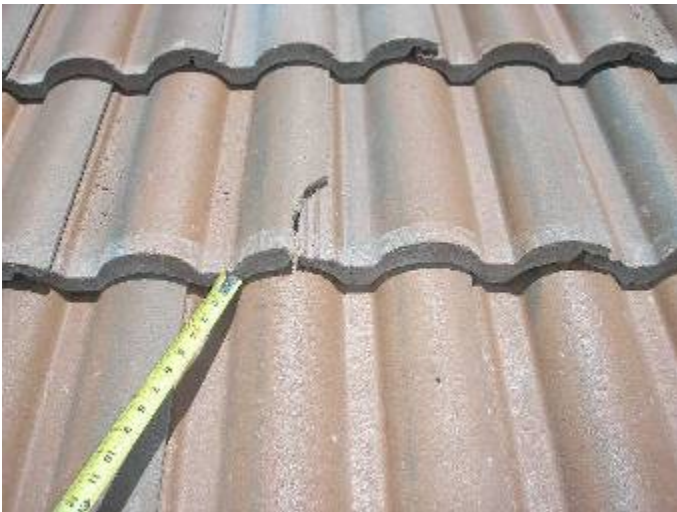
There should not be any broken tiles on the new roof. The tiles need to be removed & replaced; not "glued" back together.

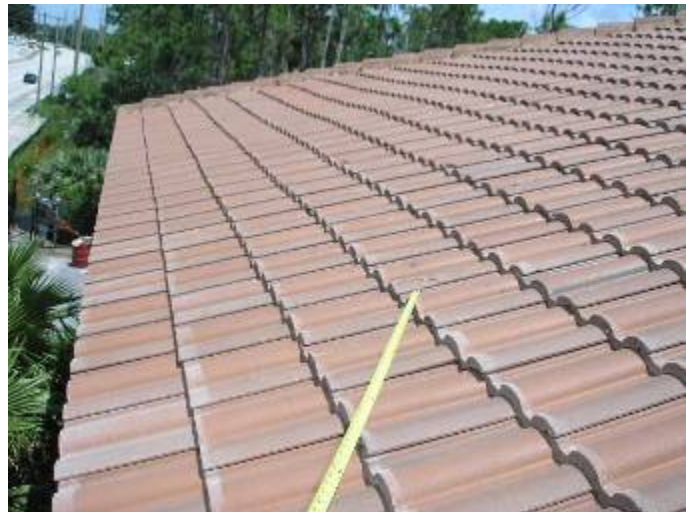
There were broken & incorrectly repaired roof tiles at several locations. The broken roof tiles should be removed & replaced, not "glued" back together.

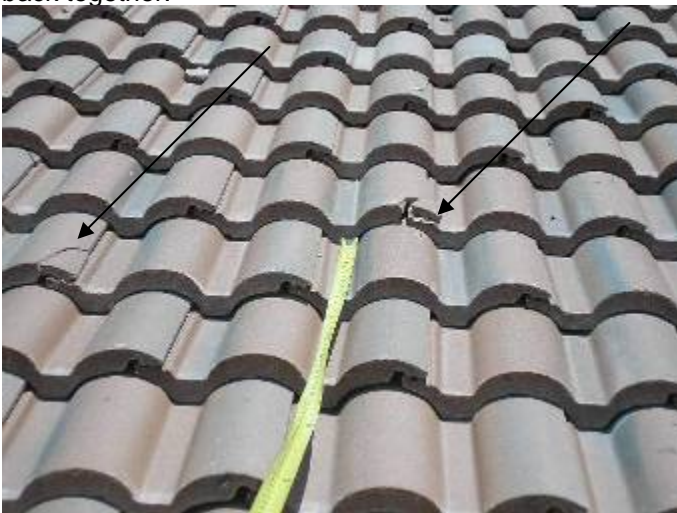
There were broken & incorrectly repaired roof tiles at several locations. The broken roof tiles should be removed & replaced, not "glued" back together.

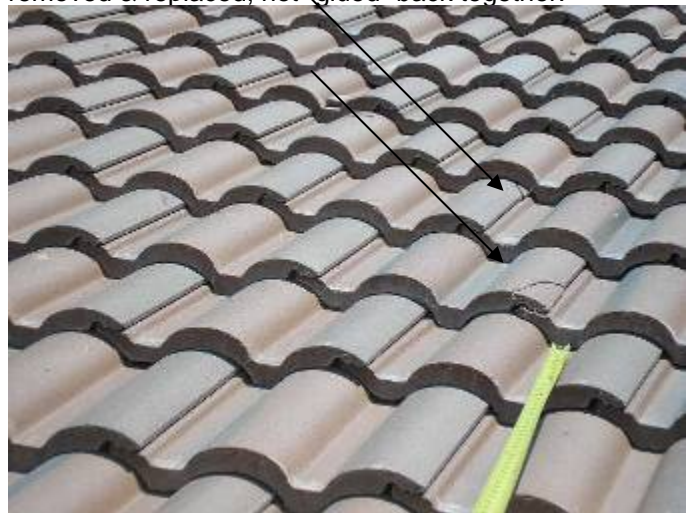
There should not be any broken tiles on the new roof. The tiles need to be removed & replaced; not "glued" back together.

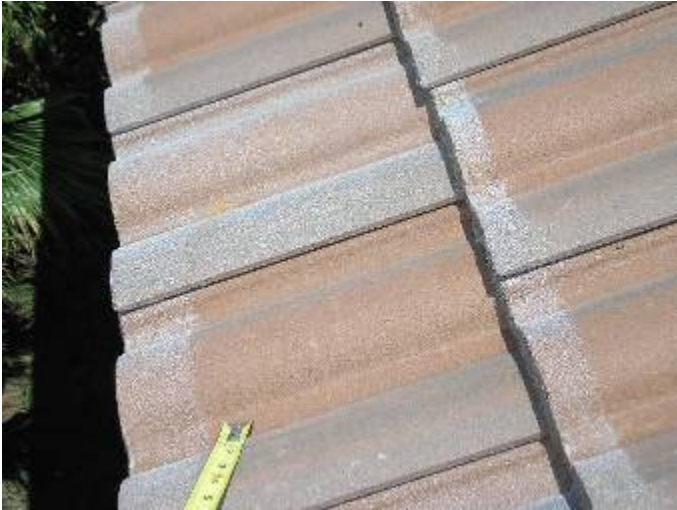
There is paint overspray on many of the roof tiles.

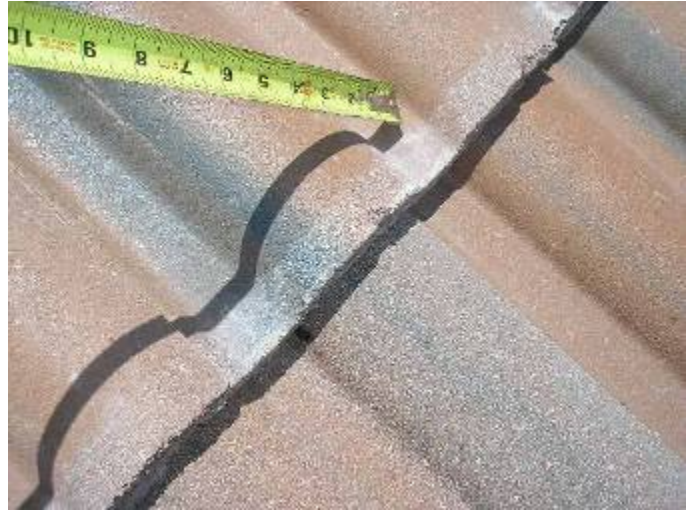
There is paint overspray on many of the roof tiles.

All debris should be removed from the roof.

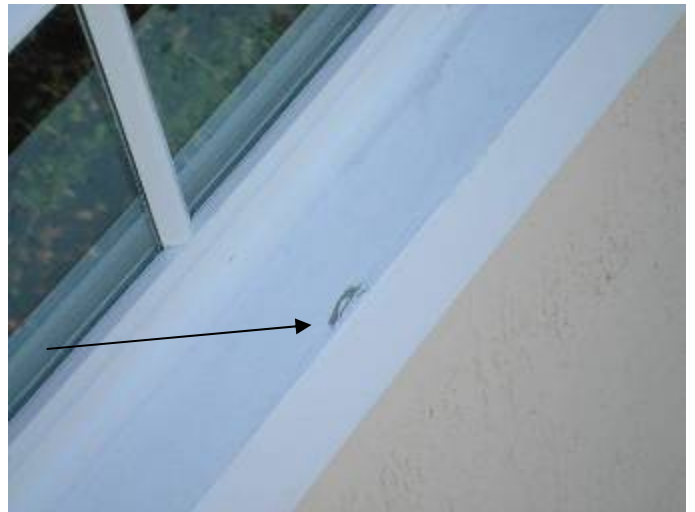
There was damage to the trim around the rear guest bedroom window.

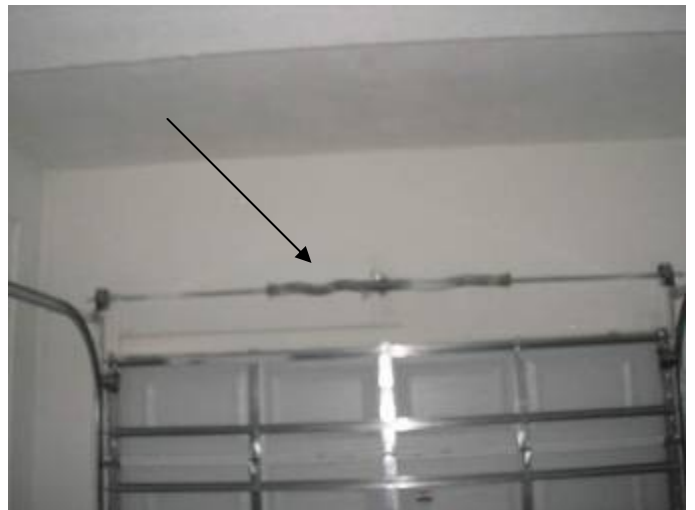
The garage vehicle auto door opener counter balance spring did not operate correctly. The door slams down when it is let go.

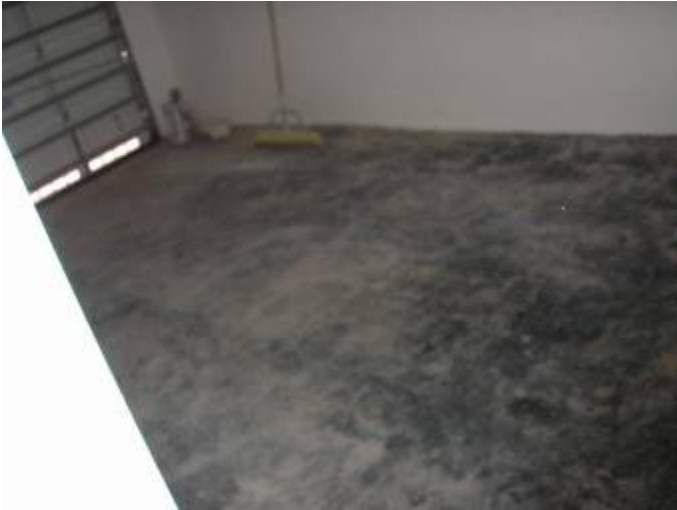
There is staining or discoloration on the garage floor. It does not appear that the discoloring can be washed away. The "new" floor should be painted.

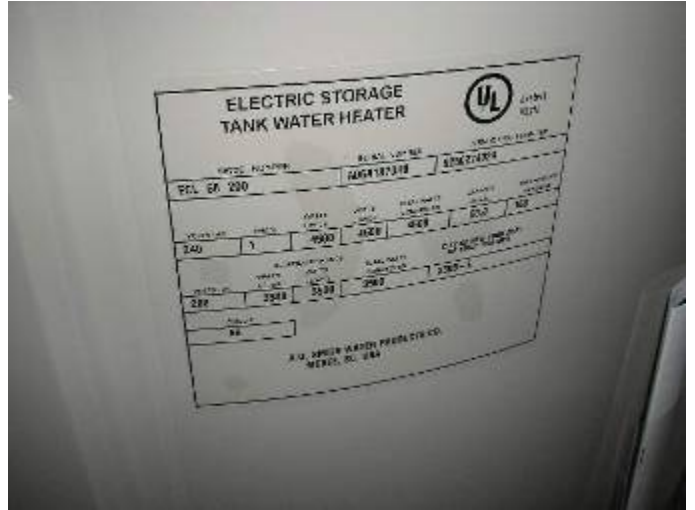
Note: 50 gallon electric water heater.

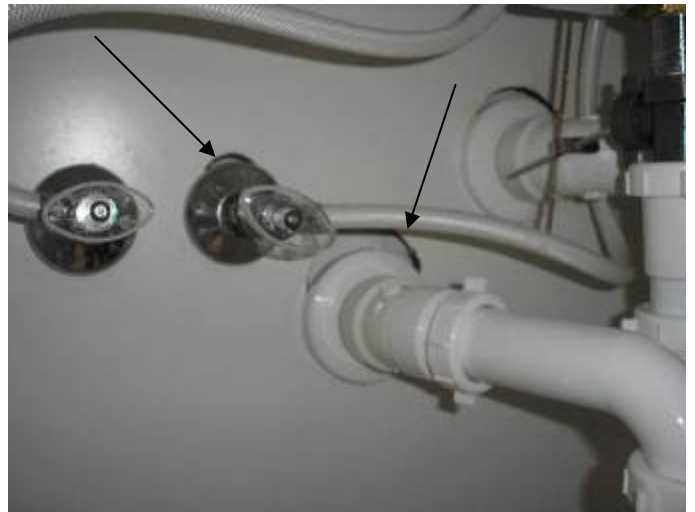
Some of the plumbing supply lines are not correctly secured or sealed at/behind the wall at the W.C. (toilets) & for the sink faucets.

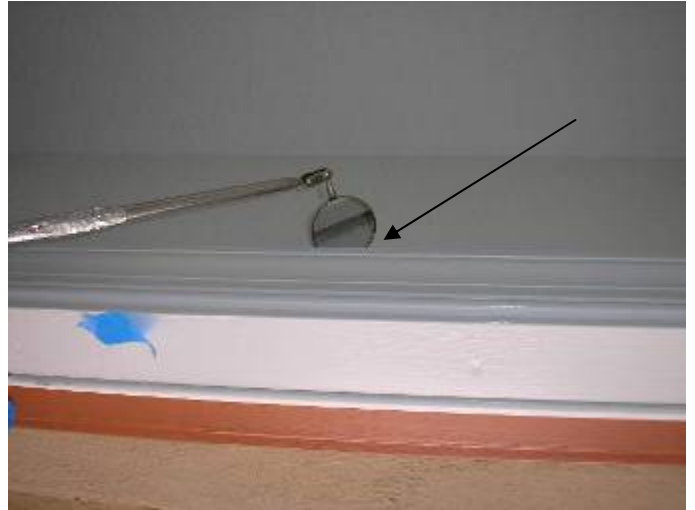
The top of the trim is not correctly sealed to prevent AC loss at the front & garage access door frames. FBC §13-606.1.ABC.1.2

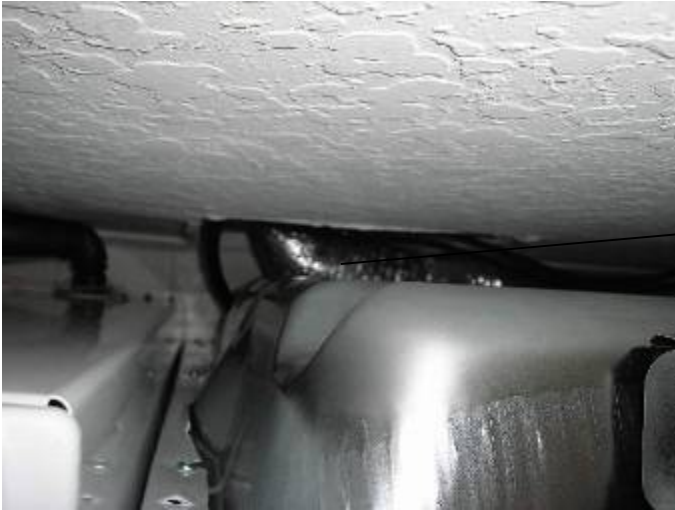
The foil vent duct is a fire hazard per the manufacturer.

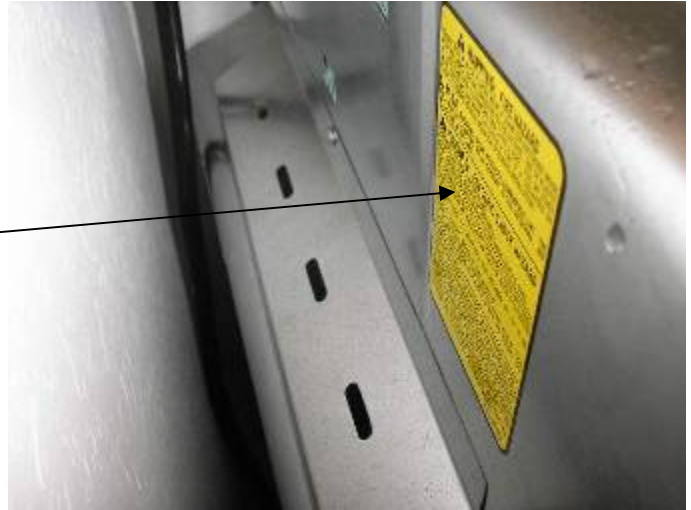
The thin aluminum foil dryer vent duct material is a fire hazard per CSPC & the manufacturer. See the warning label on the back of the dryer. §M304.1

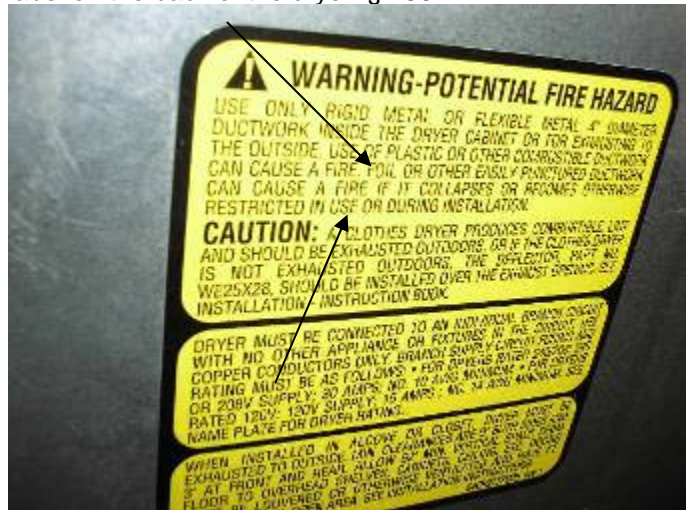
The thin aluminum foil dryer vent duct material is a fire hazard per CSPC & the manufacturer. See the warning label like this one on the back of the dryer. §M304.1

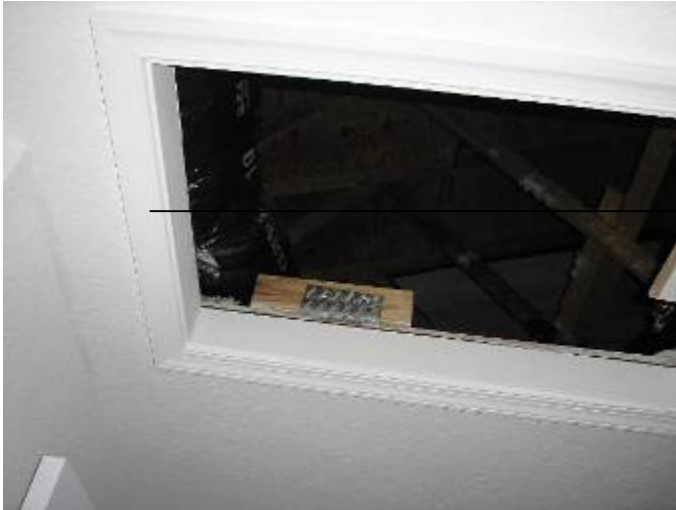
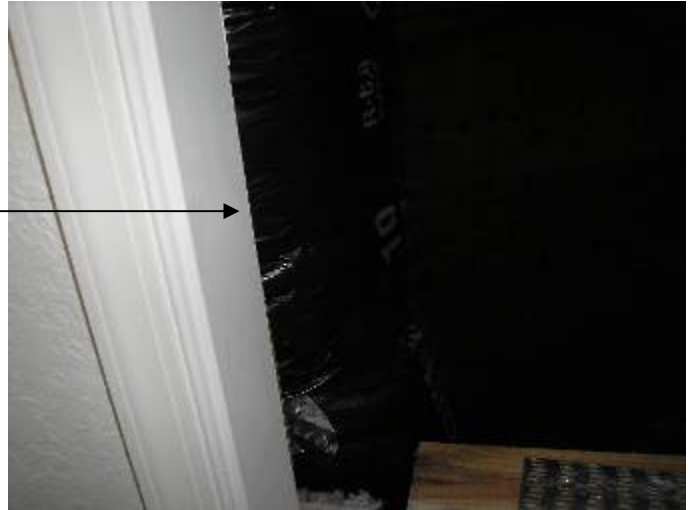
Next photos at the 2nd floor attic access. The builder does not permit the inspector to leave the ladder. A full attic inspection is recommended.

The ductwork is partially installed over the attic access. The duct should be moved to prevent damage & allow easy access into the attic.

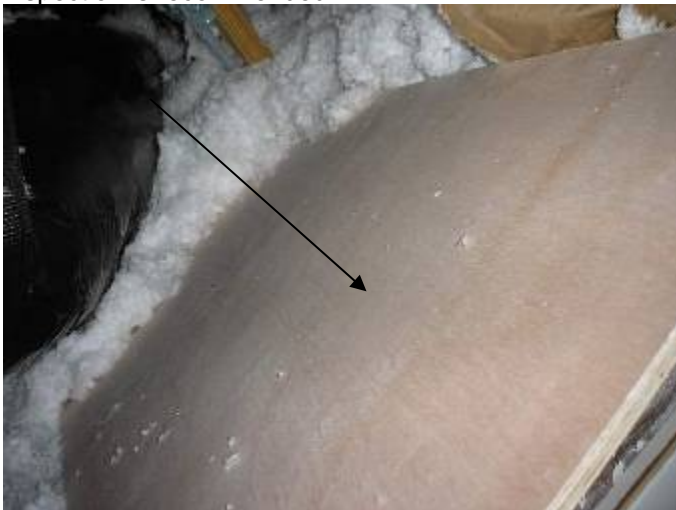
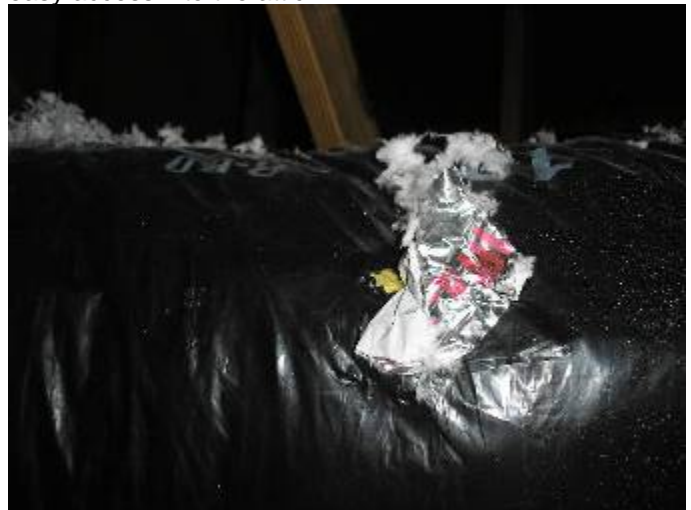
Insulation should be secured to the back of the attic access cover.

There is damage to the outer jacket of some of the AC ductwork. The duct should be correctly repaired.

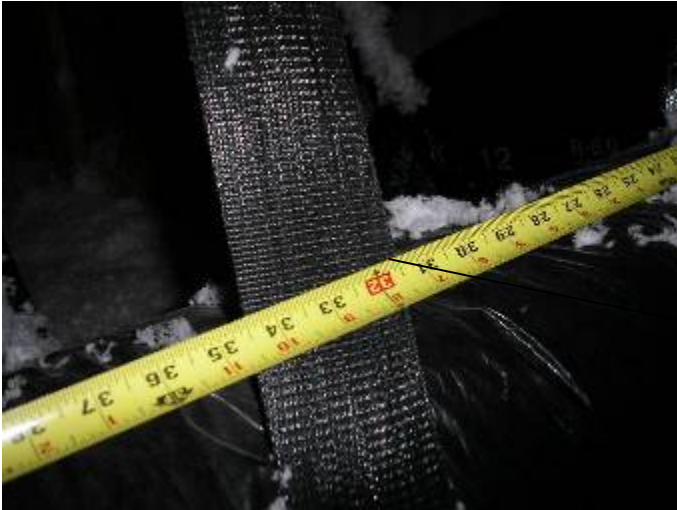
Some of the AC ductwork is not correctly installed or supported in the attic. The ducts are sagging & also need to be supported within 18" of connections or fittings.

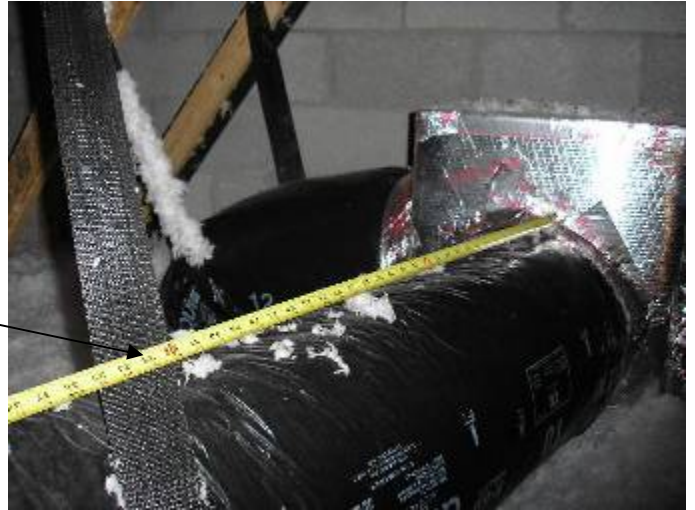
Some of the AC ductwork is not correctly installed or supported in the attic. §13-610.1.ABC.3.3.6

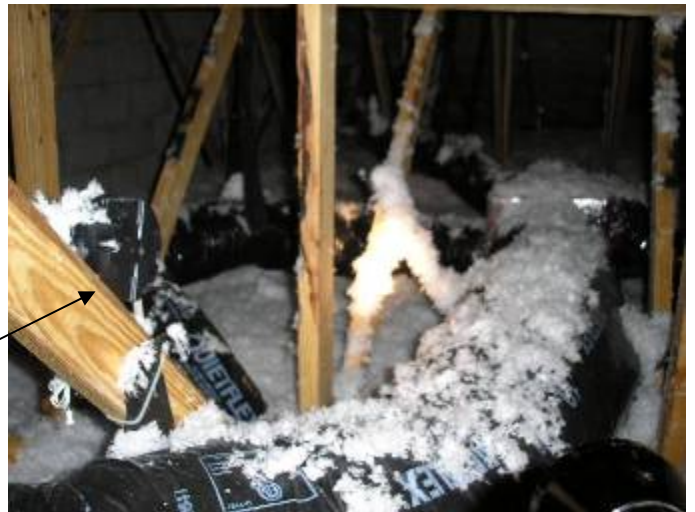
Some of the AC ductwork is not correctly installed or supported in the attic. §13-610.1.ABC.3.3.6

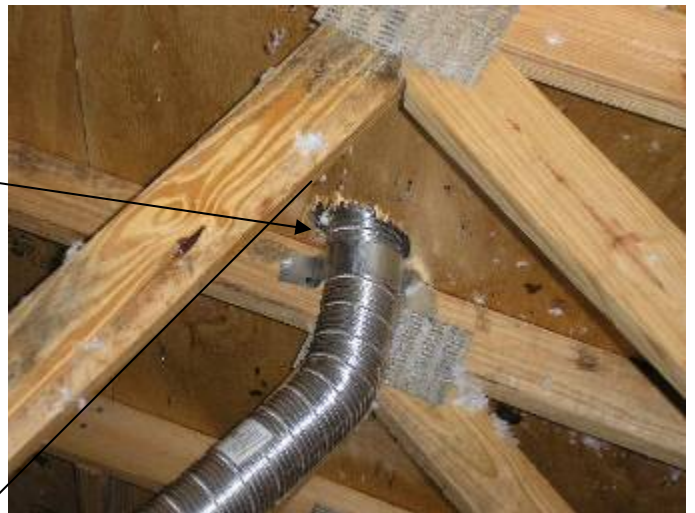
The area around the exhaust vent ducting is not sealed to prevent water & pest intrusion into the attic & house.

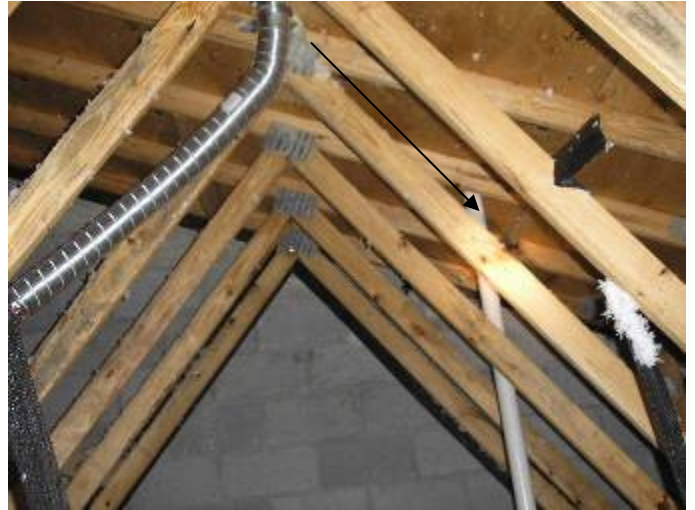
The plumbing drain waste vent stack terminates too close to bath exhaust vent opening. Sewer gasses can re-enter attic & house- Potential Hazard. §P904.5
Florida Building Code

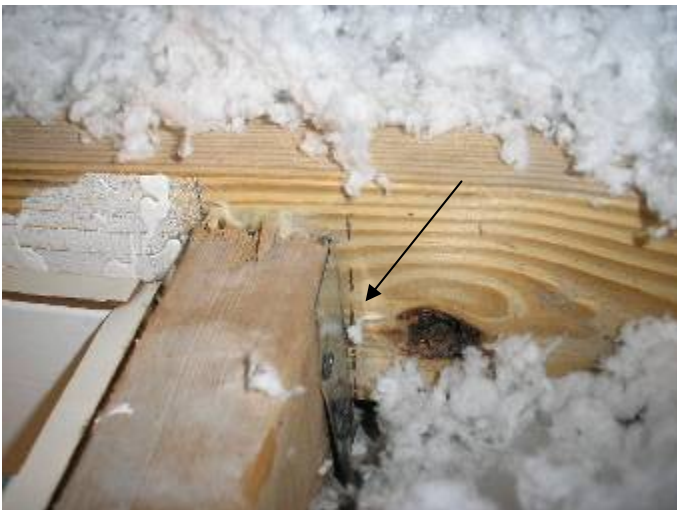
The drywall screws & light gauge metal are not designed to support the weight of persons entering the guest house attic. §2504.5

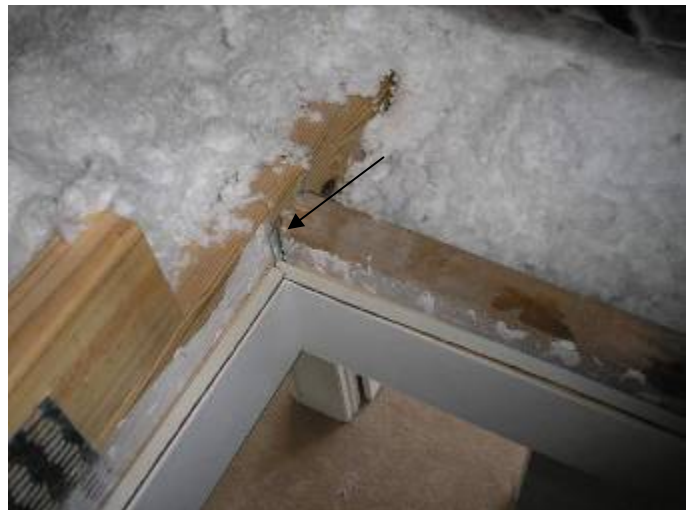
The drywall screws & light gauge metal are not designed to support the weight of persons entering the guest house attic. §2504.5

Drywall screws & light, 25 gauge metal framing studs are not designed to support persons entering an attic at the 2x4 wood blocking between the trusses. §2504.5.1

The 2x4 blocking should be secured through the trusses with 16d nails.
