January 12, 2007

13304 W. Stella Lane
Litchfield Park, AZ 85340

Re: Inspection

The purpose of this inspection was to document the areas of structural movement and damage. The following report details those areas of the home that have experienced structural movement. We have included photographs to help explain our findings.

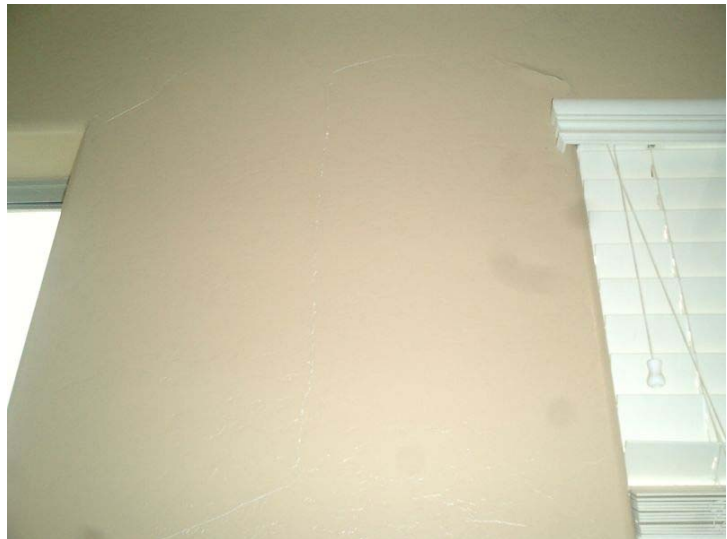
The kitchen window drywall is cracked between window sill and countertop.

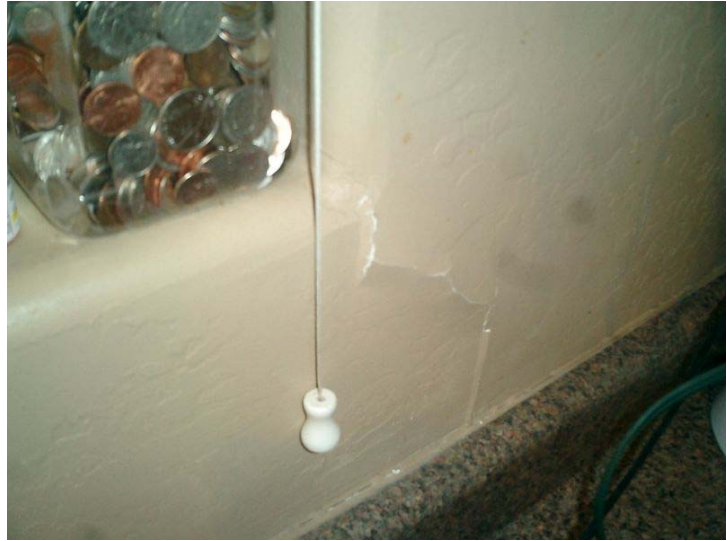
- ◆ The kitchen east wall has diagonal drywall movement cracks at top north and south corners and lower south corner
- ◆ The kitchen floor tiles are hollow sounding (not fully bonded to concrete)
- ◆ Six tiles at bottom of stairs are missing due to “peaked” tiles that came loose
- ◆ The kitchen east wall countertop backsplash has separated from the wall
- ◆ The kitchen east exterior wall below south side of window has a three foot vertical crack
- ◆ The kitchen east exterior window above top south corner has three diagonal cracks three to four feet long

The top south side of the kitchen window has diagonal drywall cracking.

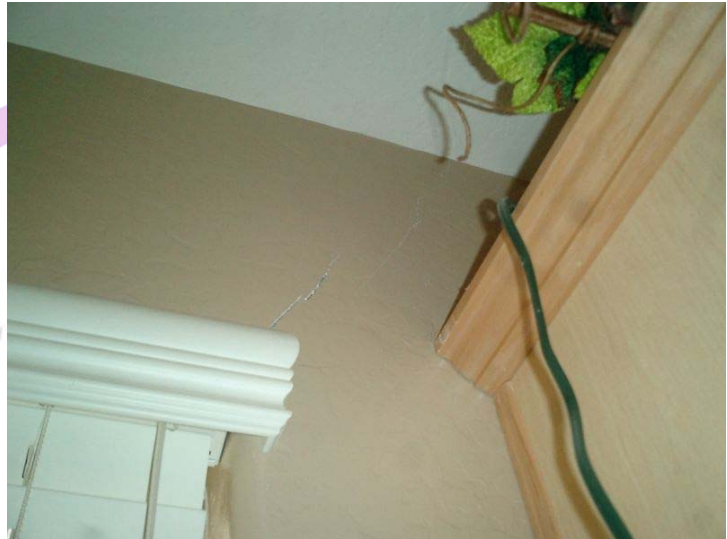
- ◆ The breakfast nook east wall between kitchen window and south fixed window has a 12” diagonal crack and a 30” vertical crack
- ◆ The southeast vertical wall corner under bar top has a hairline crack
- ◆ The east wall baseboard has separated from wall 4’ north of south corner
- ◆ The east wall has a 16” concrete diagonal crack at bottom north side of north window with a horizontal 16” crack below to north corner
- ◆ The east wall has a horizontal crack from north corner 10’ south at 4’ high
- ◆ The east wall has three small drywall cornerbead cracks at east windows
- ◆ The breakfast nook floor tiles are hollow sounding (not fully bonded to concrete)

The breakfast nook east wall at north end has a horizontal and diagonal drywall crack.

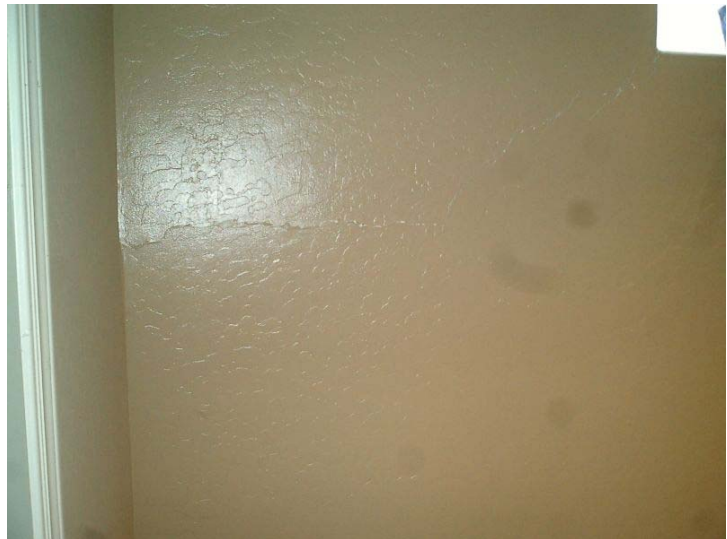
View of the breakfast nook east wall horizontal crack.

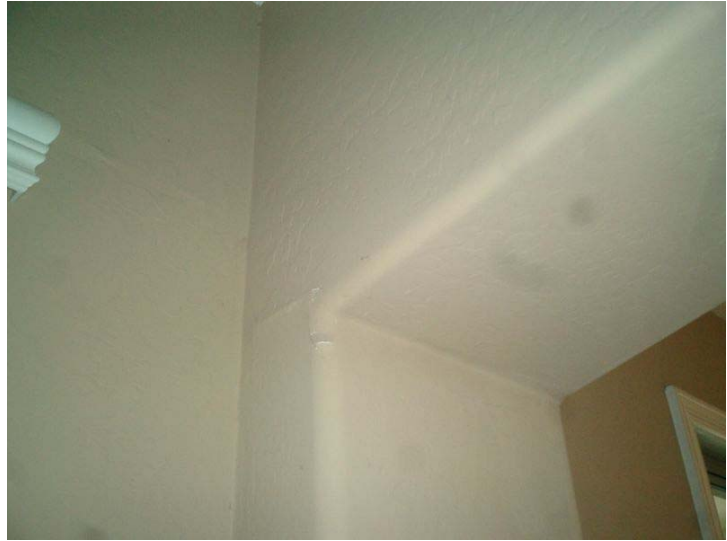
- ◆ Ceiling peak at east end has an 8" crack

The upper hall/master bedroom ceiling peak at east end has a drywall crack.

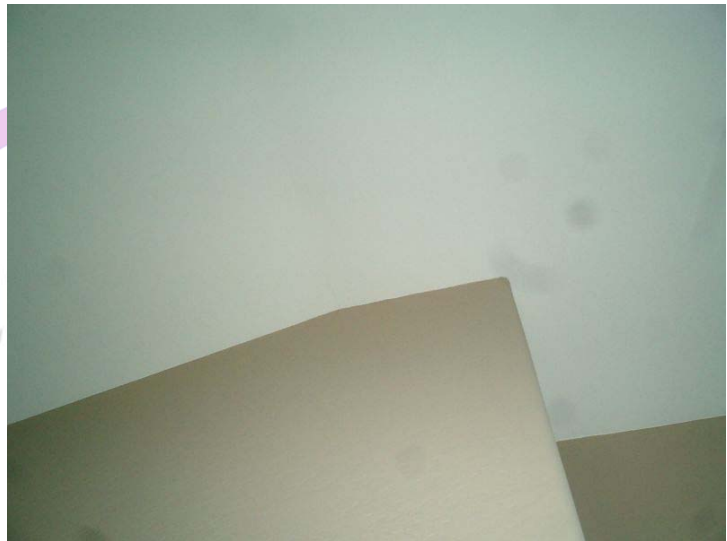
- ◆ The east wall has a 9' long horizontal crack at 4-1/2 high and a vertical 4' concrete crack 30" north of south wall
- ◆ The entry door is 1/2" out of alignment with jamb at top and lock won't latch
- ◆ A horizontal crack at top east side of door 12" long

The northeast bedroom east wall has horizontal and vertical drywall cracking.

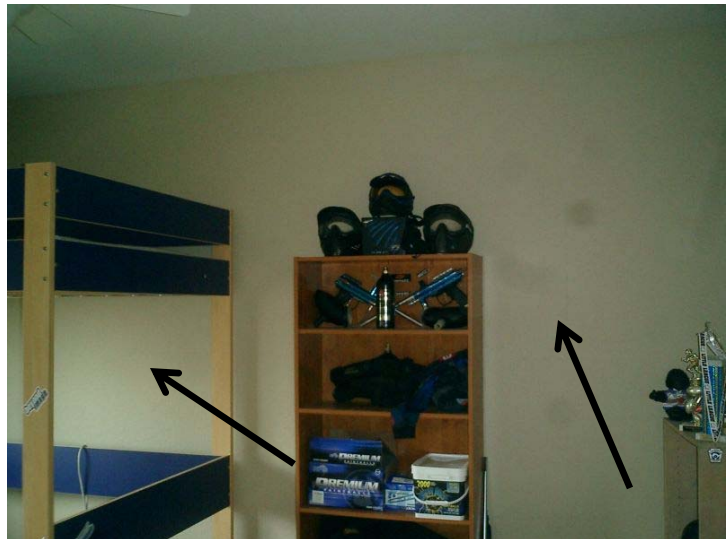
View of the northeast bedroom east wall drywall cracks.

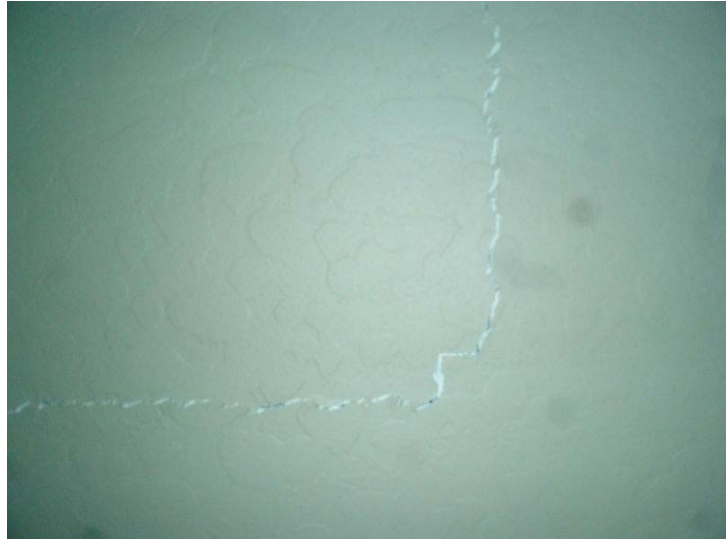
- ◆ The entry door wall (southwest) has a vertical 10” crack above west side of top window
- ◆ A moisture stain is visible at southwest wall between windows
- ◆ The southwest wall between windows has a vertical crack at east side

View of vertical crack and moisture stain at foyer wall between windows.

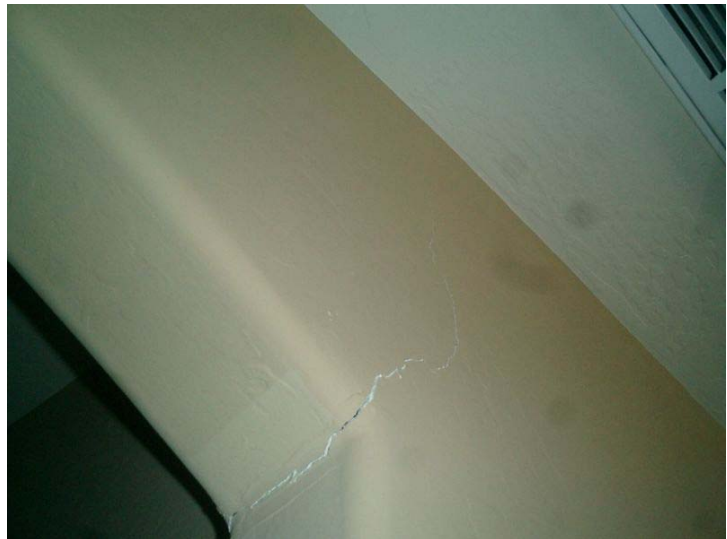
View of upper game room north wall.

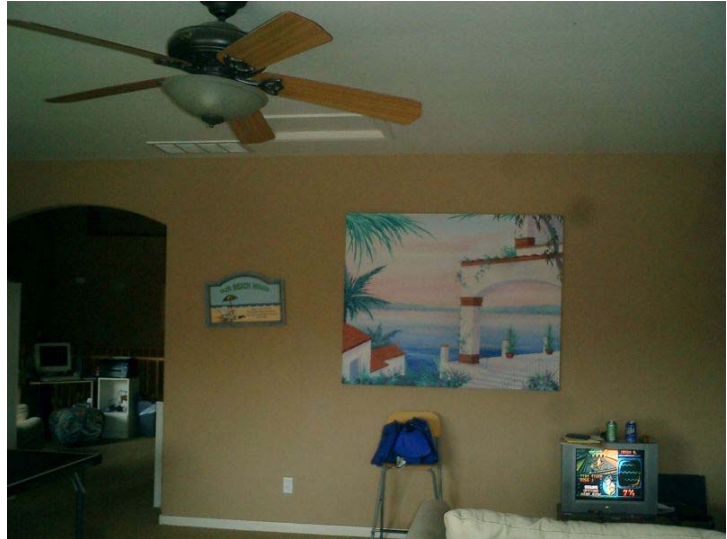
- ◆ The north ceiling along north wall has 26 nail pops (below east to west girder truss)
- ◆ The north wall at top east side of arch has a diagonal/vertical crack from arch to ceiling

The upper game room ceiling has multiple drywall nail "pops" along north wall.

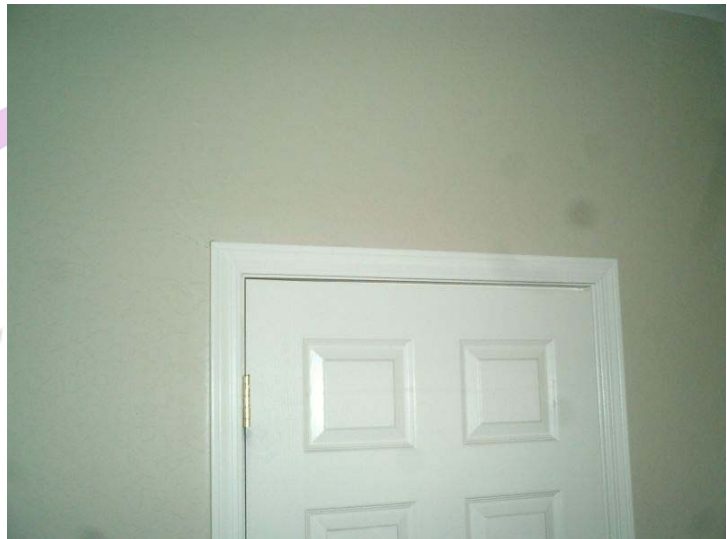
The northeast bedroom entry door is out of alignment with the top jamb.
