# Re-Inspection & 3rd Walk Through Inspection of 1076 Fleming Way 7.19.06

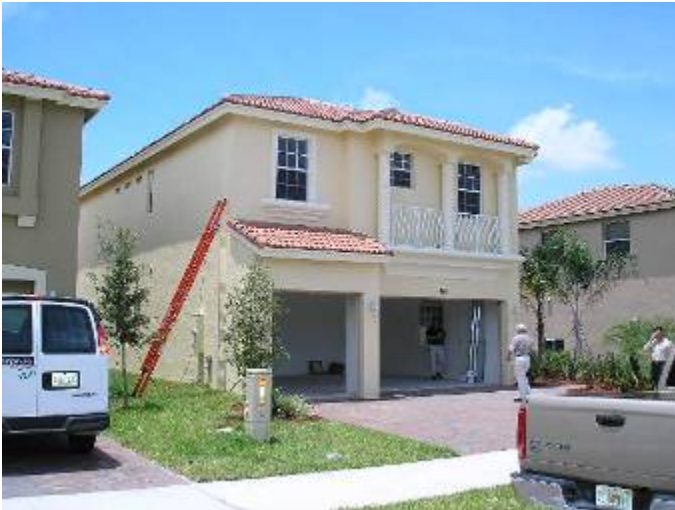
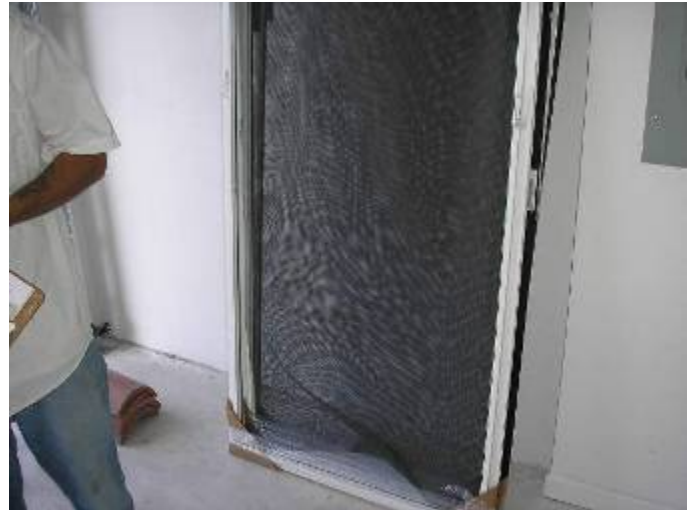
The rear sliding screen door was damaged at the time of the inspection. The builder's representative contacted a repair person to correct the condition.

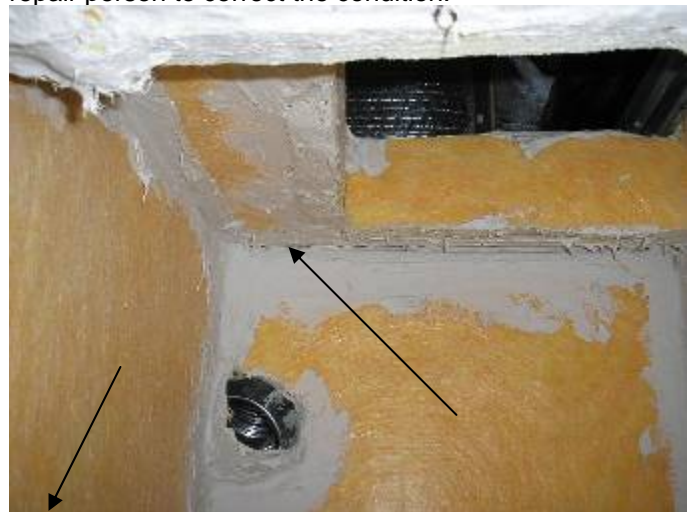
Repairs to the duct board were completed during the 3<sup>rd</sup> inspection.

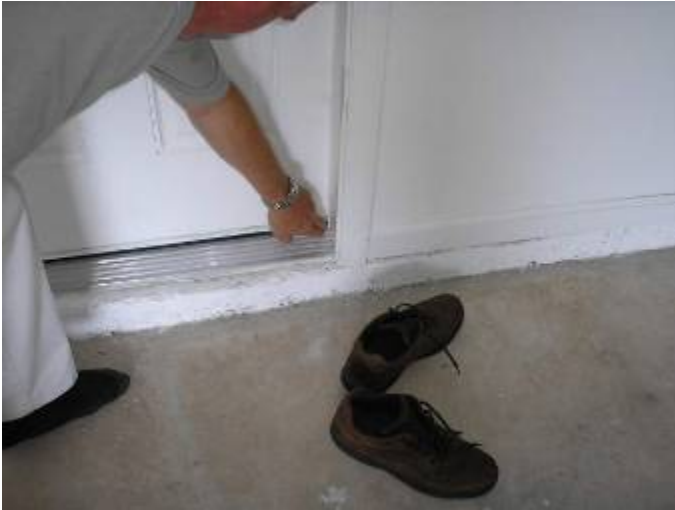
There was an unsealed gap between the door & frame at the garage/laundry area access. §13-606.1.ABC.1.2

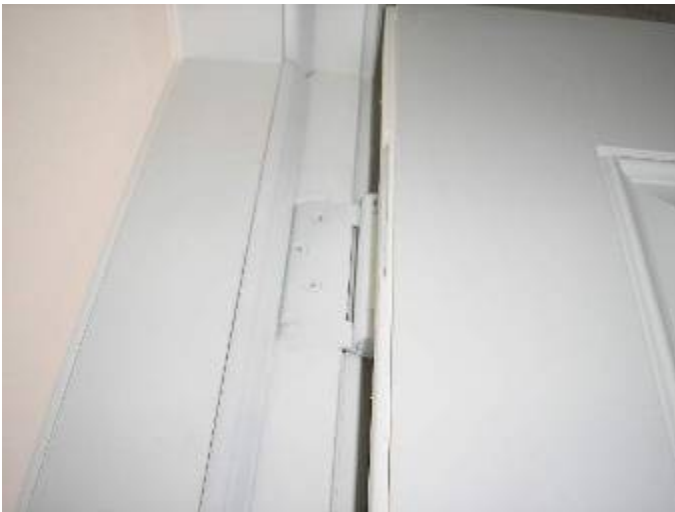
Touch-up paint was applied at the hinges at the garage/laundry door frame at the time of the inspection.

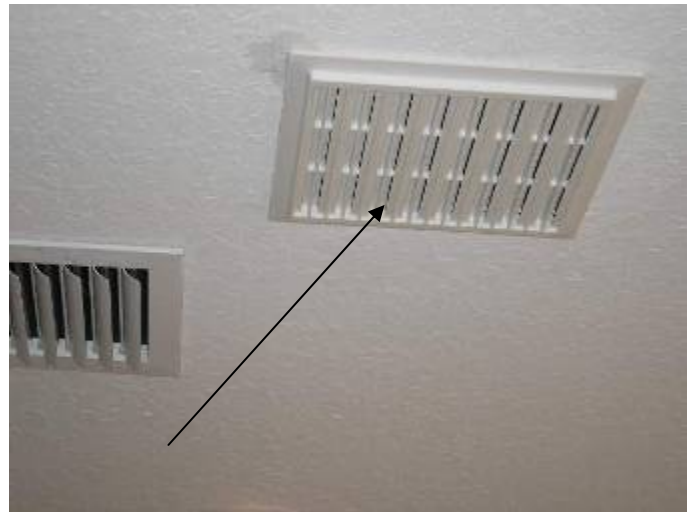
The exhaust vent fan was still very noisy & not operating correctly at the 2<sup>nd</sup> floor SW guest bathroom. The repair to the fan was in progress at the end of the inspection.

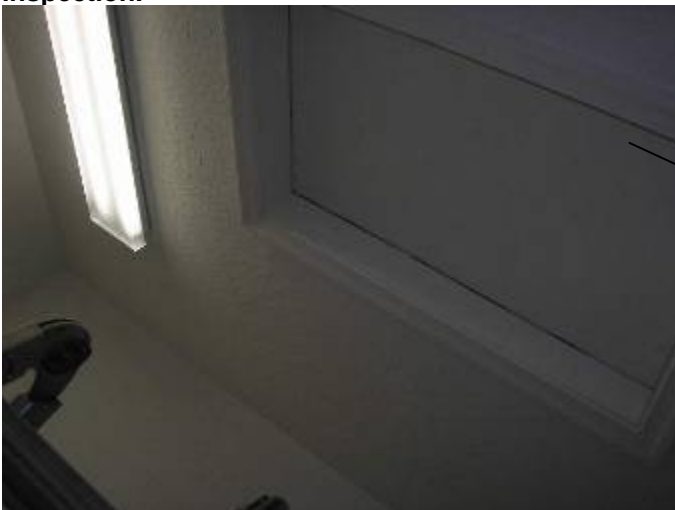
Permission to view the attic space from a ladder was given at this inspection.

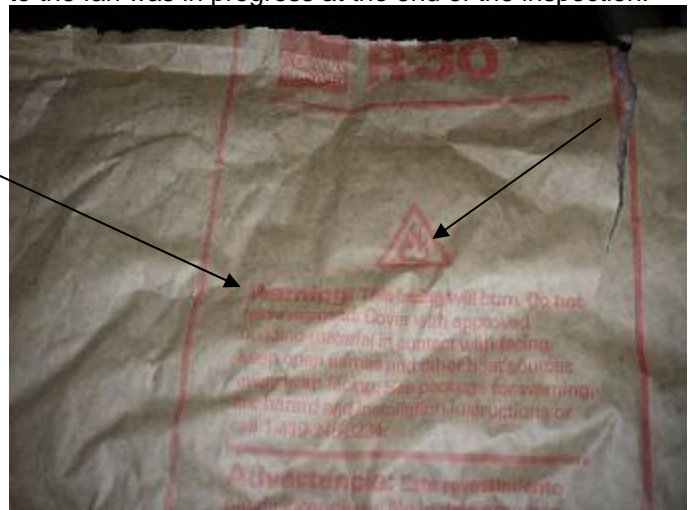
There is exposed kraft paper insulation backing in the attic. The manufacturer states the facing will burn & should not be exposed. §M304.1, §708.2

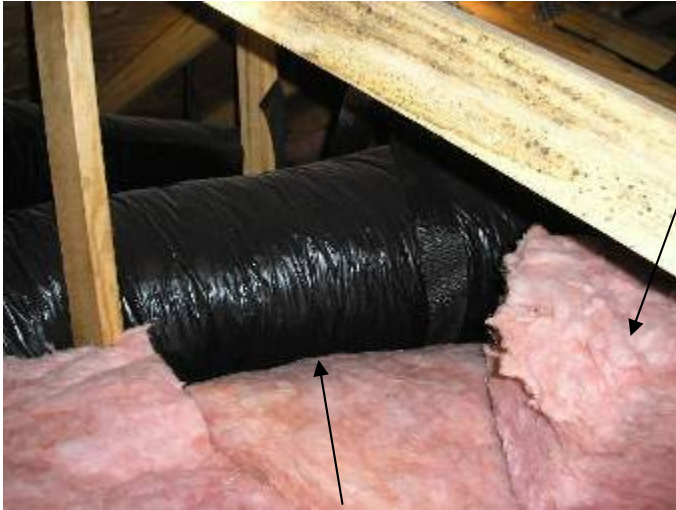
Some of the ductwork was not correctly supported off the attic insulation or other ductwork to prevent condensation & related problems. §M603.11, §M603.5.6.6

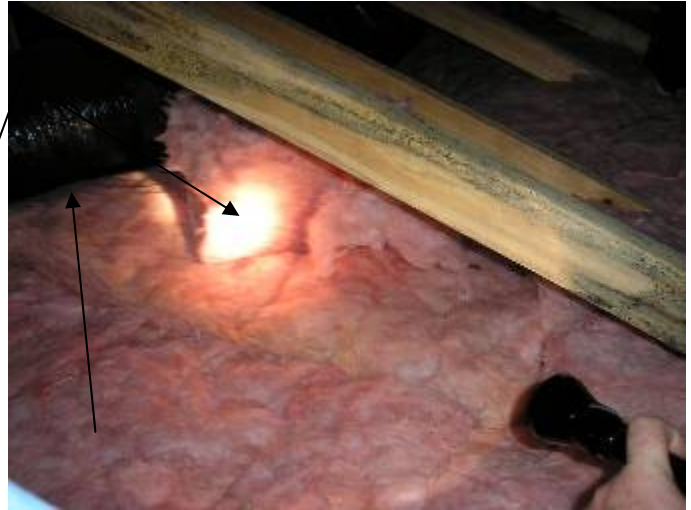
All debris & insulation scraps should be removed from the attic.

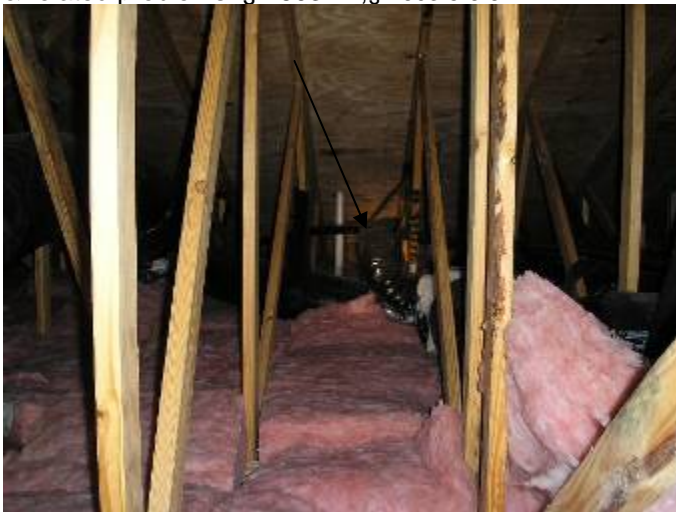
Some of the ductwork was not correctly supported off the attic insulation or other ductwork to prevent condensation & related problems. §M603.11, §M603.5.6.6

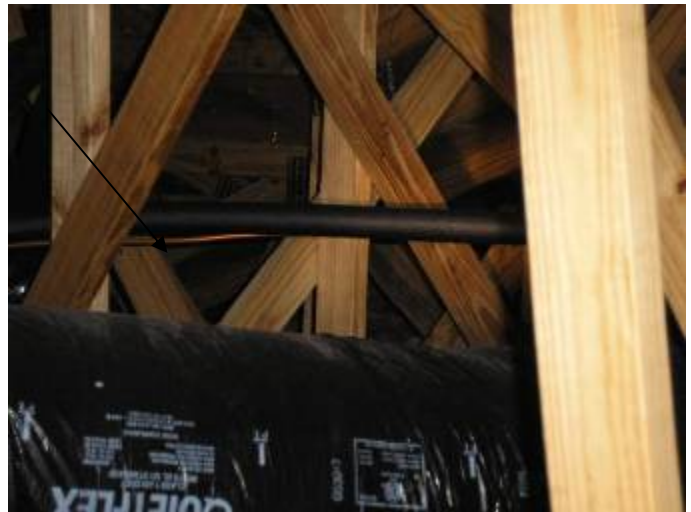
Some of the AC refrigerant line piping was not correctly supported in the attic. §M305.4

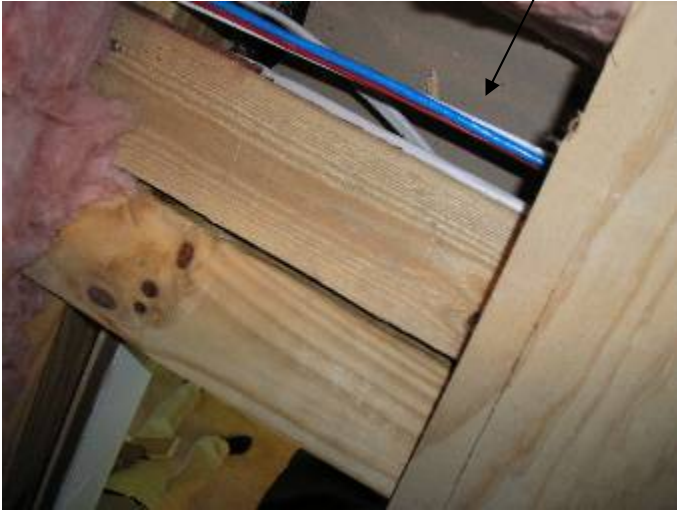
Insulation had not been installed at the back of the drywall by the attic access opening. §13-604.1.ABC.1

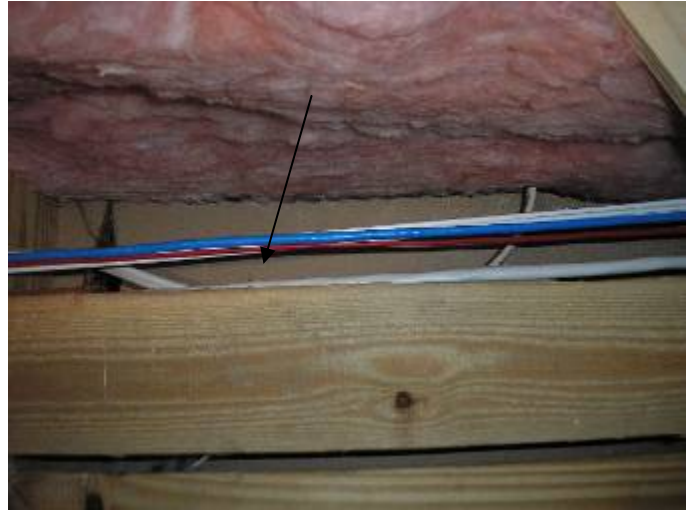
Insulation had not been installed at the back of the drywall by the attic access opening. §13-604.1.ABC.1

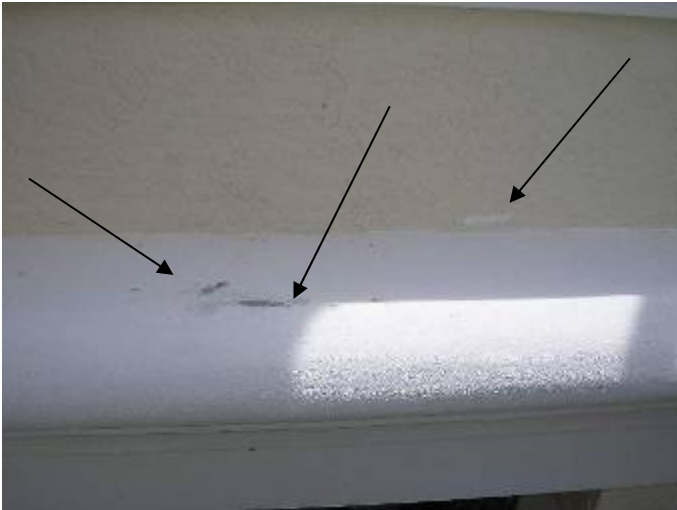
There were some areas that needed paint touch-up &/or cleaning.

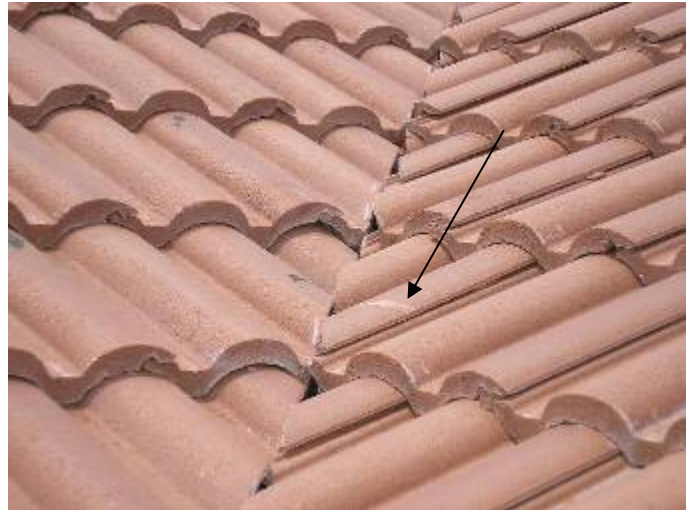
There were some broken tile pieces that were incorrectly "glued" back together with an RT-600 type adhesive product. These tiles should be removed & replaced.

**Broken roof tiles cannot be "glued" back together**

**Thanks for your inquiry regarding our products. RT600 is specified for replacing an entire tile, not for gluing a broken tile back together. Please email or call (800) 624-7767 with any questions. Sincerely, BHeineking OSI Sealants / Tech Service**

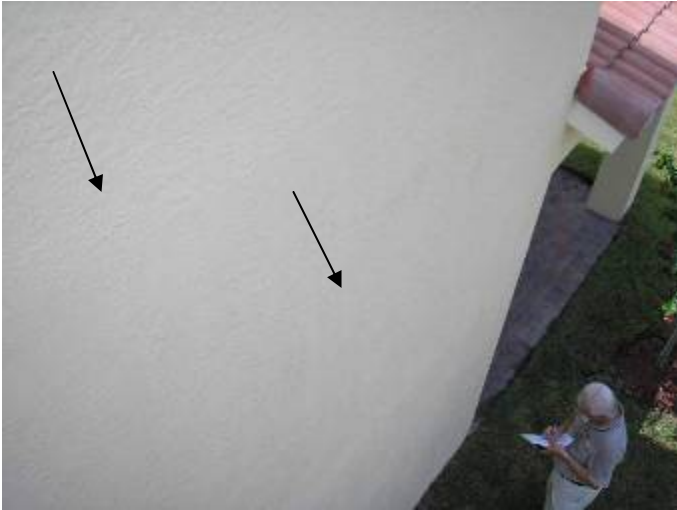
There were still some areas with exposed stucco & not enough paint on the exterior walls.

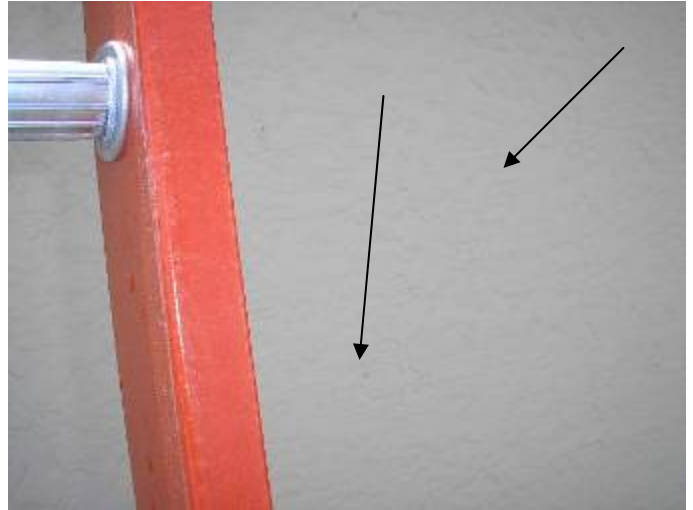
There were still some areas with exposed stucco & not enough paint on the exterior walls.

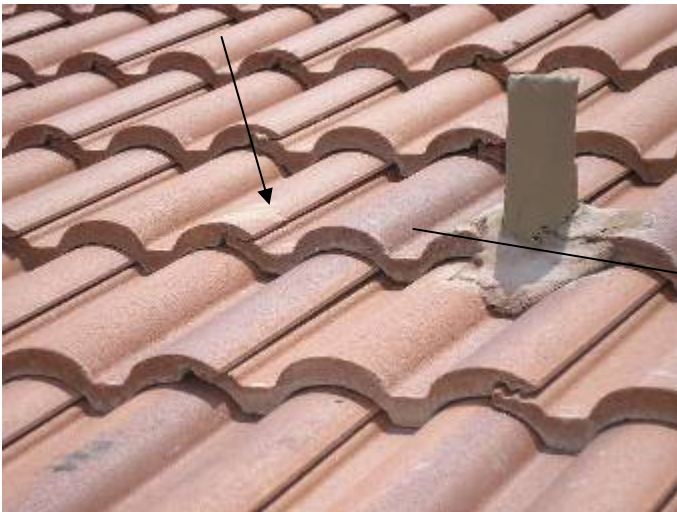
There were some broken tile pieces that were incorrectly "glued" back together with an RT-600 type adhesive product. These tiles should be removed & replaced.

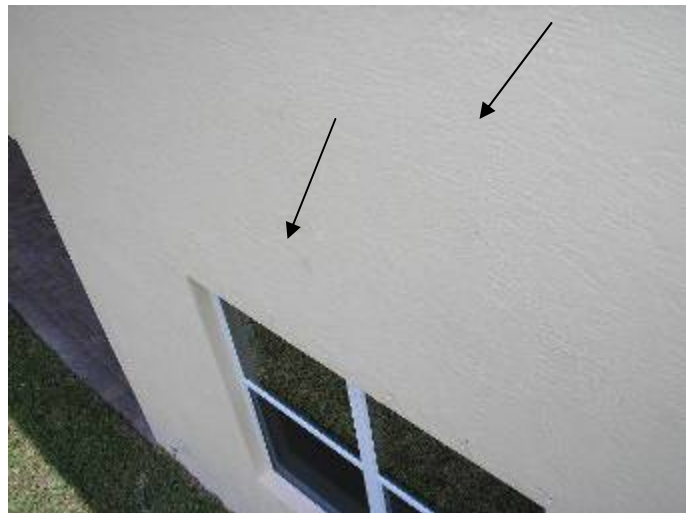
There were still some areas with exposed stucco & not enough paint on the exterior walls.

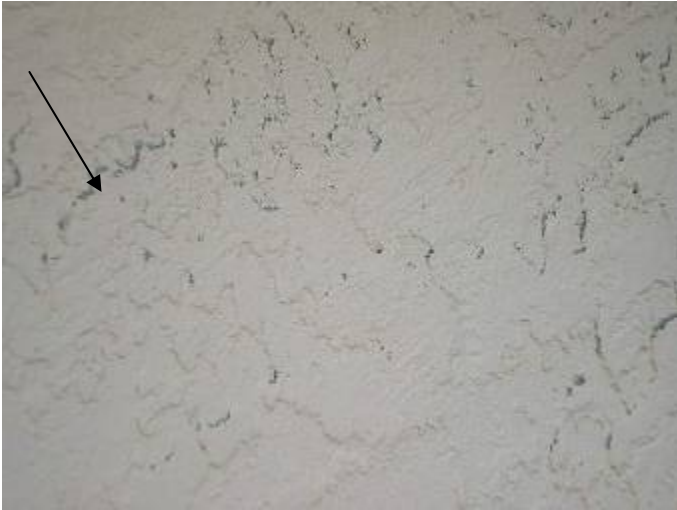
There were still some areas with exposed stucco & not enough paint on the exterior walls.

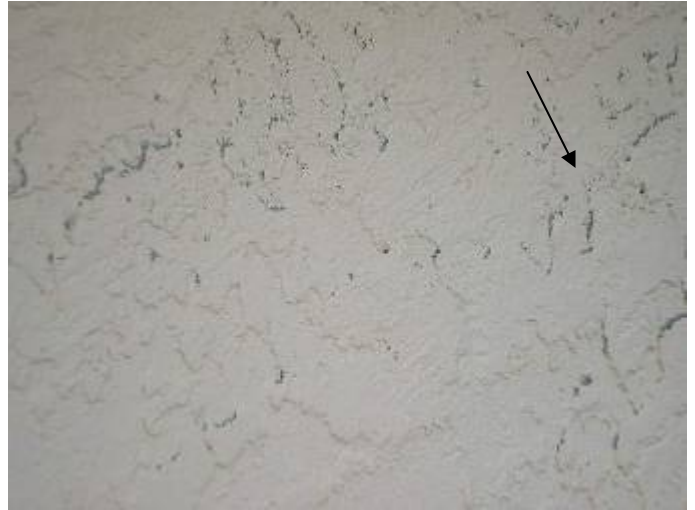
There were still some areas with exposed stucco & not enough paint on the exterior walls.

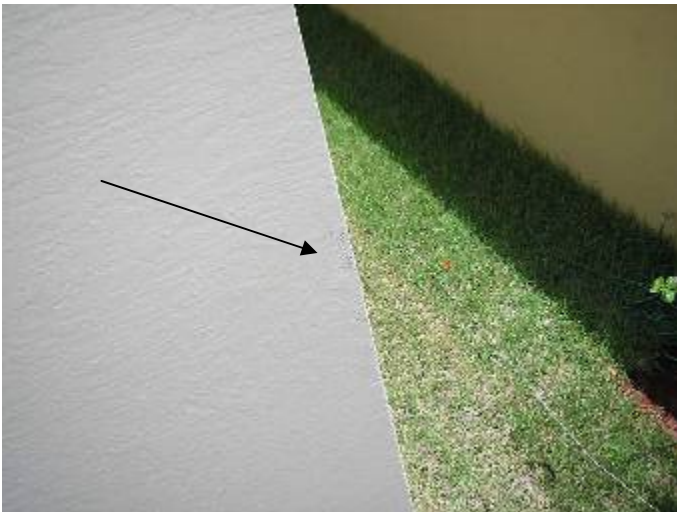
There were still some areas with exposed stucco & not enough paint on the exterior walls.

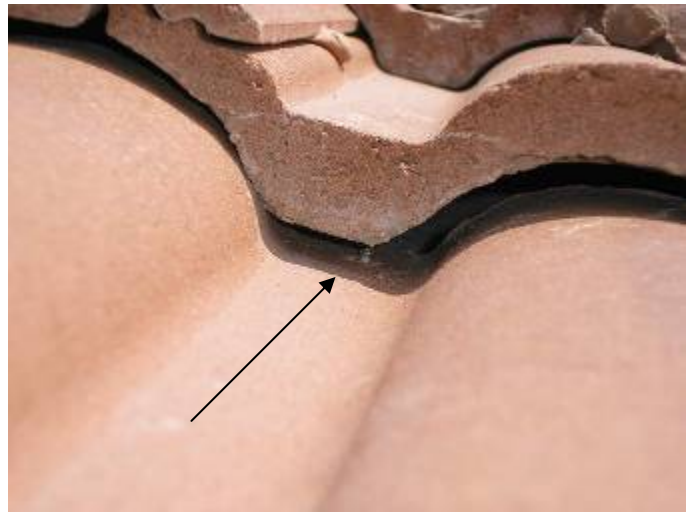
There is a roof tile anchor nail that is not fully set & holding up the adjacent tile. The nail should be properly set to allow the tile to be positioned correctly.

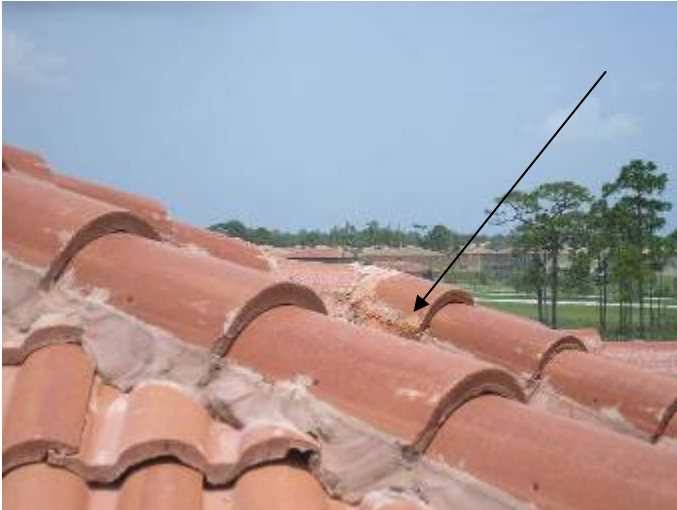
The RT-600 type roof tile adhesive is not designed to be exposed to the U.V./sunlight. The tile should be correctly secured.

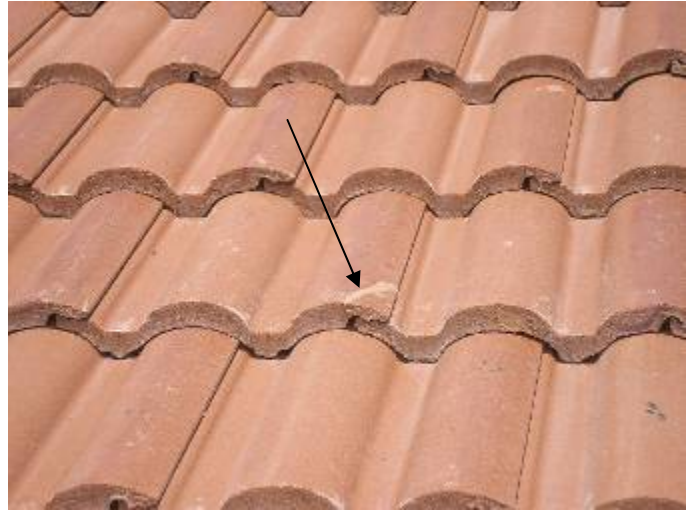
There were some broken tile pieces that were incorrectly "glued" back together with an RT-600 type adhesive product. These tiles should be removed & replaced.

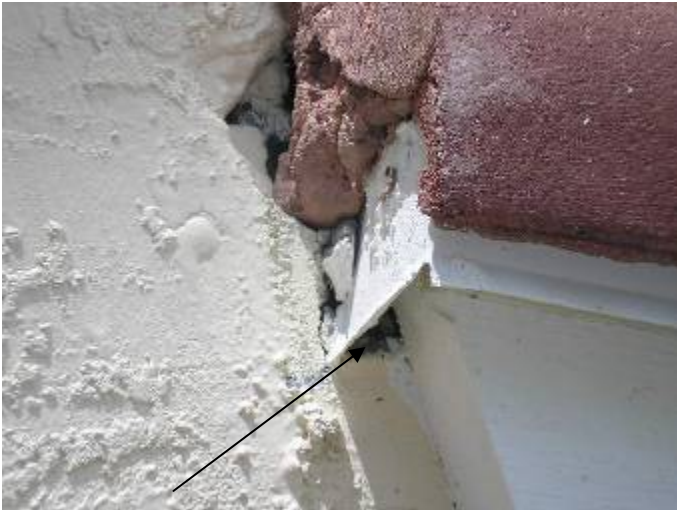
There is an open/unsealed opening under the roof drip edge flashing.

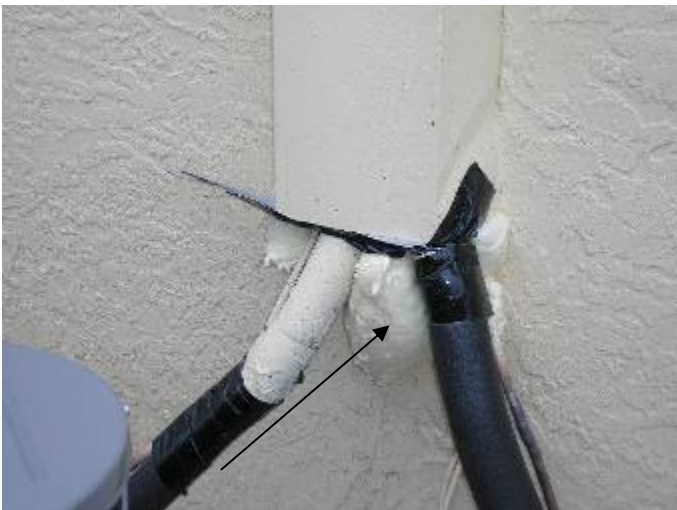
The expandable foam is not designed to be exposed to U.V. damage from sunlight. The bottom of the refrigerant line cover is not correctly sealed. §1205.1.2.2

**This item remains uncorrected as of the time of the inspection.**

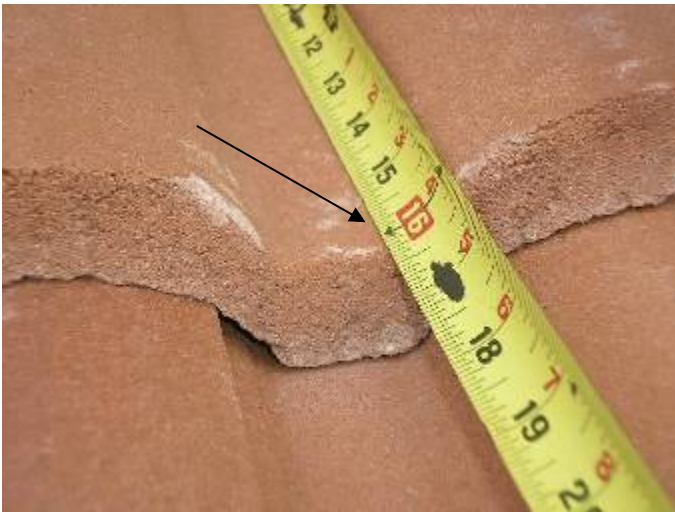
The builder has documentation indicating the code section concerning headlaps is not fully applicable in the installation of these roof tiles.

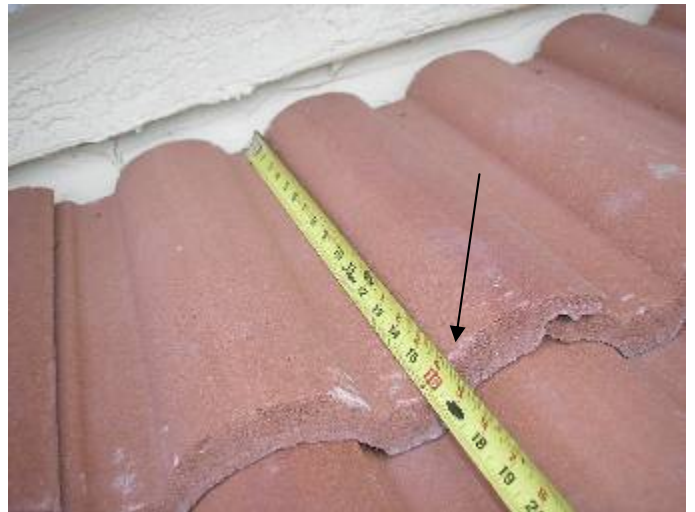
The maximum allowed tile exposure should be not more than 13 & ¼ inches. §1518.8.11

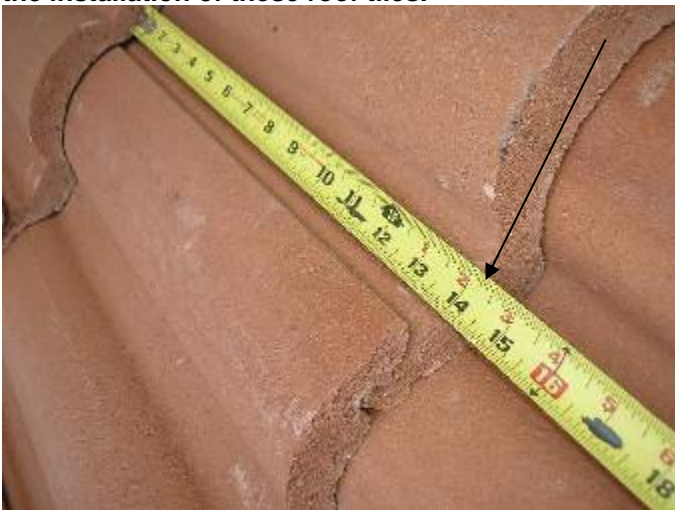
Some of the tile exposures are 14 inches or more.

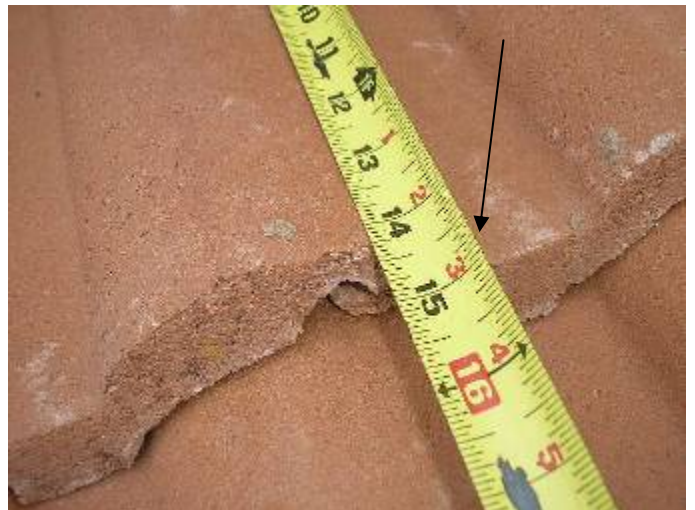
Some of the roof tile headlaps are 2 inches or less. The minimum headlap (tile overlap) is 3 inches. §1518.8.11

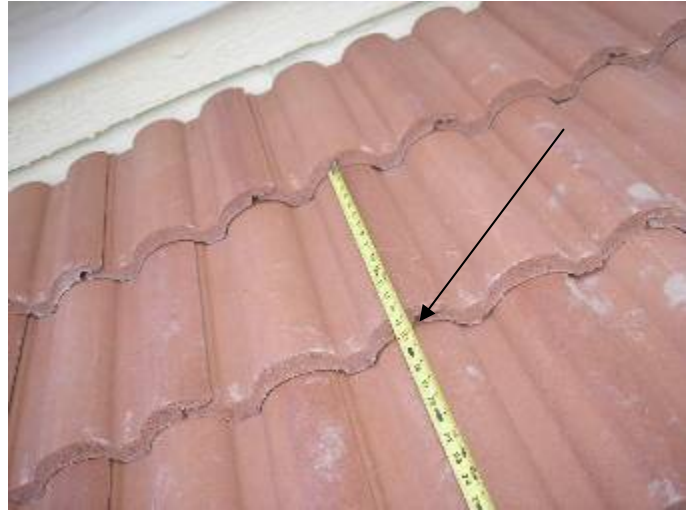
The roof tiles are 16" to 16 & 1/2" in length. There should be no more than 13 – 13 & 1/2 inches of exposed roof tile to allow for the correct headlap. §1518.8.11

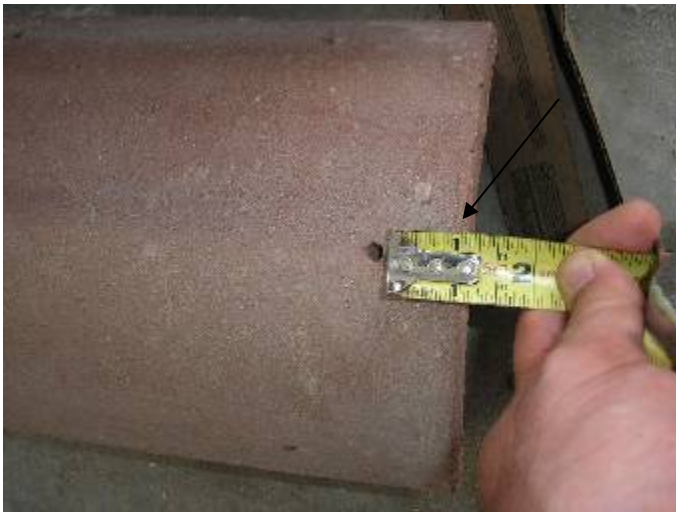
The openings in the ridge cap tiles measure approximately 1 inch from the edge. There should be no exposed nail openings in the tiles on the roof. §1518.8.11

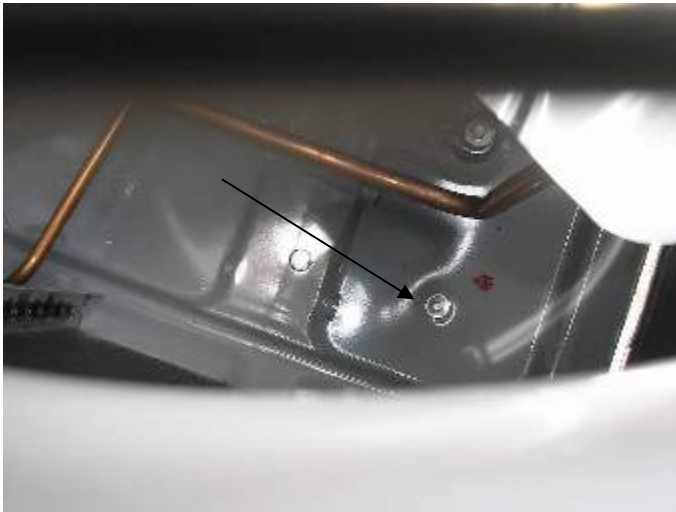
The A/C condensers are not secured properly. There are not enough straps or fasteners at the base of the units.

**The builder has documentation from the AC contractor's mechanical engineer approving the anchoring method used for these condensing units.**

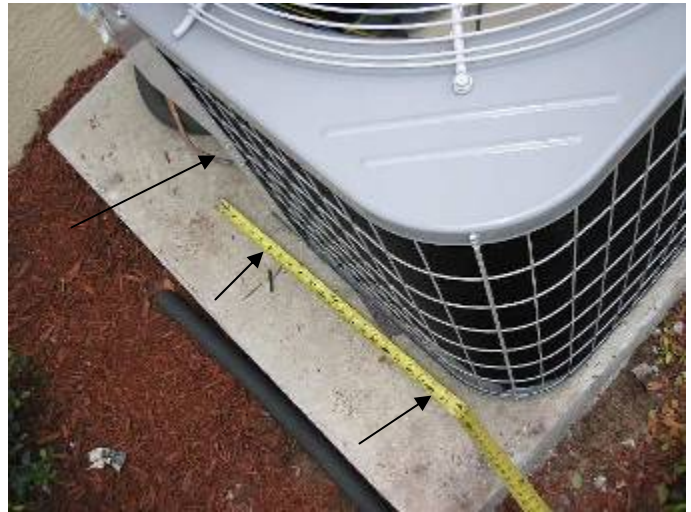
The A/C condensers are not secured properly. There are not enough straps or fasteners at the base of the units.

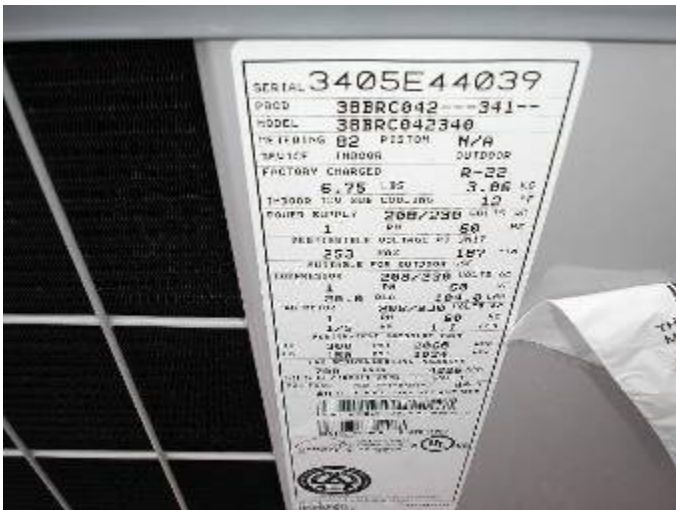
Note: Condensing unit size & information. 3 & 1/2 ton compressor.

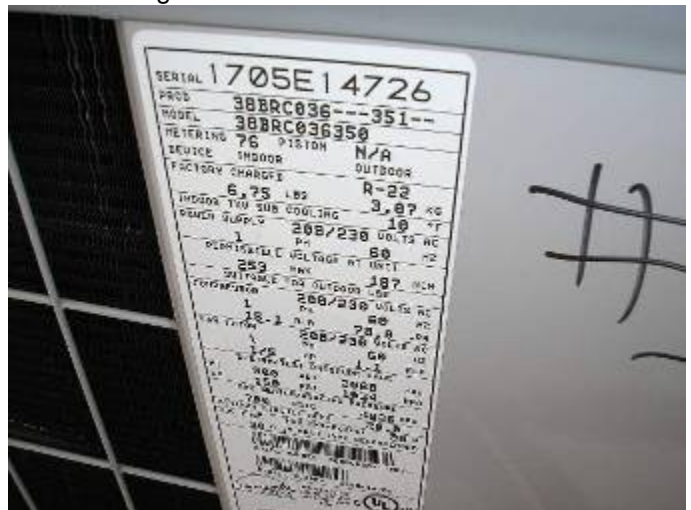
Note: Condensing unit size & information. 3 ton compressor.

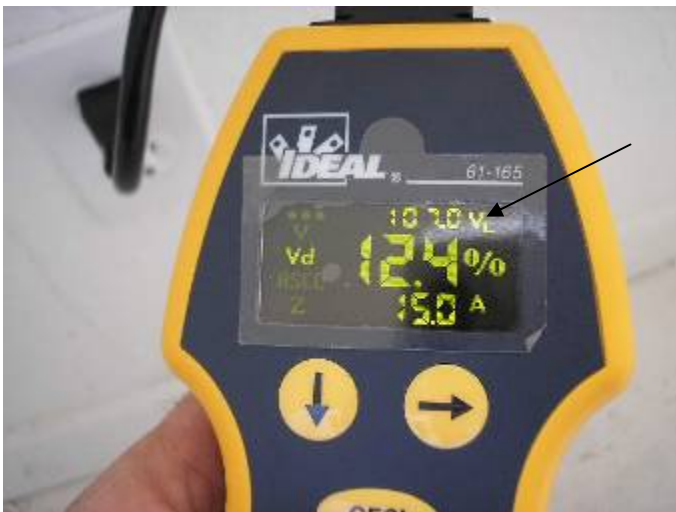
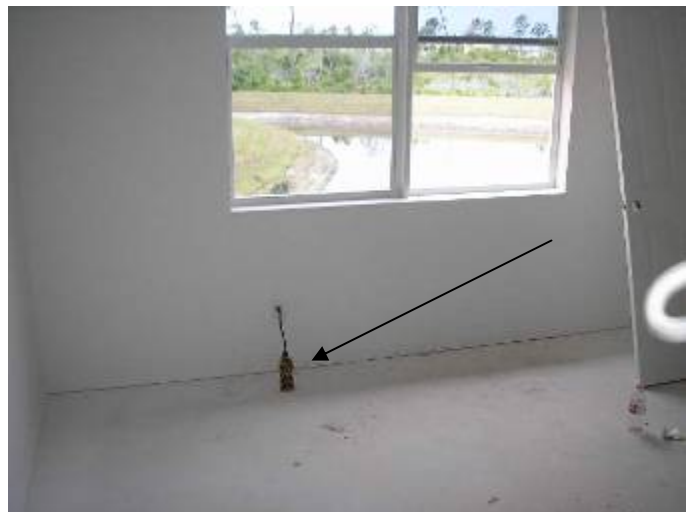
Many of the receptacle outlets had excessive voltage drops at the throughout the house. 2002(NEC) 210.19 Conductors

Location of the previous photo/s. The voltage drops should not exceed 5%. 2002(NEC) 210.19 Conductors

See the builder's/electrical engineer's response to this item. **The voltage drops noted in the report are referenced as a suggested guideline & informational only. They are not considered a violation of the code & this condition is not enforceable.**

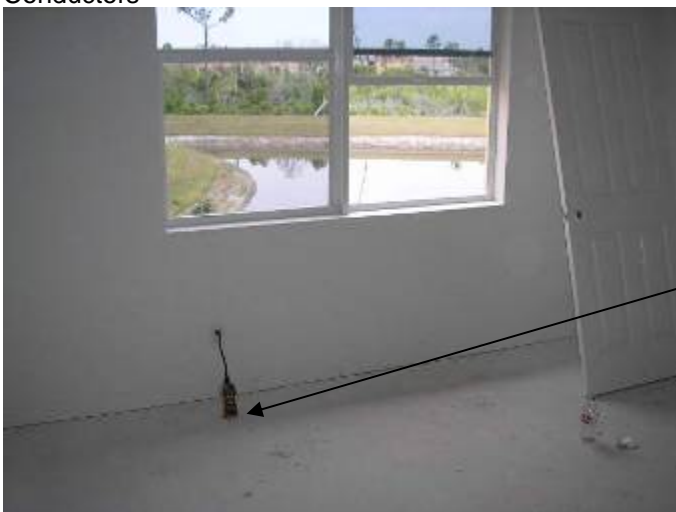
Location of the previous photo/s. Some of the voltage drops exceed 5%. 2002(NEC) 210.19 Conductors

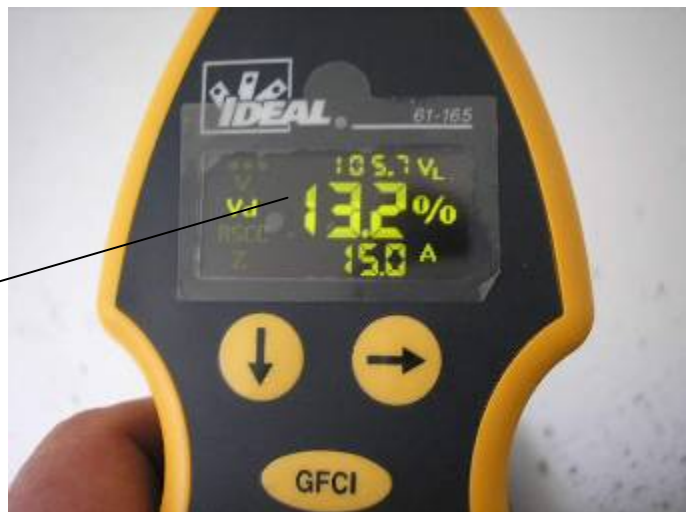
Some of the receptacle outlets had voltage drops that exceed 5% 2002(NEC) 210.19 Conductors. - See Below.
