**Inspection Report of 1076 Fleming Way Stuart FL 34997  
Prepared for Mr & Mrs Stander**

**The State of Florida requires the builder to build in compliance with the Florida Building Code.**

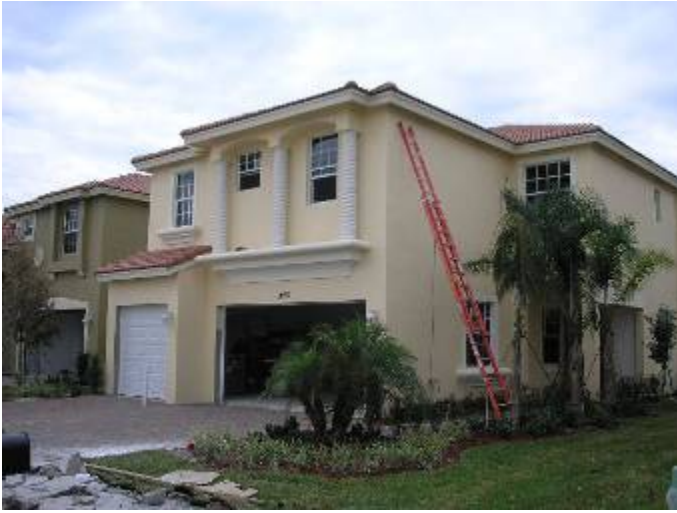
Site photo. The front of the house faces towards the east.

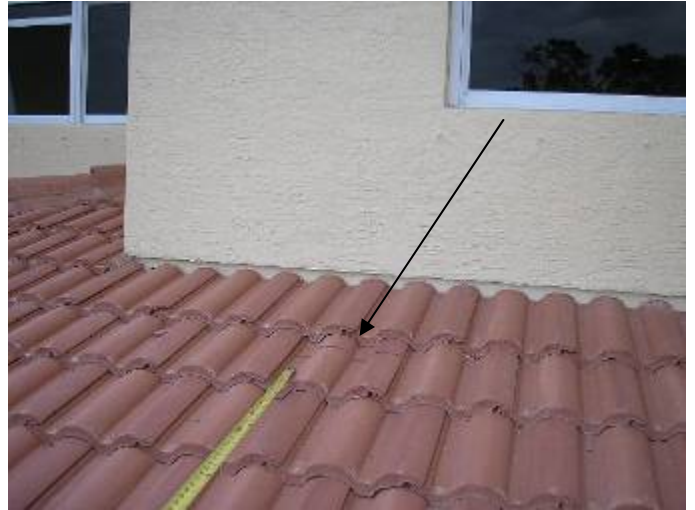
There are loose & incorrectly bonded roof tiles over the back patio. These tiles need to be correctly secured. §1518.8.5, §1518.8.11, 1507.4.5.2.1

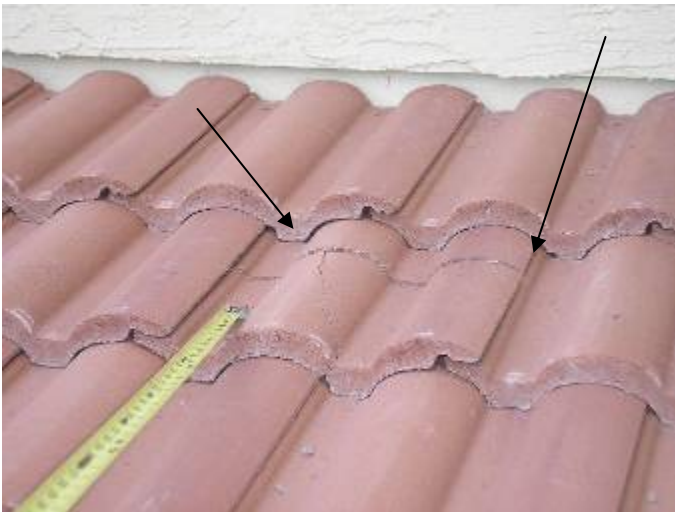
There should not be any broken tiles on the new roof. The tiles need to be removed & replaced; not "glued" back together.

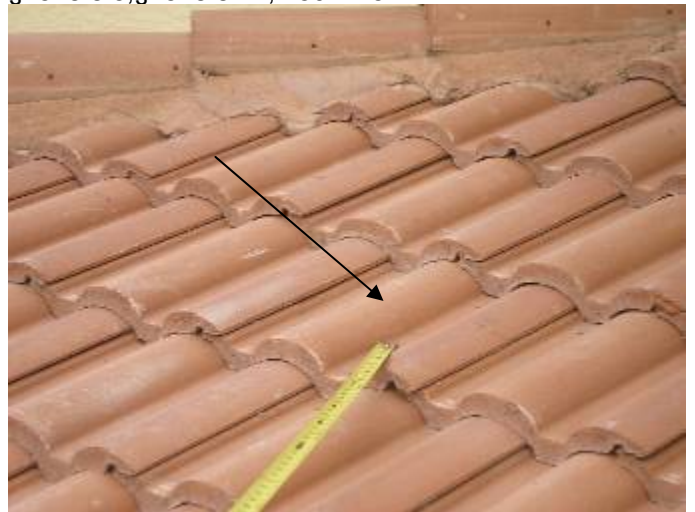
There are loose & incorrectly bonded roof tiles over the back patio. These tiles need to be correctly secured. §1518.8.5, §1518.8.11, 1507.4.5.2.1

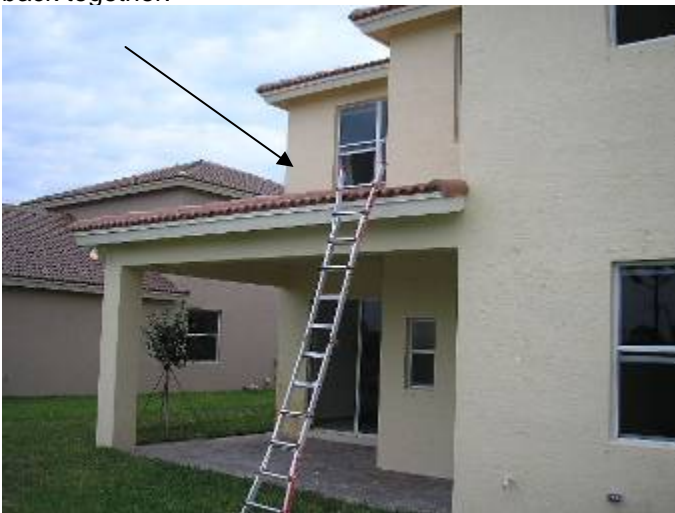
Location of the previous photos at the back patio.

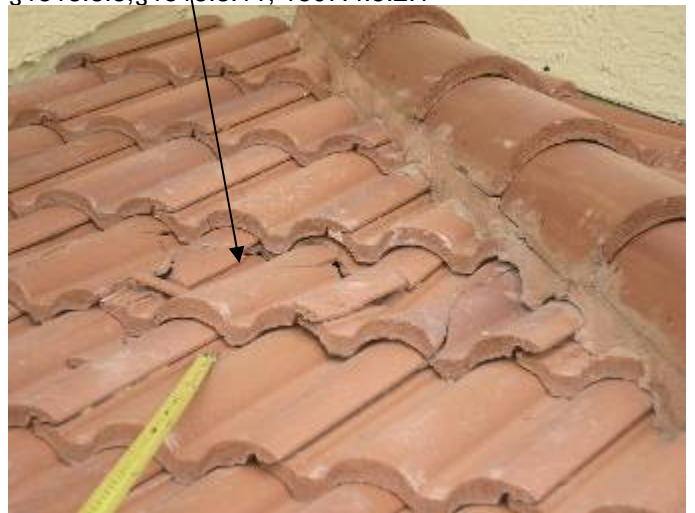
There are loose & incorrectly bonded roof tiles over the back patio. These tiles need to be correctly secured. §1518.8.5, §1518.8.11, 1507.4.5.2.1

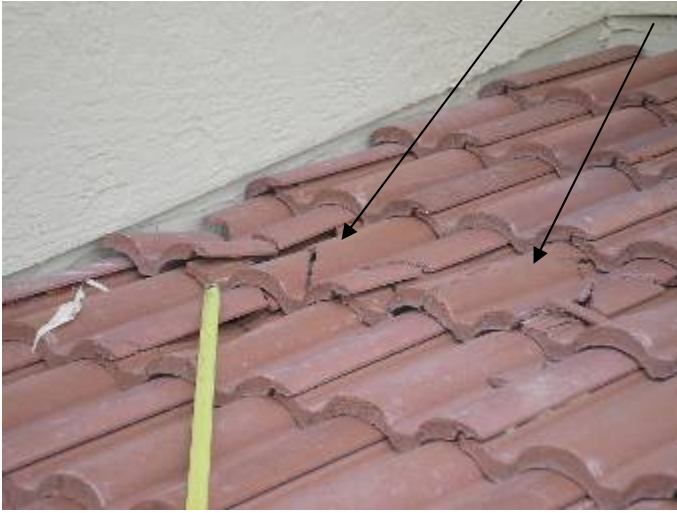
All of the broken tiles need to be removed & replaced; not “glued” back together.

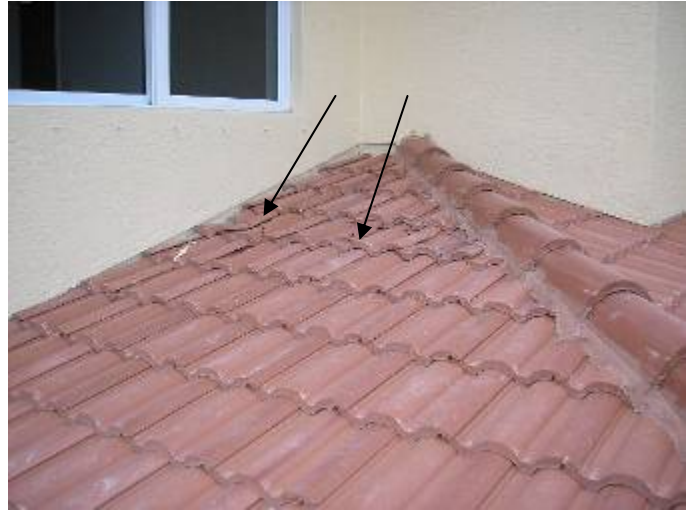
There should not be any broken tiles on the new roof. The tiles need to be removed & replaced; not “glued” back together.

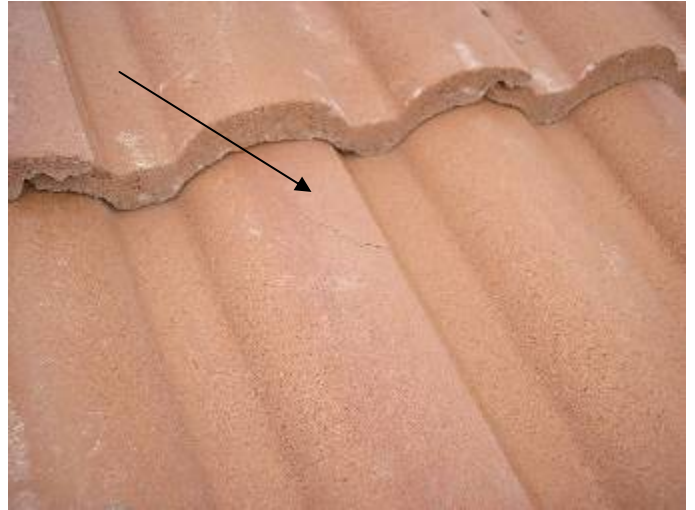
There should not be any broken tiles on the new roof. The tiles need to be removed & replaced; not "glued" back together.

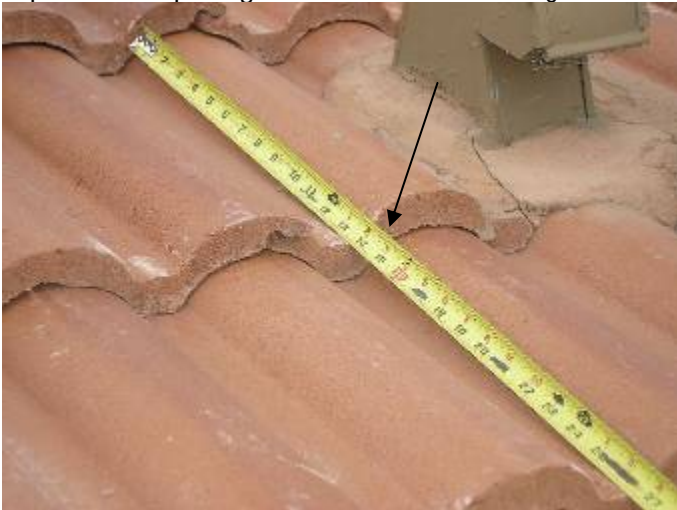
The roof tiles measure 16 & ¼ inches. The overlap (headlap) is required to be a minimum of 3 inches at all tiles. §1518.8.11

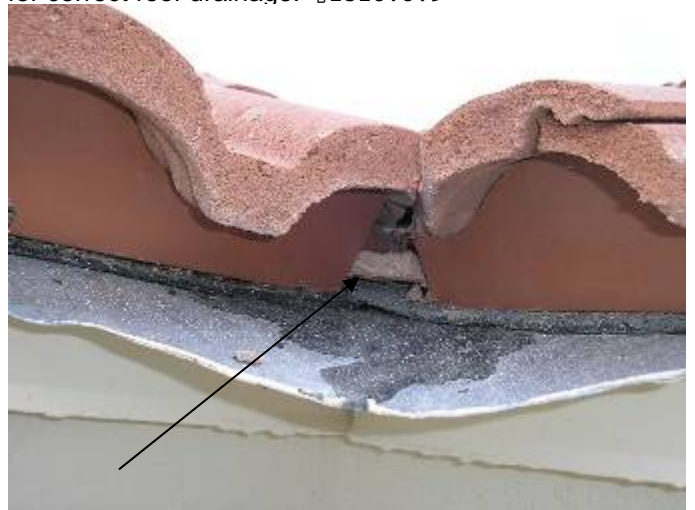
There are broken pieces of tile & debris obstructing the valleys. The roof will not drain correctly.

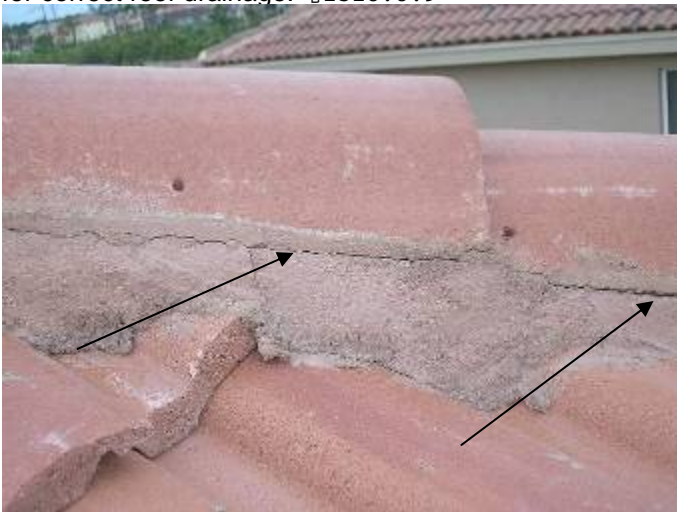
All loose tiles need to be correctly secured.

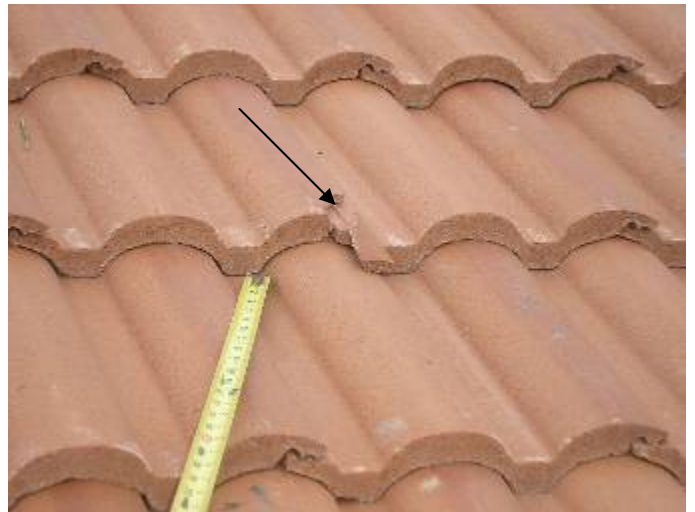
There should not be any broken tiles on the new roof. The tiles need to be removed & replaced; not "glued" back together.

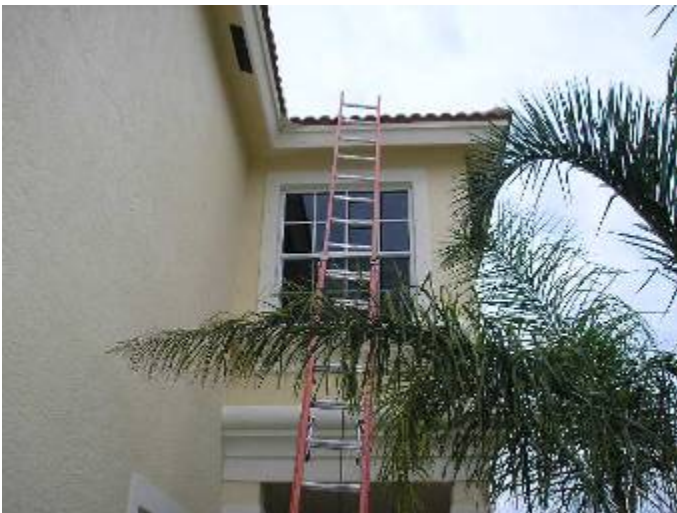
Location of the previous photos at the front entry way.

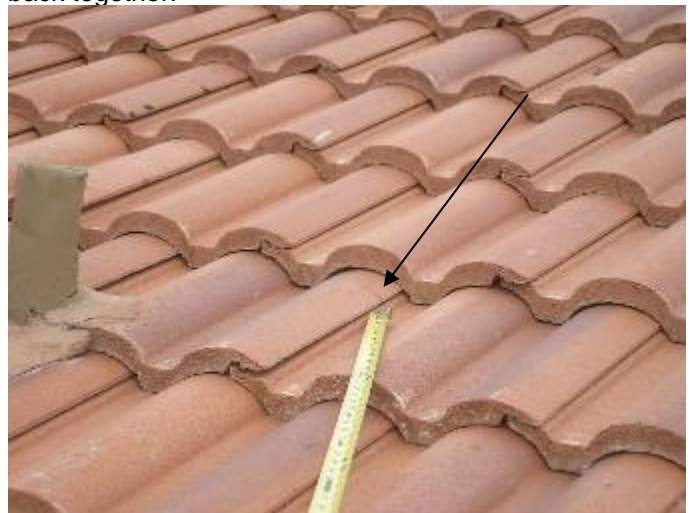
There are broken & loose roof tiles over the 2<sup>nd</sup> floor. The tiles need to be removed & replaced; not "glued" back together. §1518.8.5, §1518.8.11, 1507.4.5.2.1

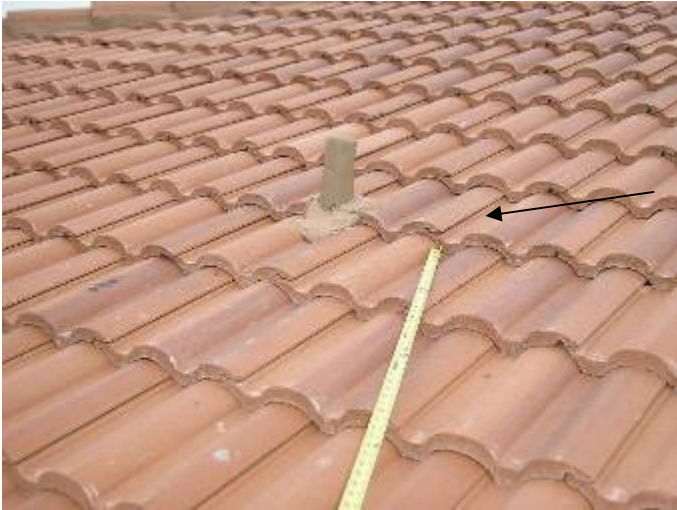
There are loose & incorrectly bonded roof tiles over the 2<sup>nd</sup> floor. These tiles need to be correctly secured. §1518.8.5, §1518.8.11, 1507.4.5.2.1

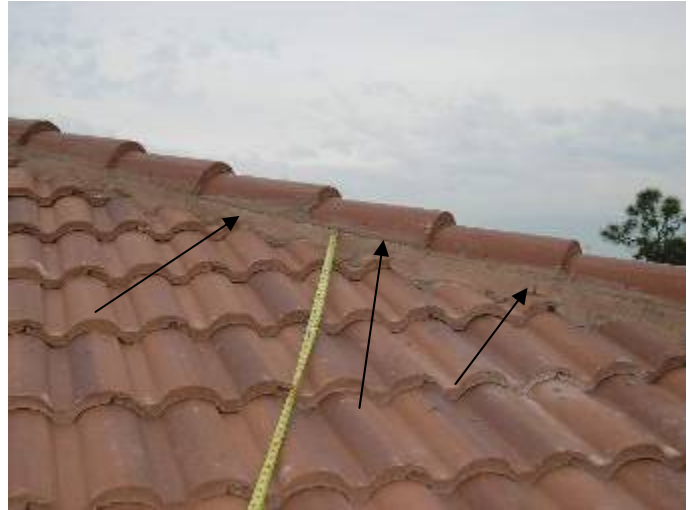
Some of the hip & ridge cap tiles are not correctly secured or bonded. §1518.8.5, §1518.8.11, 1507.4.5.2.1

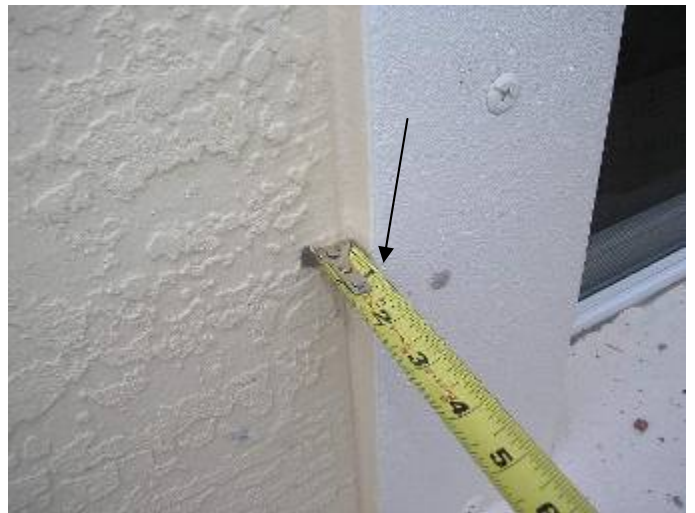
We recommend core sampling to verify the thickness of the exterior stucco & compliance with ASTM C 926.

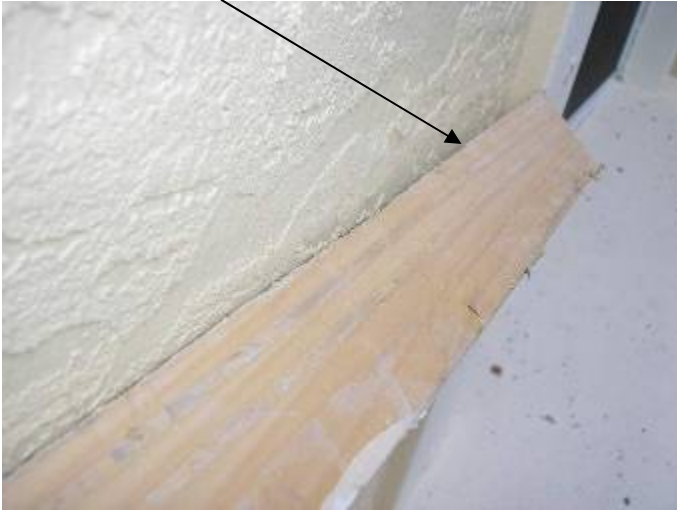
The stucco at some at the walls is concave or curved in & does not appear to be the correct thickness. §2509.1.1, ASTM C 926

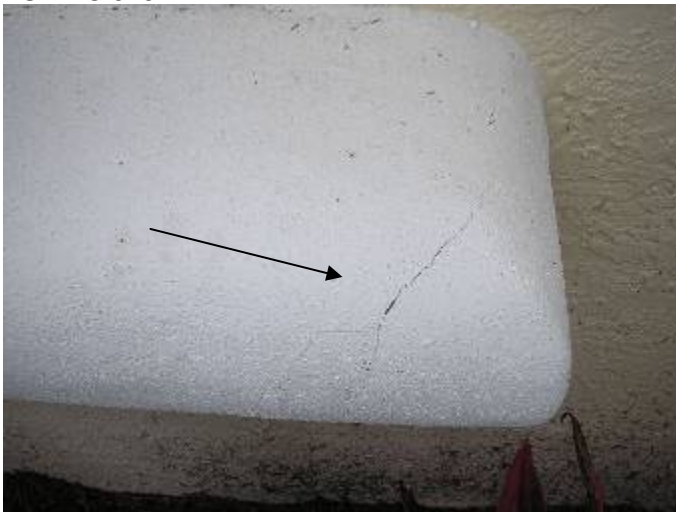
Damaged areas & unsealed openings in the stucco trim & Styrofoam banding need to be corrected. §13-606.1.ABC.1.2

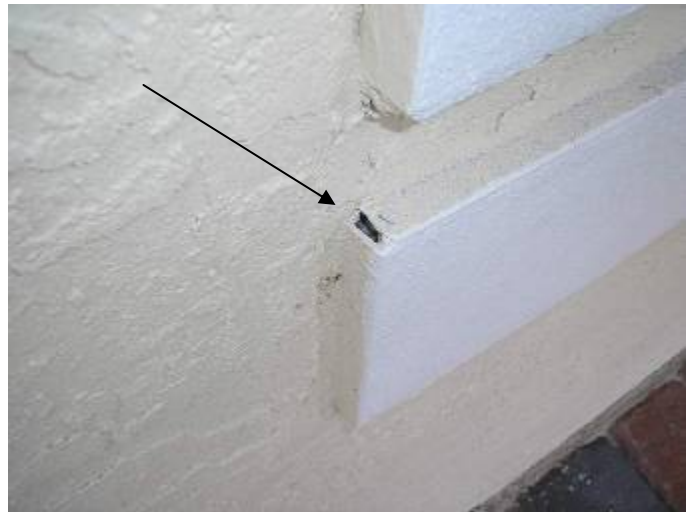
All openings in the building envelop need to be correctly sealed. §13-606.1.ABC.1.2

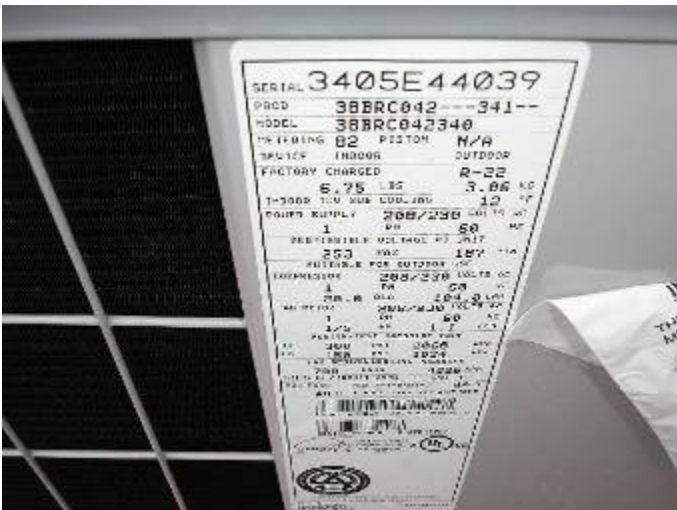
Note: Condensing unit size & information. 3 & 1/2 ton compressor.

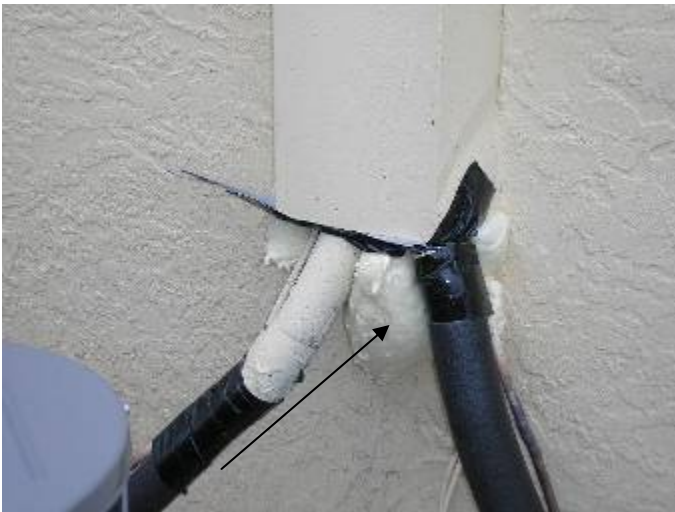
### Florida Building Code

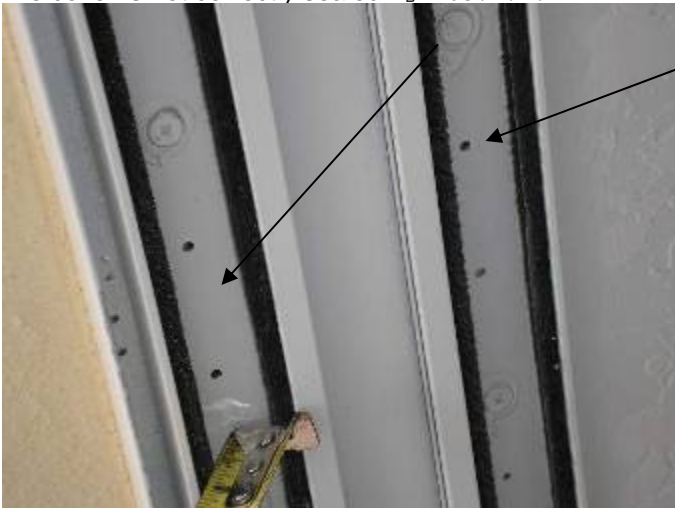
Some of the frame openings are not correctly sealed to prevent water & pest intrusion around the door frames. §13-606.1.ABC.1.2

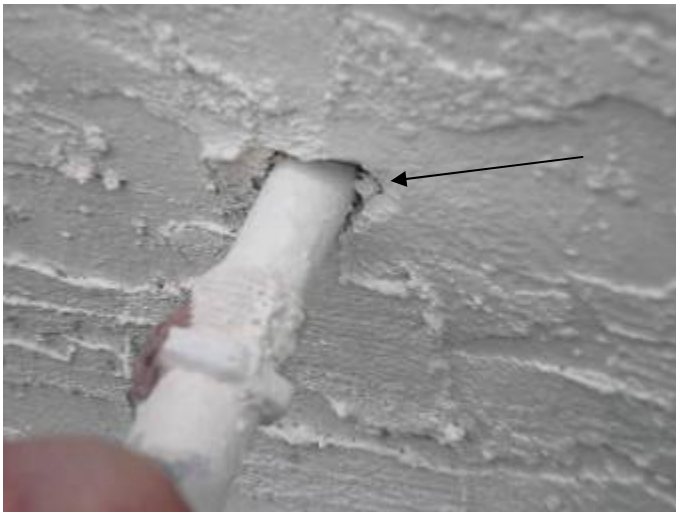
The hose bibb supply piping was not correctly secured or sealed at the wall. Sheathing is required to protect the copper piping & was not visible. §P305.1

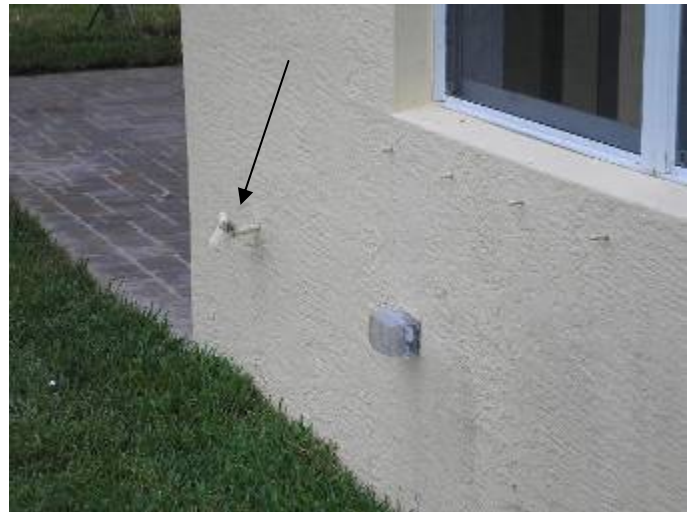
Location of the previous photo. The pipe is not correctly sealed or secured at the wall. §13-606.1.ABC.1.2

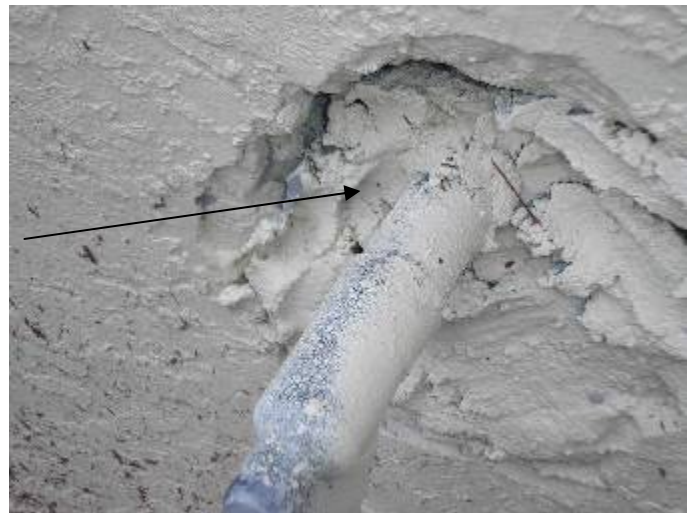
The main water supply piping was not correctly secured or sealed at the wall. Sheathing is required to protect the copper piping & was not visible. §P305.1

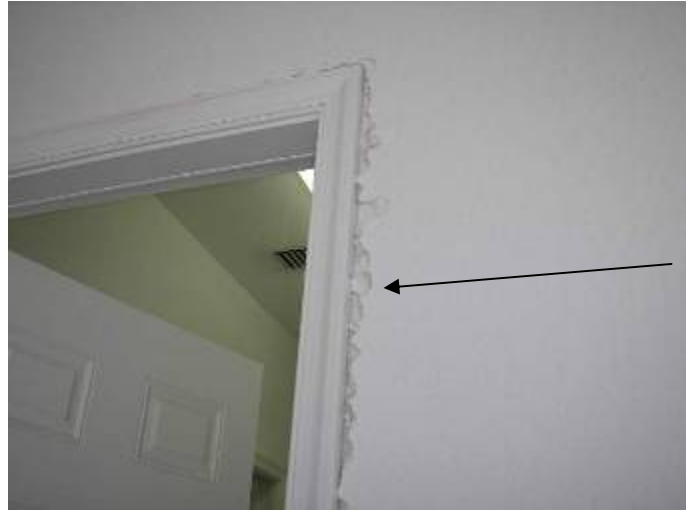
There is damage around the garage/laundry access door. Why was this method used to adjust the wall?

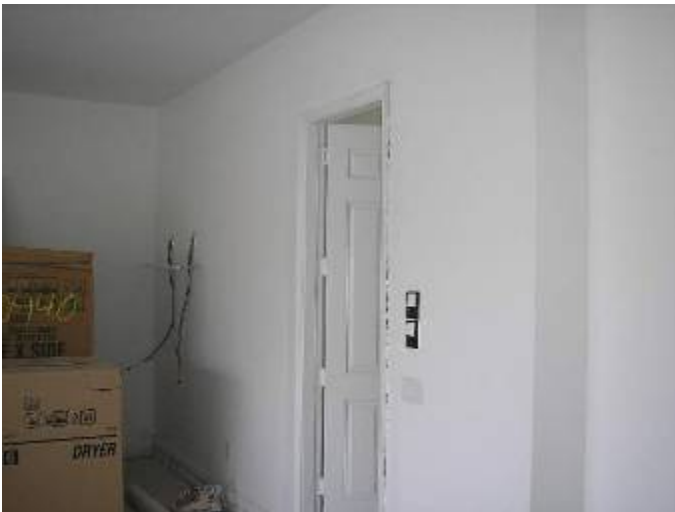
Location of the previous photo. The water heater was not installed; the water was not turned on.

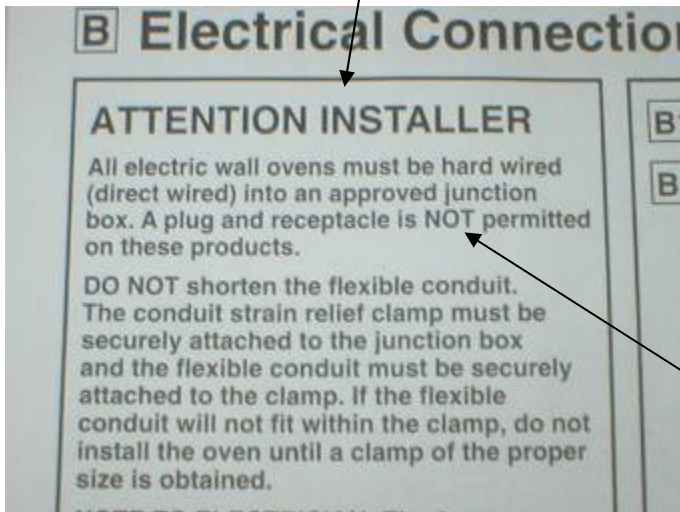
Install in accordance with manufacturer's instructions. §M304.1
