**Inspection Report of 1196 Fleming Way Stuart Fl 34997
Prepared for Mr Fishman**

The State of Florida requires the builder to build in compliance with the Florida Building Code.

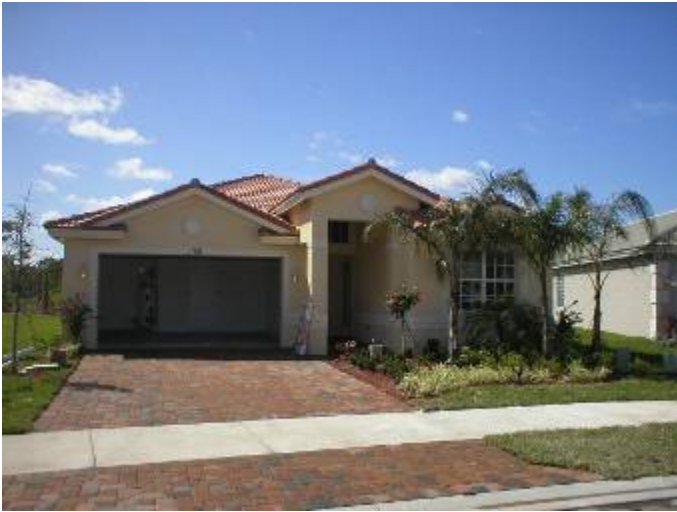
Site photo. The front of the house faces towards the north.

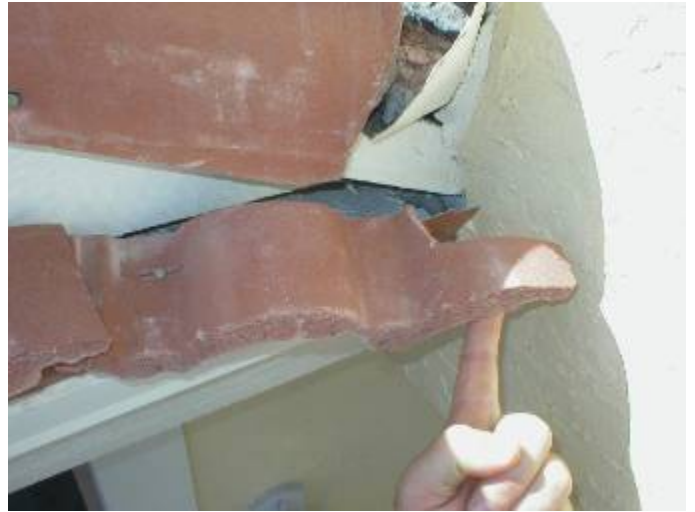
There are loose, incorrectly secured roof tiles at the front over the garage.

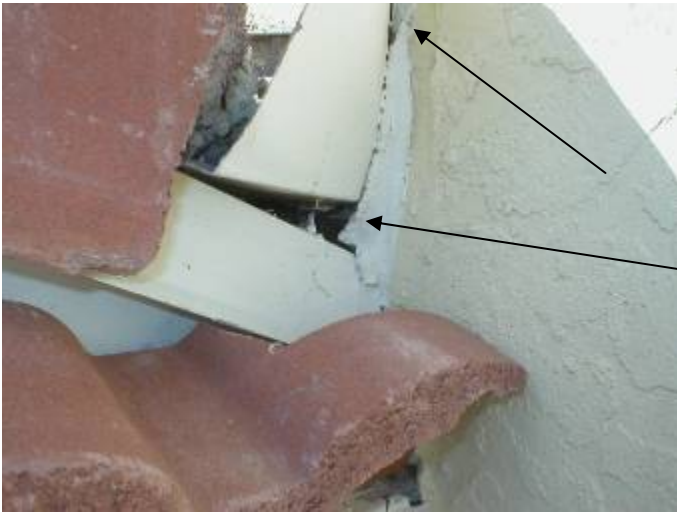
The wall is not correctly sealed at the flashing to prevent water & pest intrusion at the corner above the front of the garage. §1403.1.3

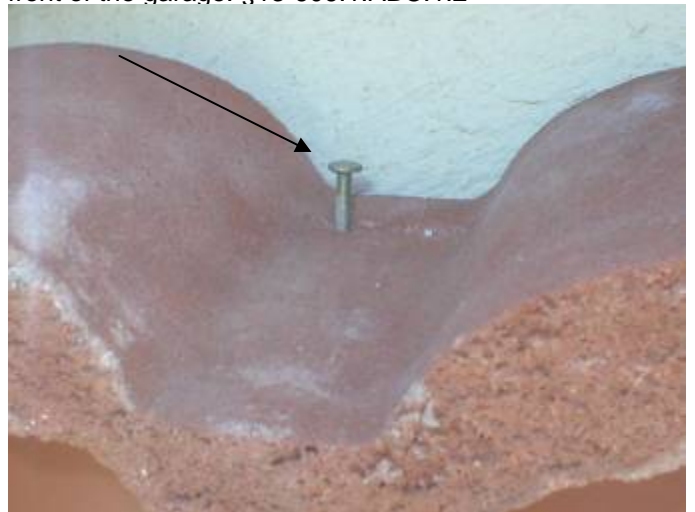
There are loose, incorrectly secured roof tiles at the front over the garage.

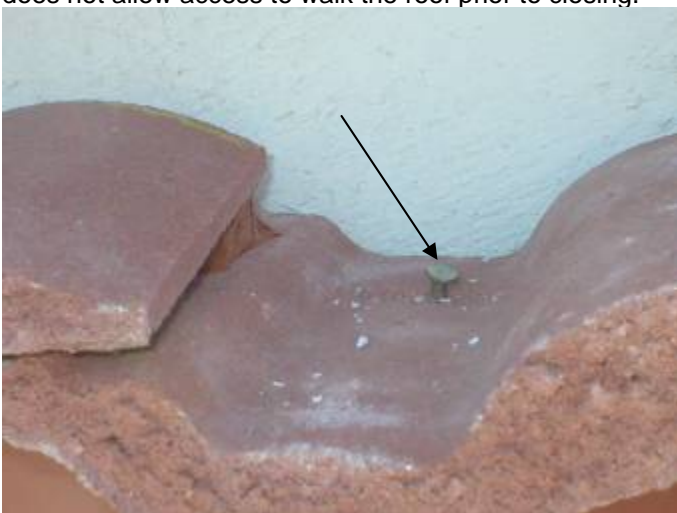
There are loose, incorrectly secured roof tiles at the front over the garage.

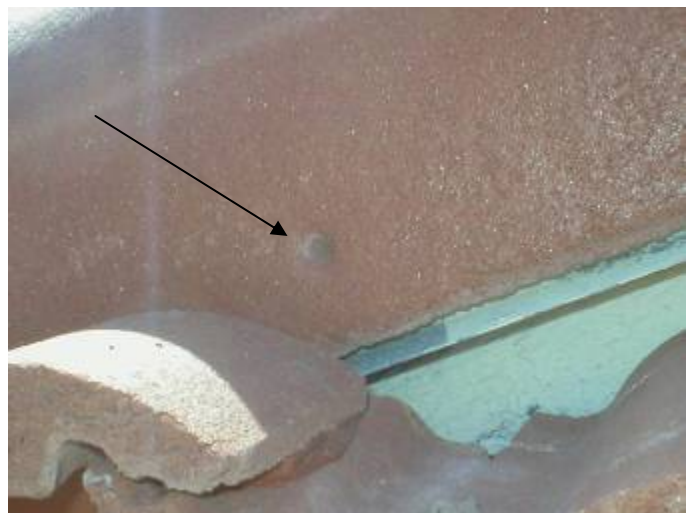
The nail anchor is not installed at the rake tile at the left front side over the garage.

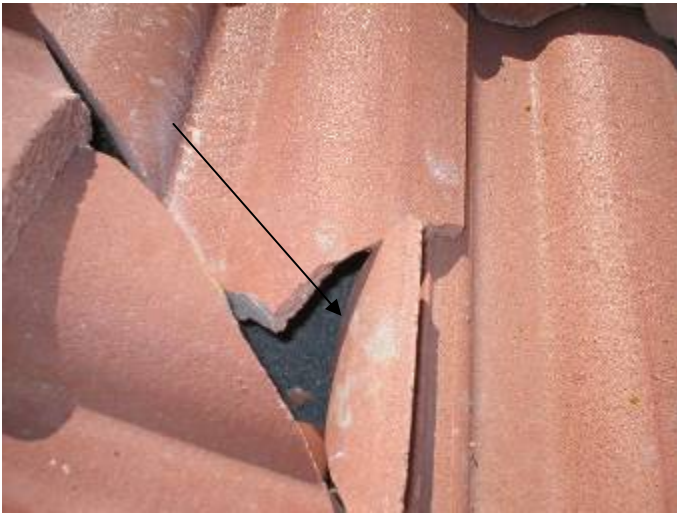
There are several broken pieces of tile on the roof.

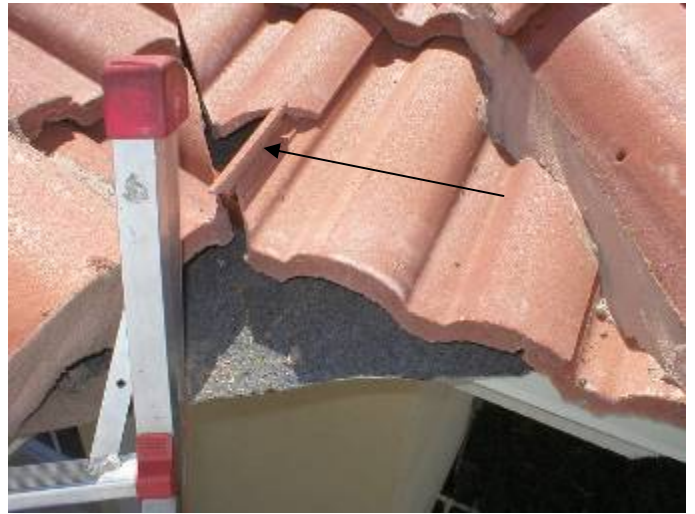
There are several broken pieces of tile & construction debris on the roof.

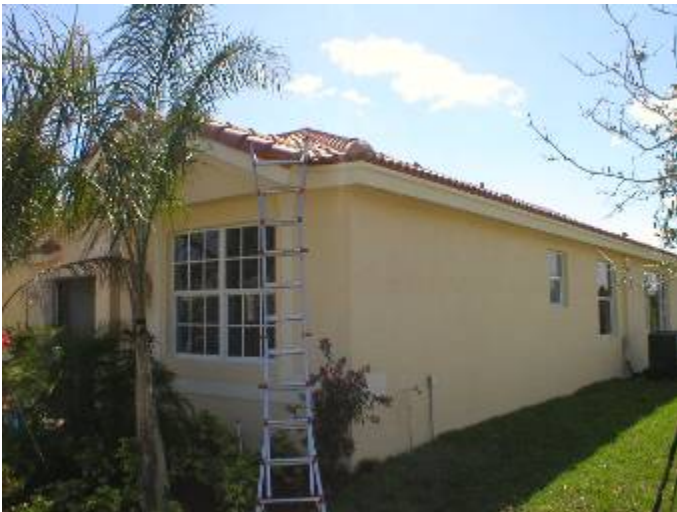
Location of previous photo taken from the north west corner of the building.

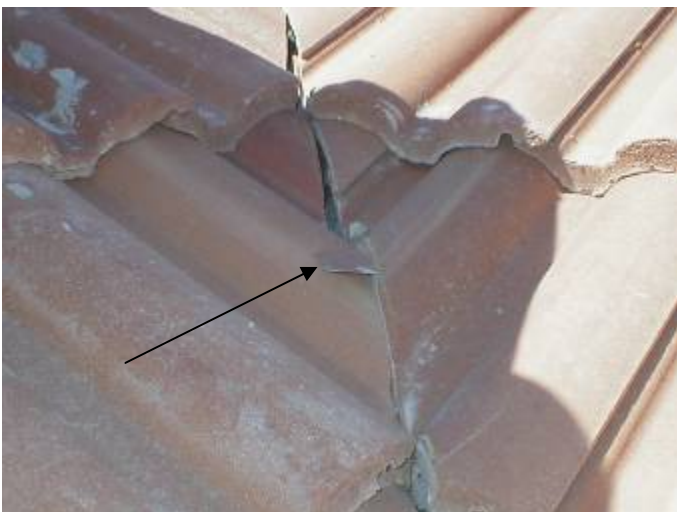
There are several broken pieces of tile & construction debris on the roof.

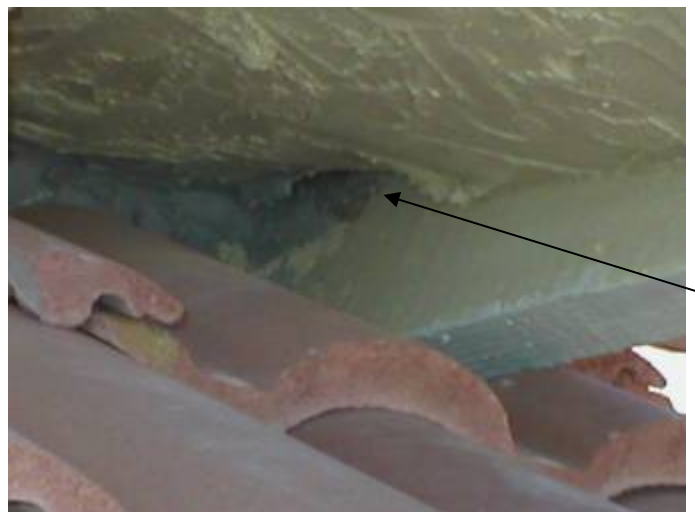
The stucco is not correctly sealed at the soffit return area to prevent water & pest intrusion above the right front side of the house. §2509.2.4.1

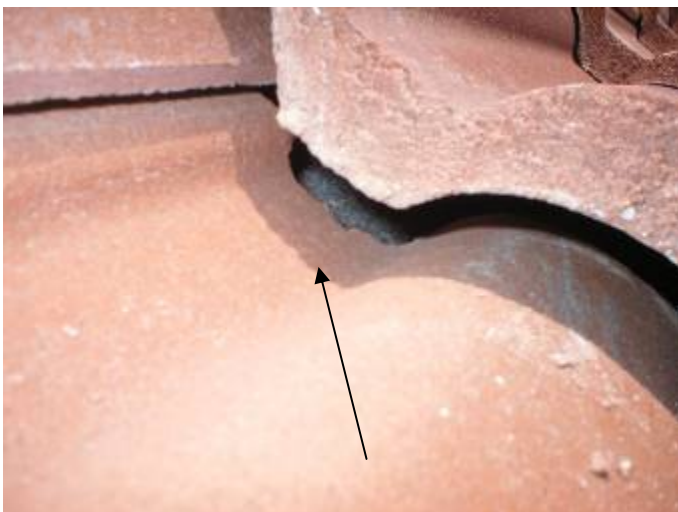
The tile is not correctly secured & broken at the fastener opening.

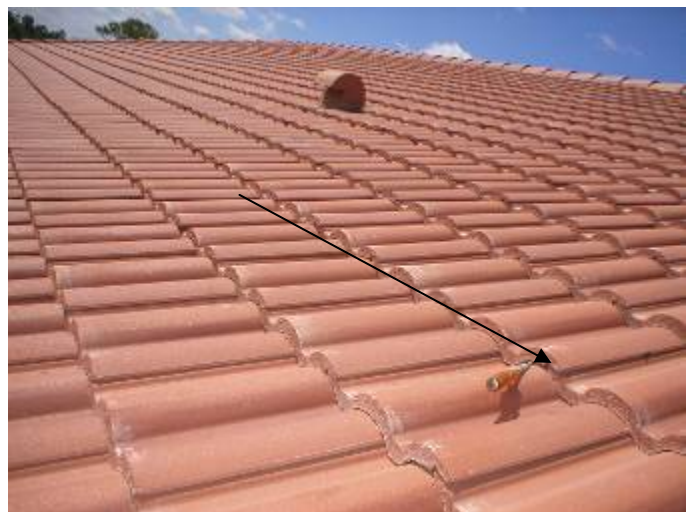
Location of the previous photos above the east side of the house.

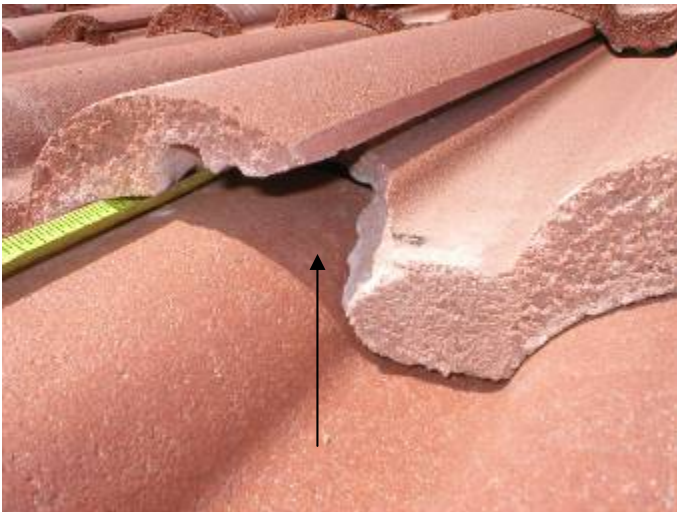
The tile is broken at the corner.

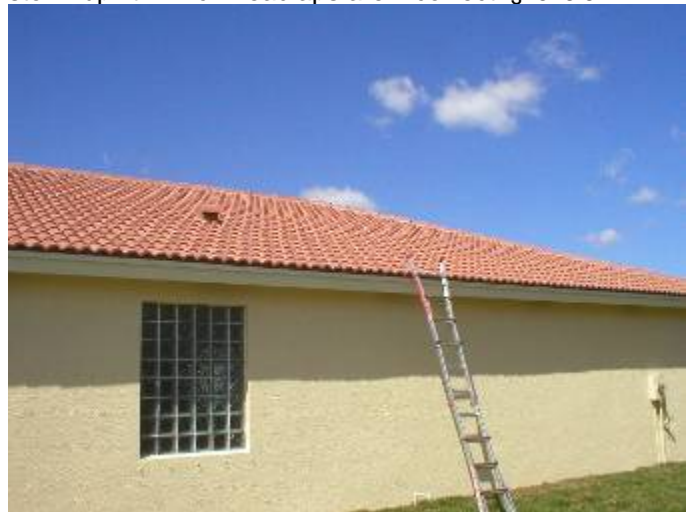
Location of the previous photos above the east side of the house.

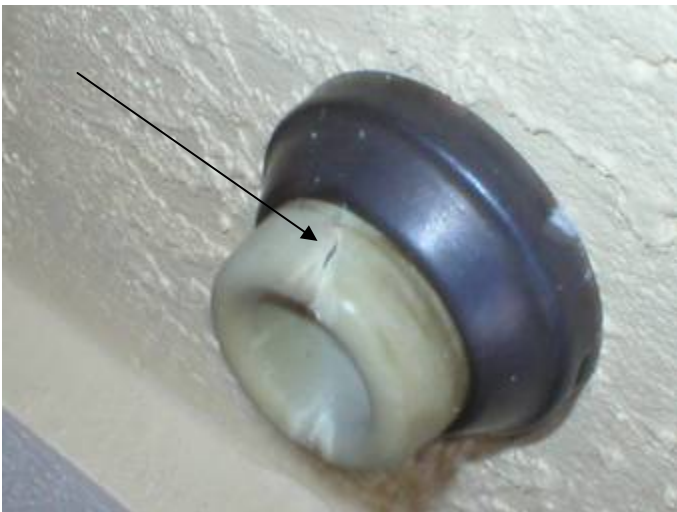
The door stop is damaged at the front entry way.

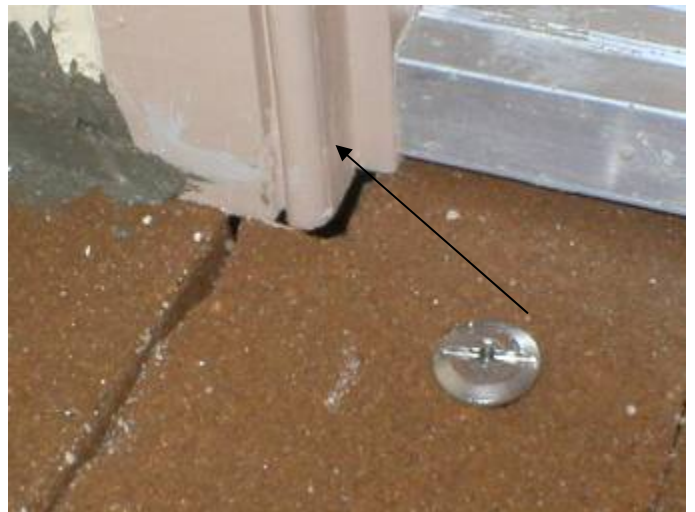
The door frame & threshold are not correctly sealed to prevent water & pest intrusion at the front entry way. §13-606.1.ABC.1.2

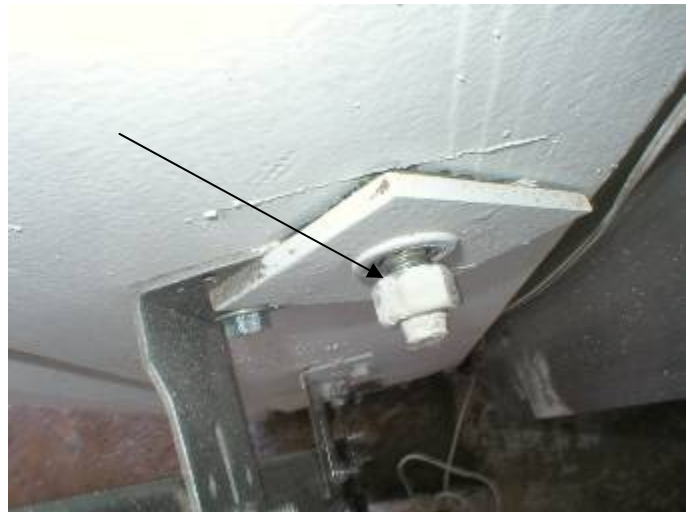
Some of the garage door wood buck anchor nuts are loose.

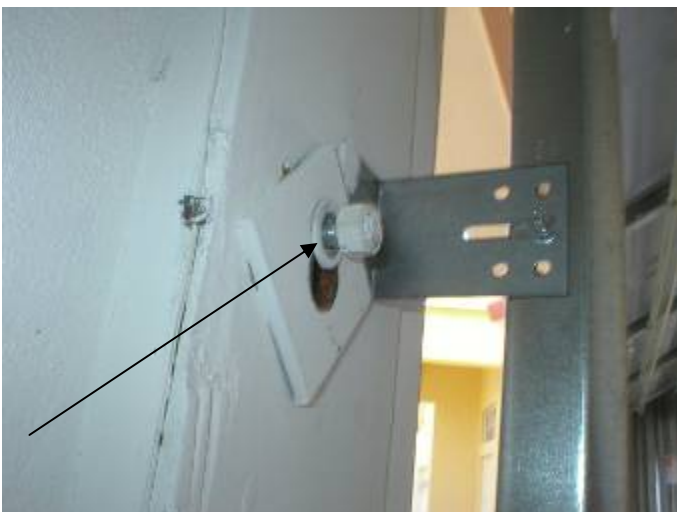
Some of the garage door wood buck anchor nuts are loose.

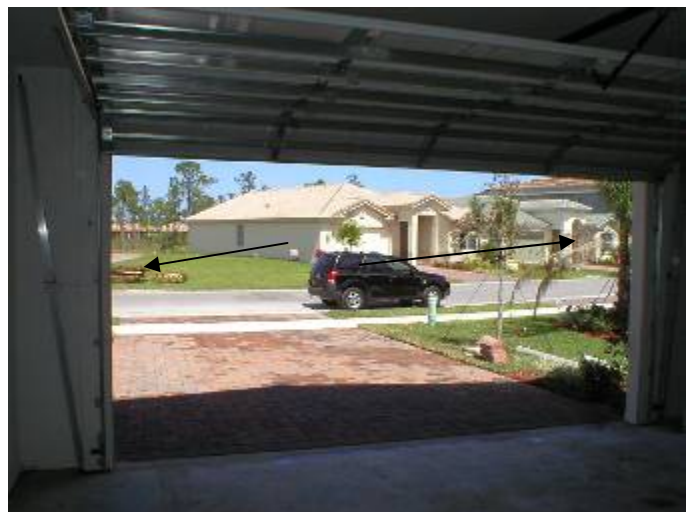
Location of the previous photos.

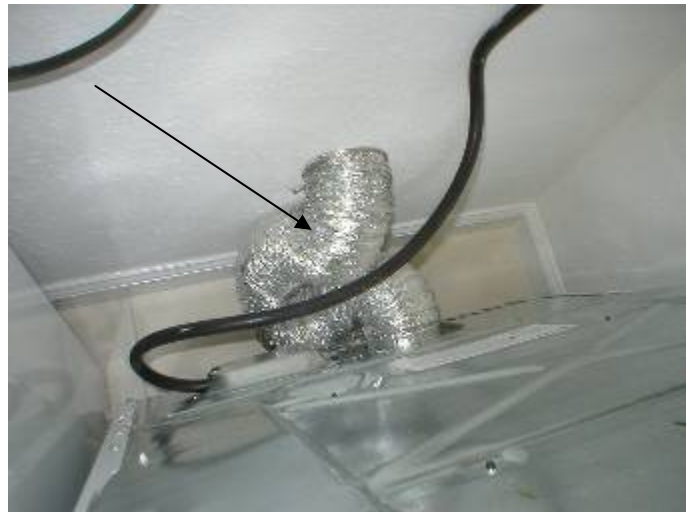
The foil dryer vent duct material is a fire hazard per UL & manufacturer. Replace with rigid or heavy flex duct material in accordance with manufacturer's instructions.

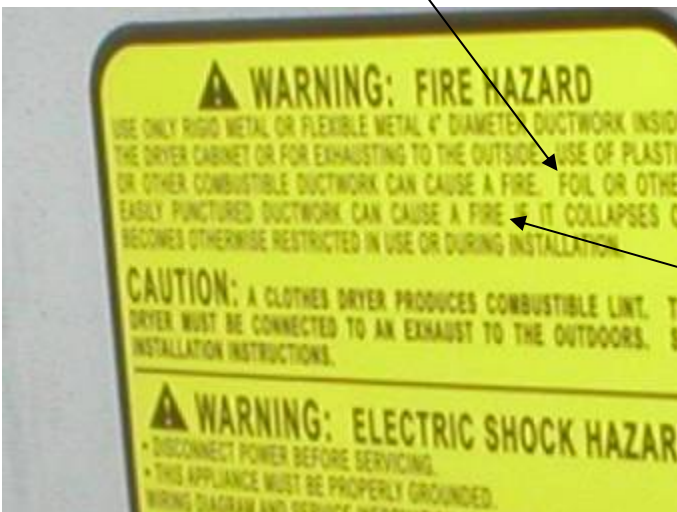
The thin aluminum foil dryer vent duct material is a fire hazard per UL & manufacturer. See warning label on back of the dryer. §M304.1

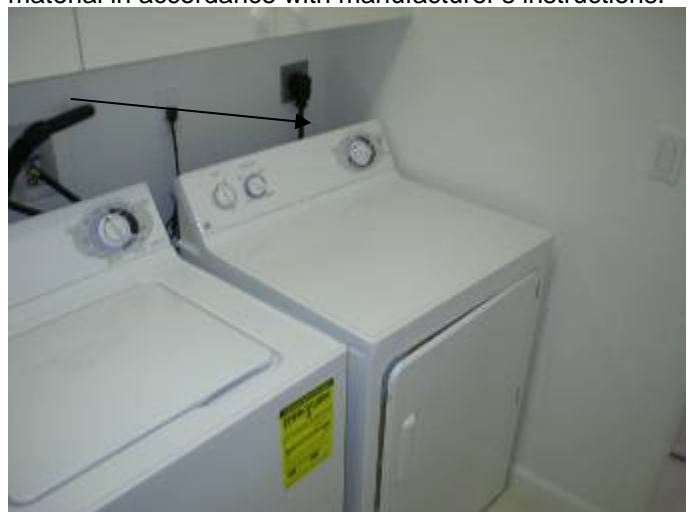
Location of previous photos.

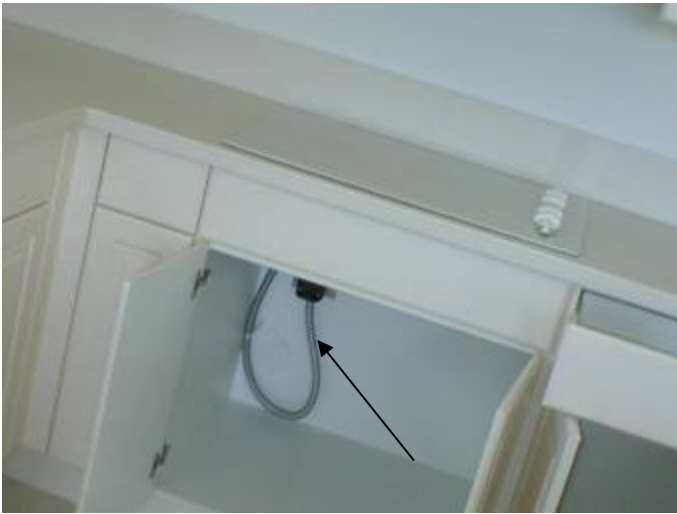
Install in accordance with manufacturer's instructions. Location in the kitchen.

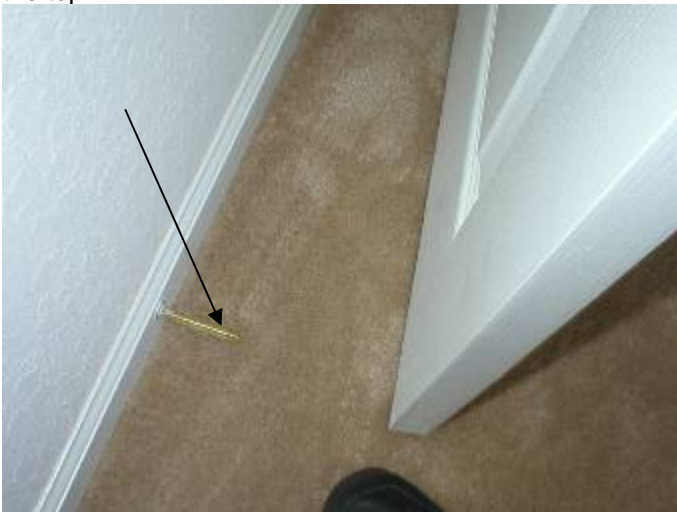
The rubber bumper is missing at the door stop at the front guest bedroom.

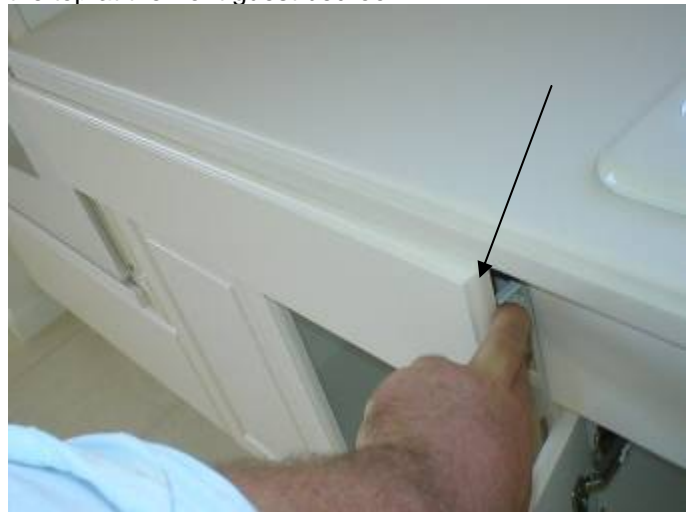
The drawer did not open correctly at the left of the kitchen sink.

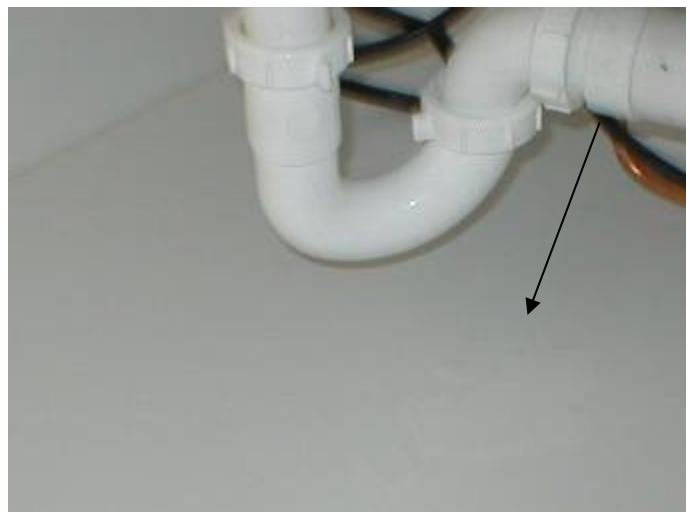
There are leaks at the plumbing drain line under the kitchen sink.

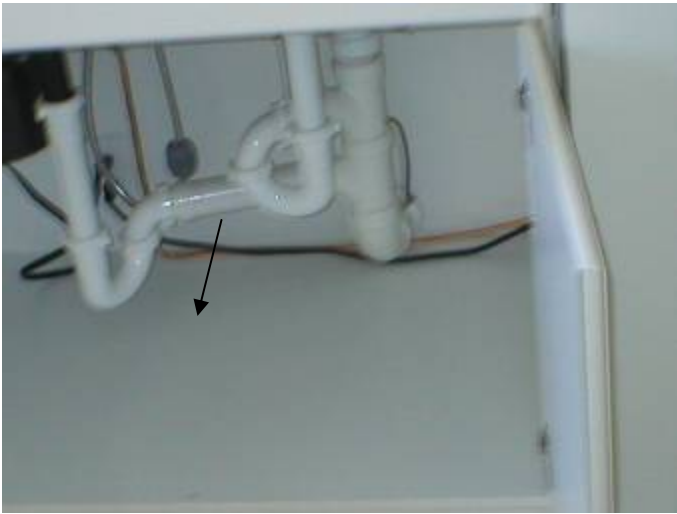
There are leaks at the plumbing drain line under the kitchen sink.

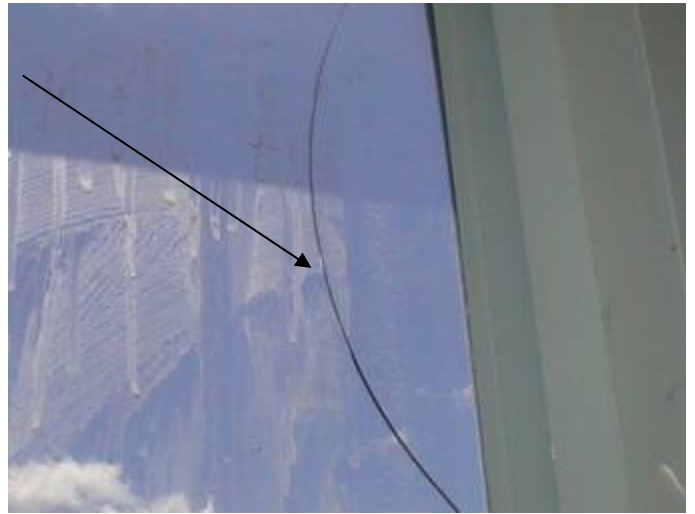
The glass is cracked at the top left window in the master bedroom.

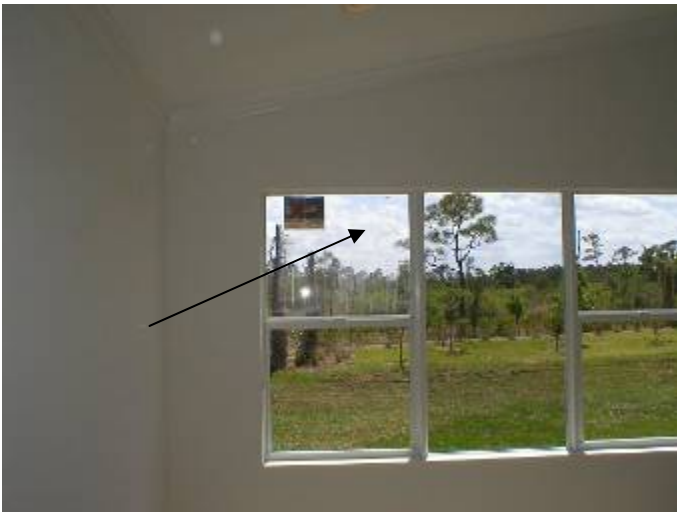
The glass is cracked at the top left window in the master bedroom.

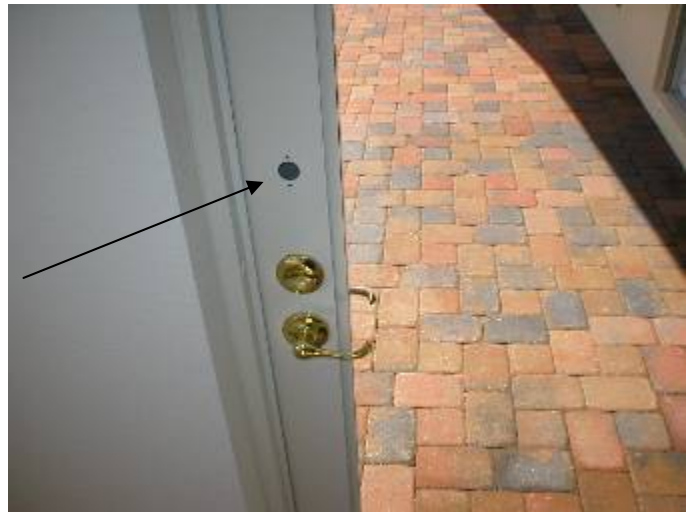
The top lockset is not installed at the master bedroom patio access door.

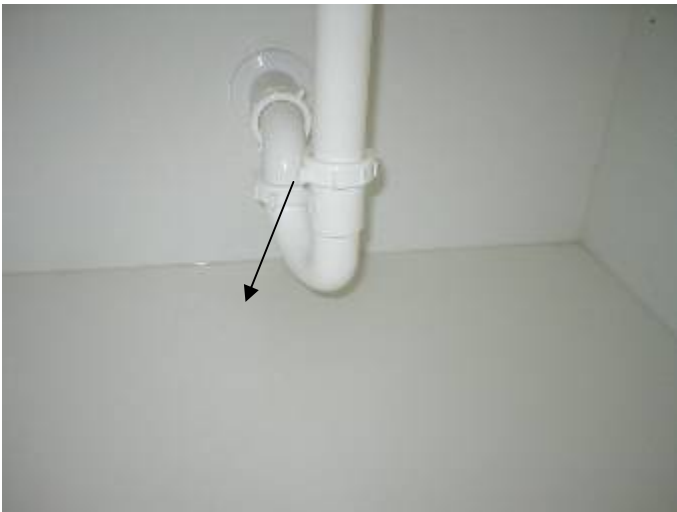
There are leaks at the plumbing drain line under the laundry room mud sink.

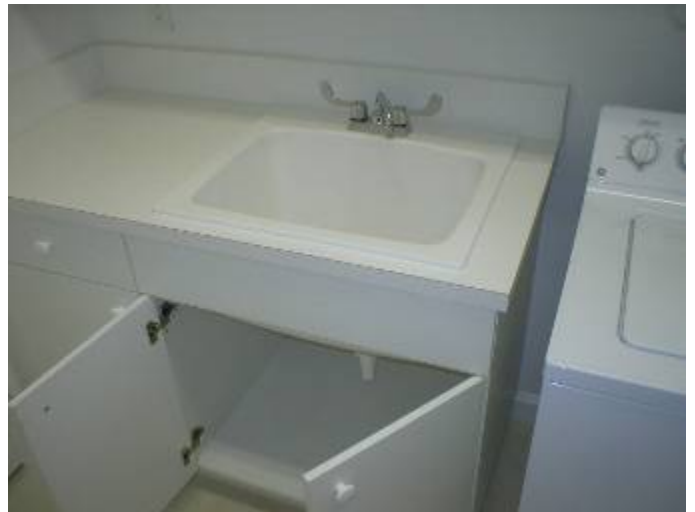
There are leaks at the plumbing drain line under the laundry room mud sink.

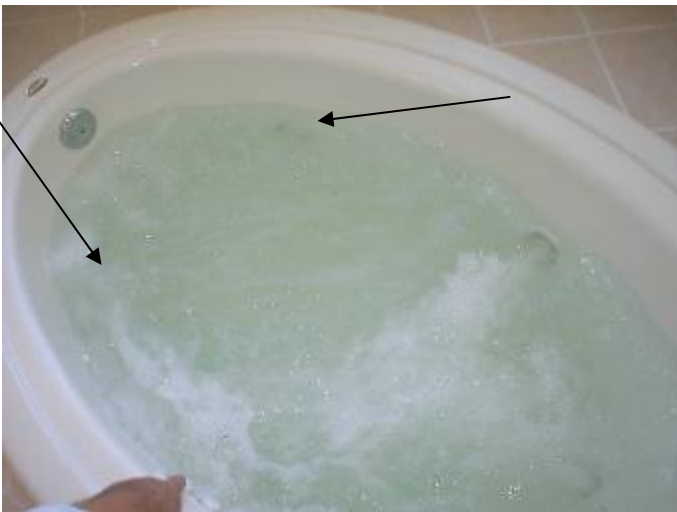
The front jets did not operate correctly at the whirlpool tub in the master bathroom.

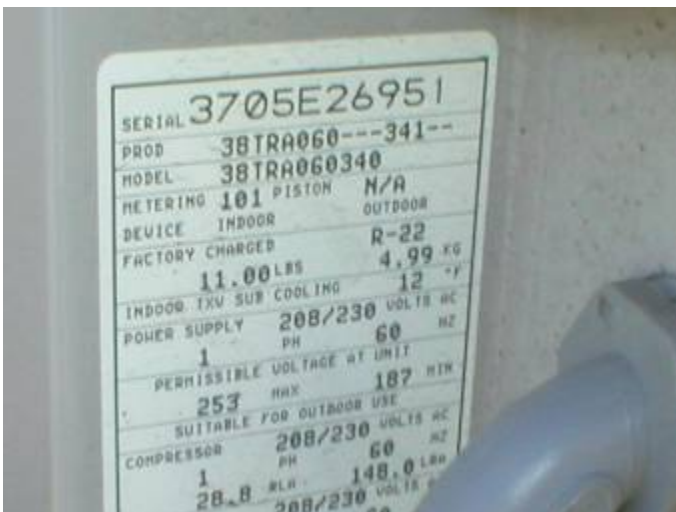
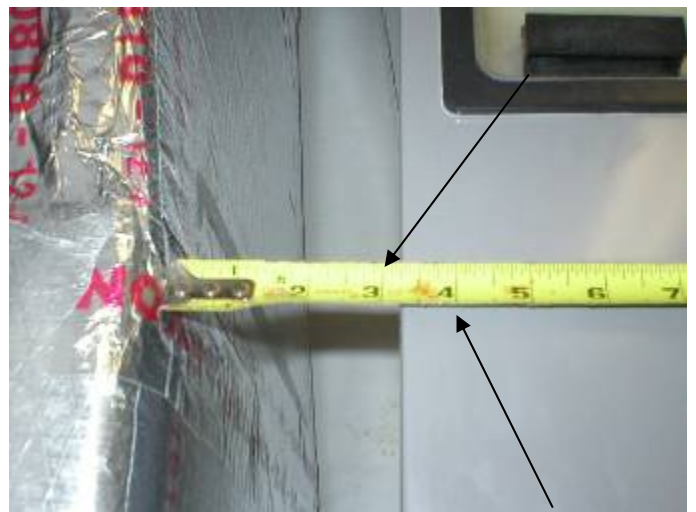
There is not enough space around the air handler at the side or back of the unit. 4 inch clearance is required. §M603.1.3 §13-410.1.ABCD.3.0.3

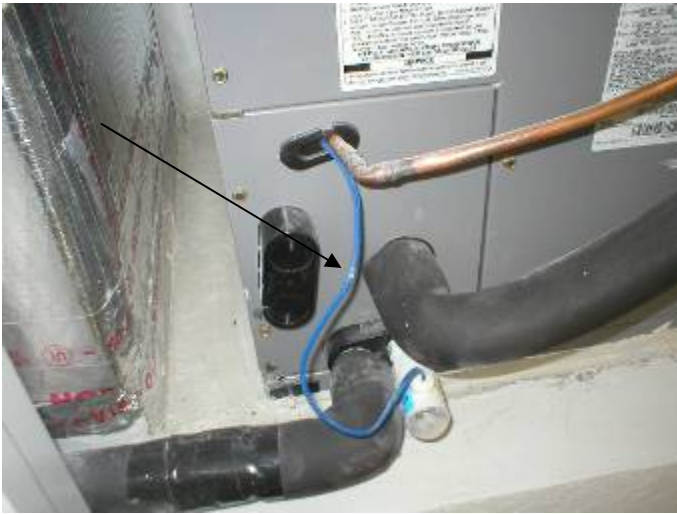
The low voltage wiring should not run through the same opening as the refrigerant line in the air handler.

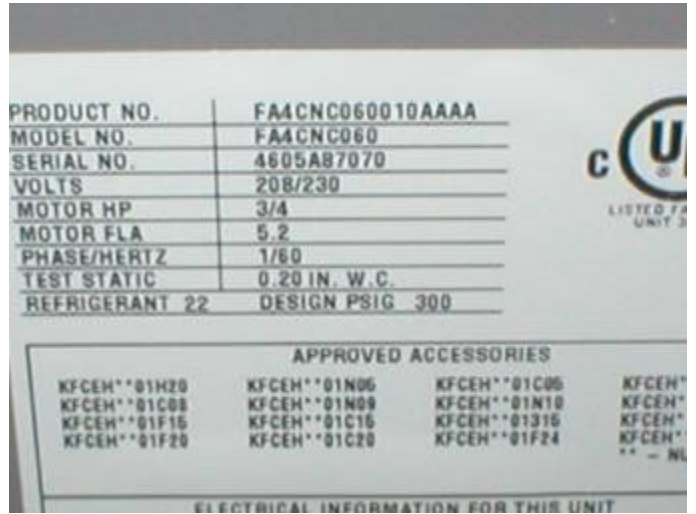
The 5 ton compressor & air handlers appear to be over sized for a 2100 square foot house. The house is cold but feels humid.

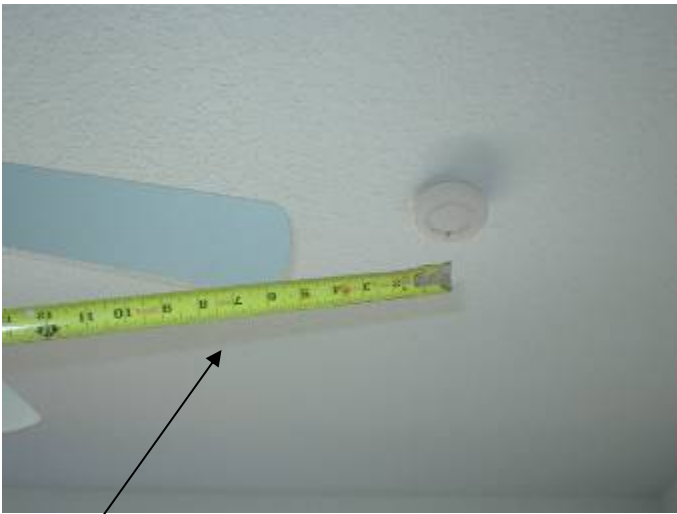
The smoke detectors are installed too close to the ceiling fan blade tips in the guest bedrooms. 3 ft horizontal clearance required.
