Inspection Report of 1743 Jamesport Dr Port St. Lucie FL 33953 Prepared for Sharon Keller

The State of Florida requires the builder to build in compliance with the Florida Building Code.

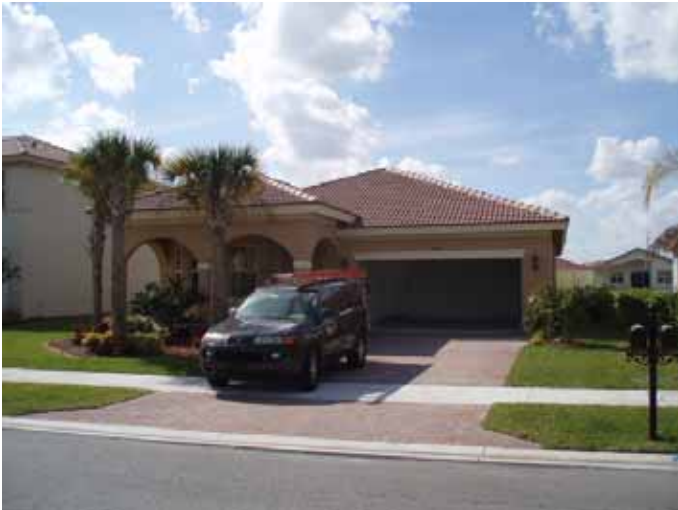
Site photo. The front of the house faces towards the southeast.

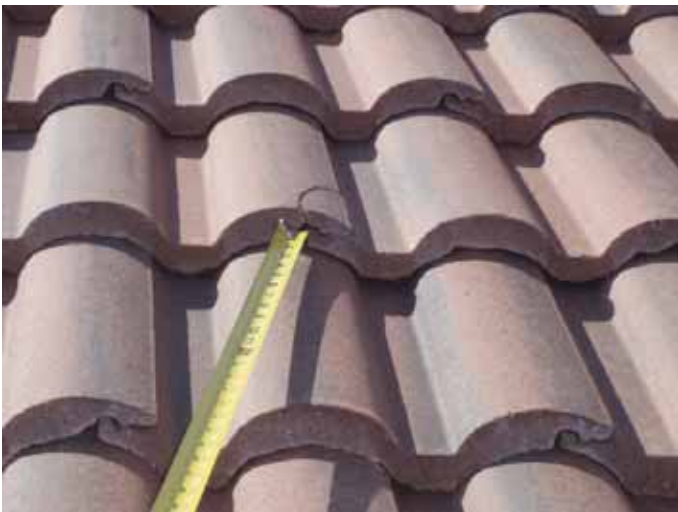
There were broken tiles that were incorrectly "glued" back together on the roof. The broken roof tiles should be removed & replaced, not "glued" back together.

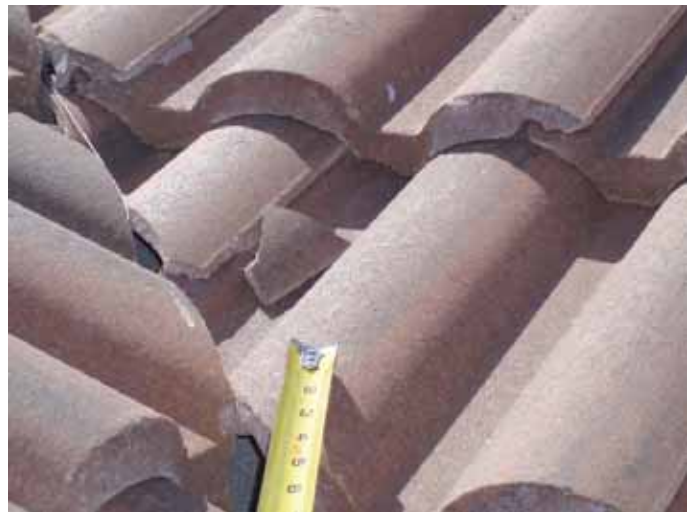
Loose & incorrectly installed roof tiles & construction debris can become windborne projectiles during a hurricane.

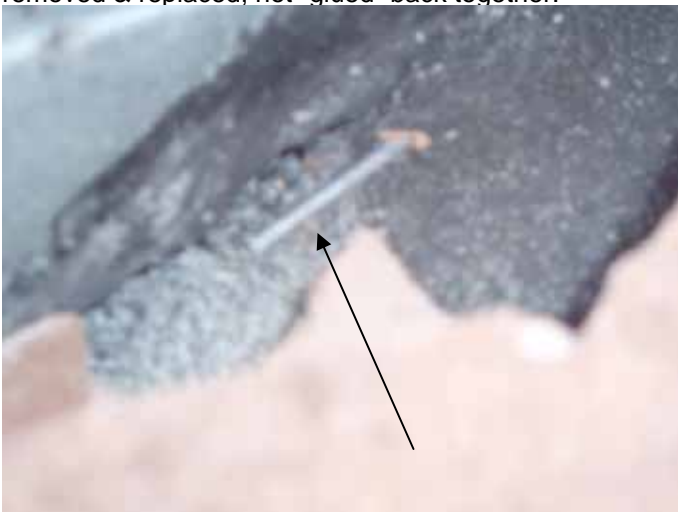
All nails & debris should be removed from the roof.

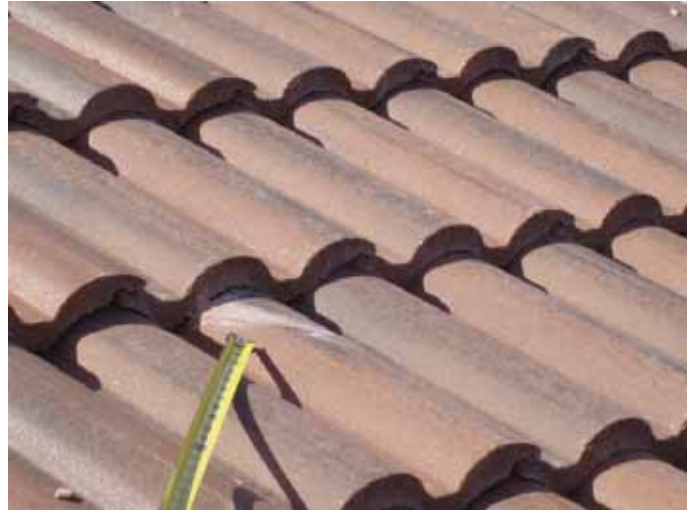
There were broken tiles that were incorrectly "glued" back together on the roof.

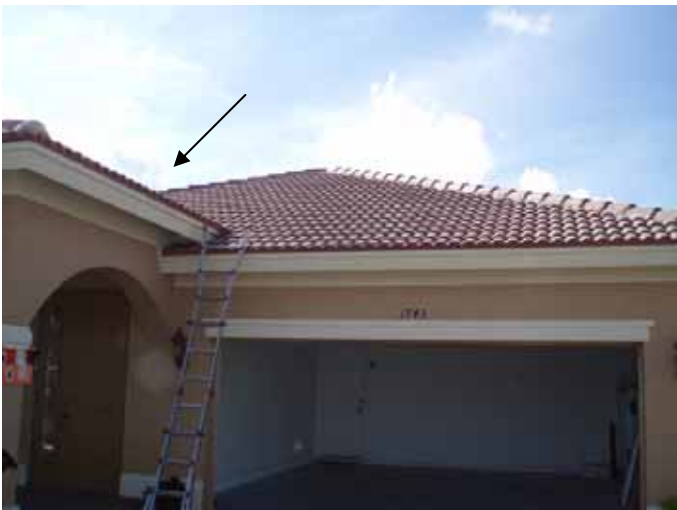
Location of the previous photos over the garage.

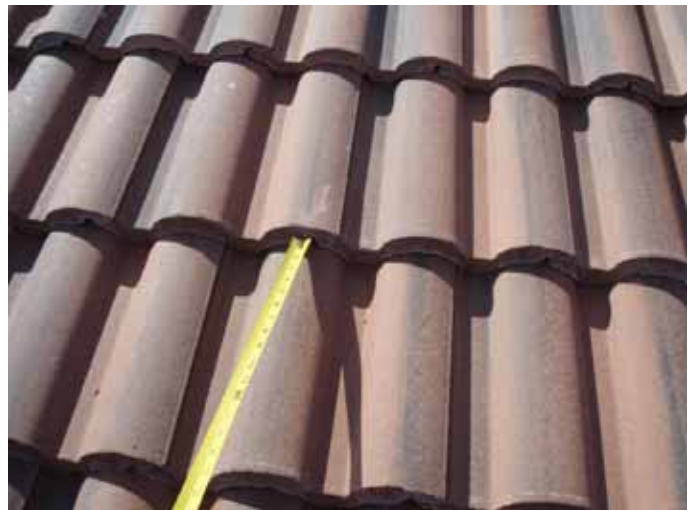
The broken roof tiles should be removed & replaced, not "glued" back together.

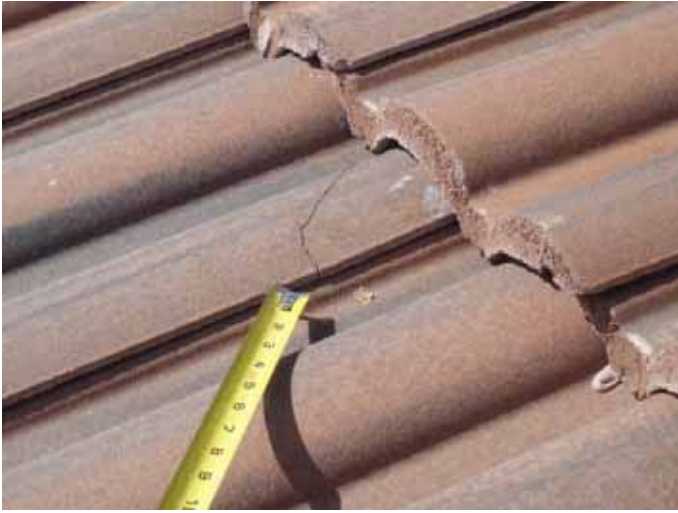
There were cracked & broken tiles on the roof at multiple locations.

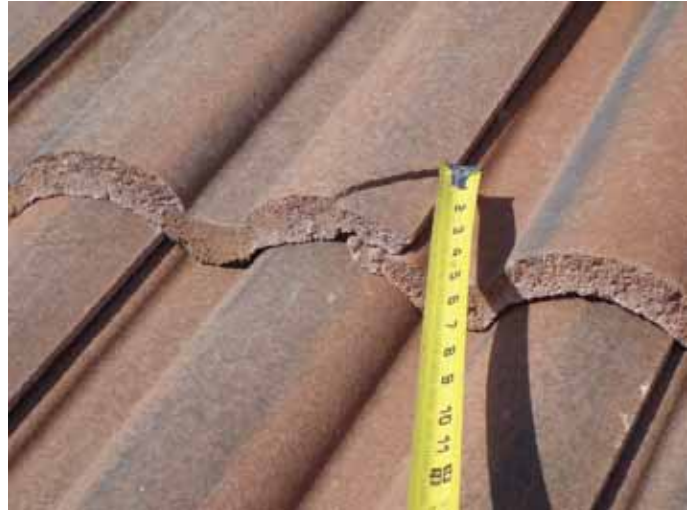
There were broken tiles that were incorrectly "glued" back together on the roof at multiple locations.

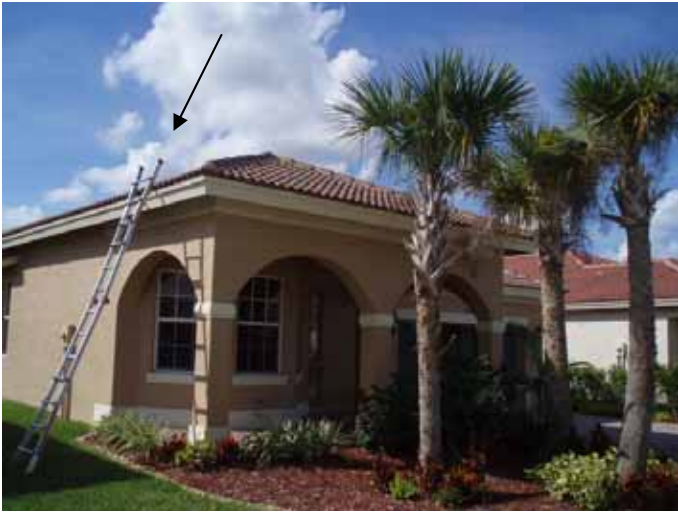
Location of the previous photos over the front entry way.

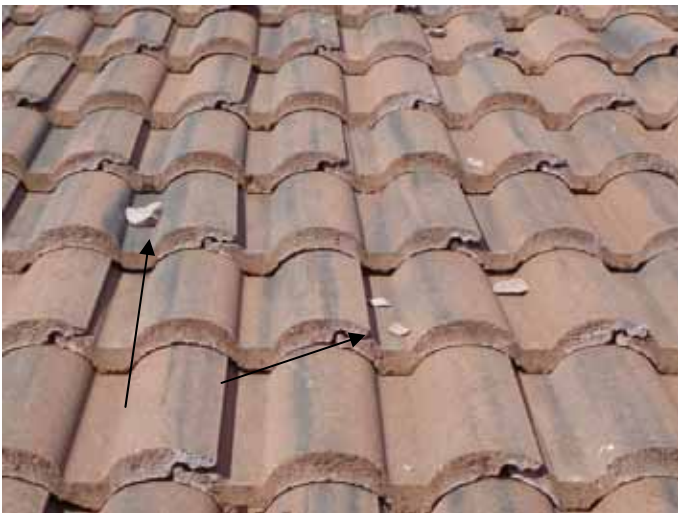
Loose & incorrectly installed roof tiles & construction debris can become windborne projectiles during a hurricane.

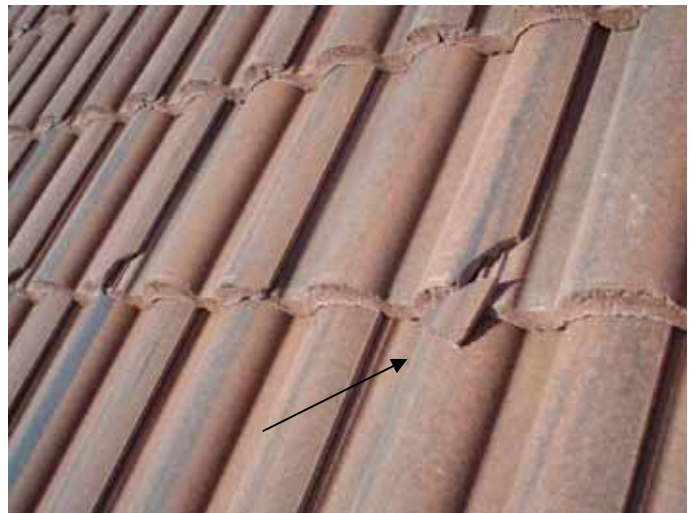
There were cracked & broken tiles on the roof at multiple locations.

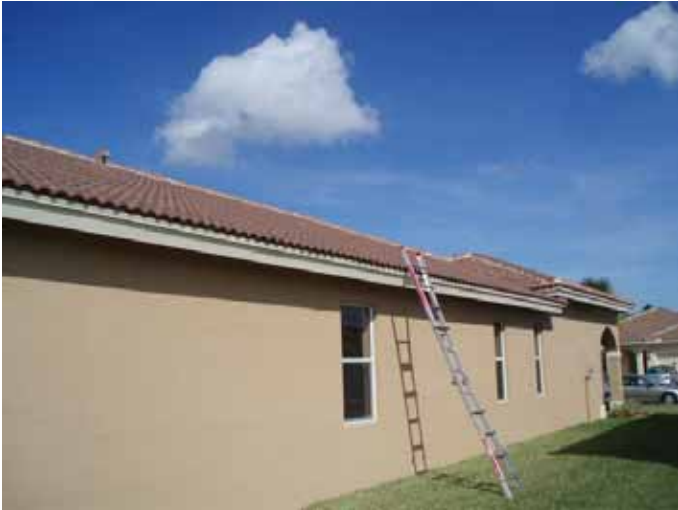
Location of the previous photos at the south side of the house.

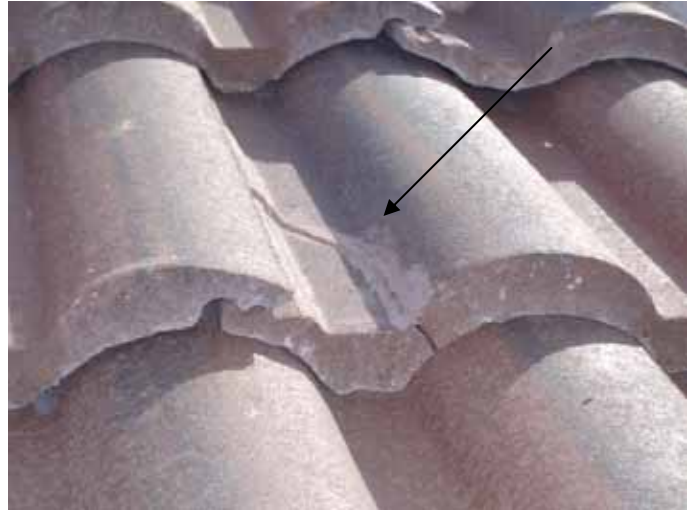
There were broken tiles that were incorrectly "glued" back together on the roof.

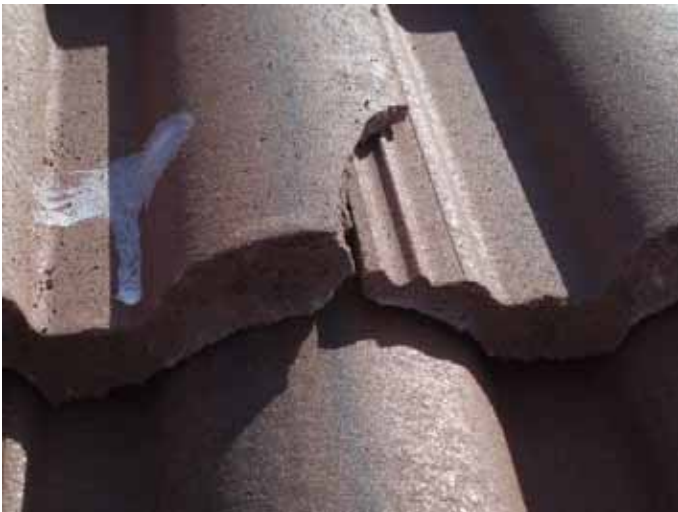
There were cracked & broken tiles on the roof at multiple locations.

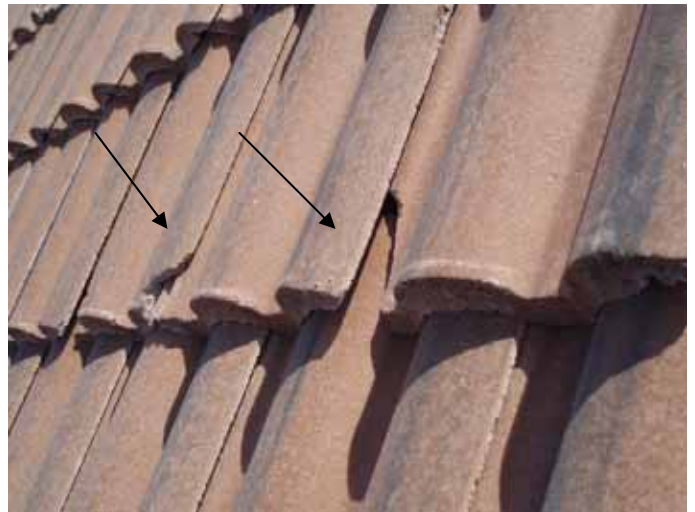
The broken roof tiles should be removed & replaced, not "glued" back together.

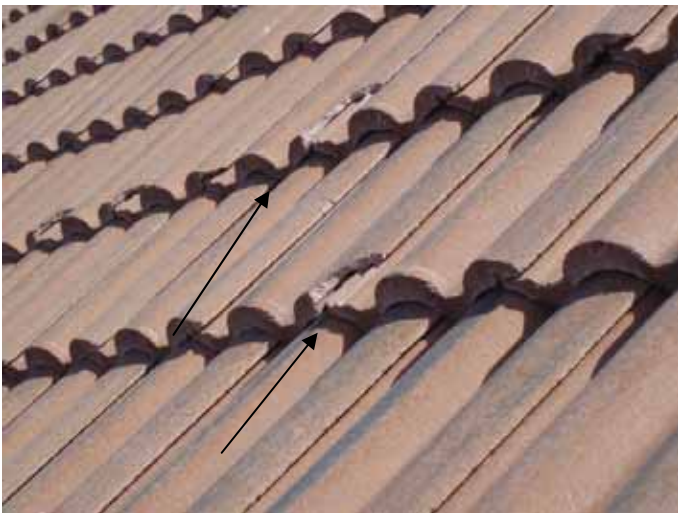
Loose & incorrectly installed roof tiles & construction debris can become windborne projectiles during a hurricane.

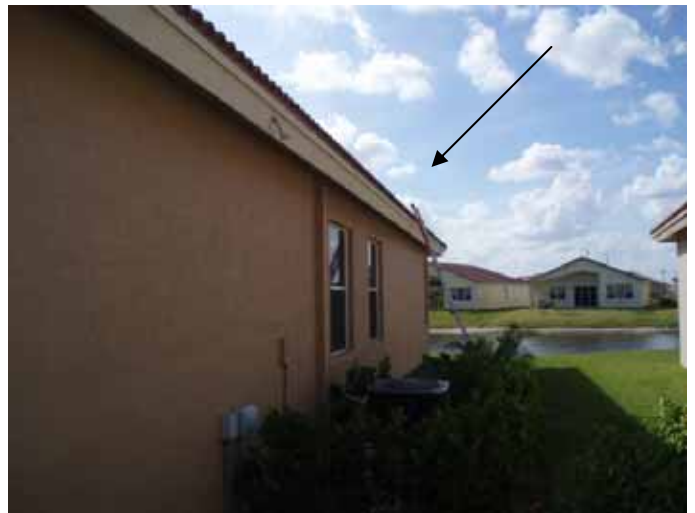
Location of the previous photos at the north side of the house.

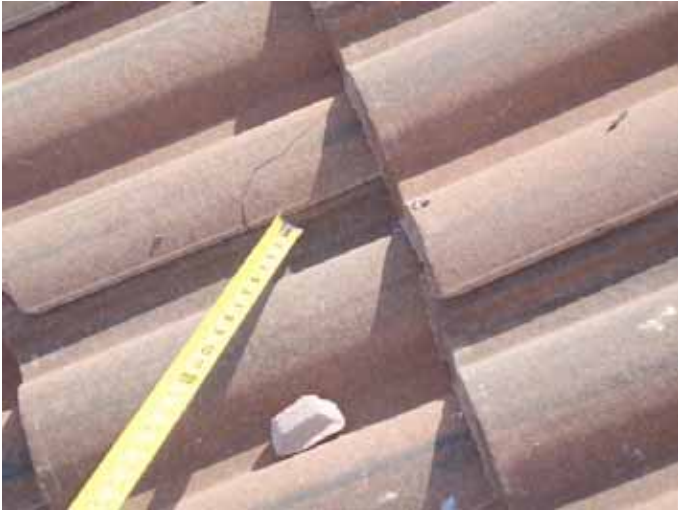
There were cracked & broken tiles on the roof at multiple locations.

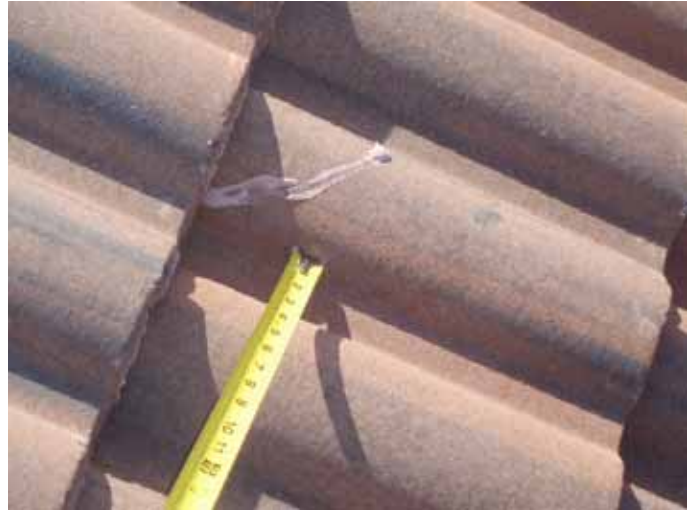
There were broken tiles that were incorrectly "glued" back together on the roof.

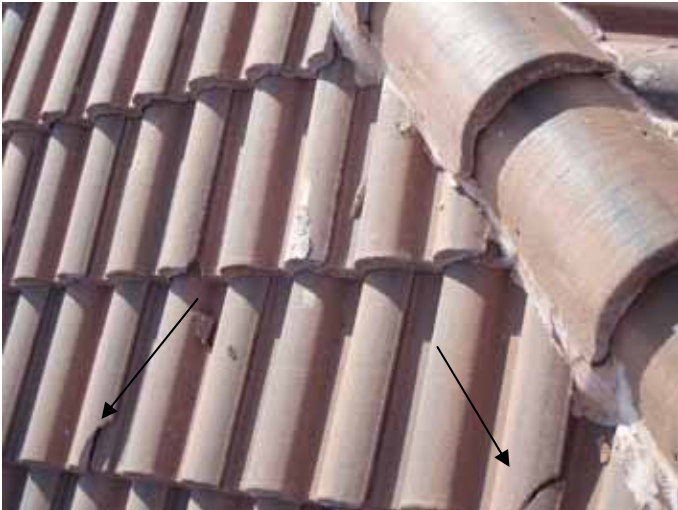
The broken roof tiles should be removed & replaced, not "glued" back together.

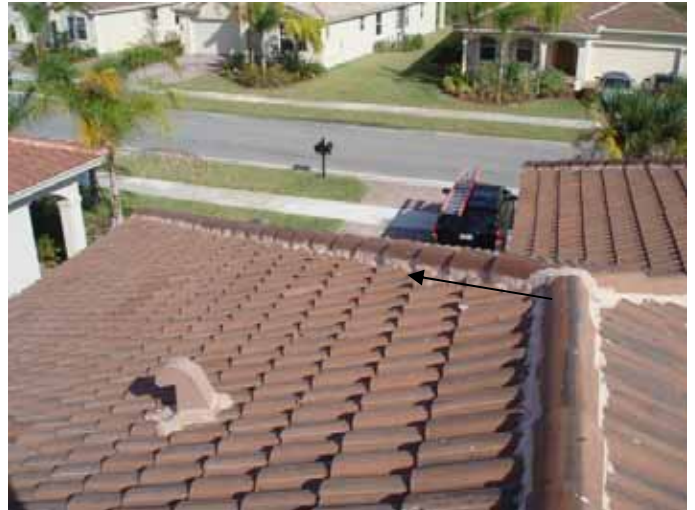
Location of the previous photos.

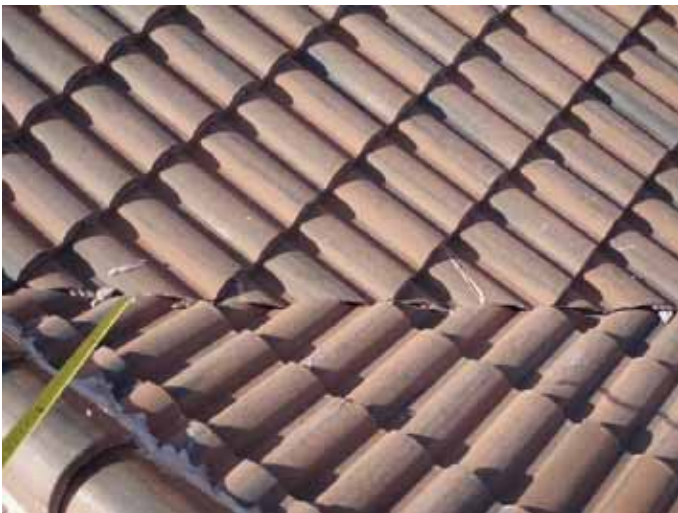
There were broken tiles that were incorrectly "glued" back together on the roof.

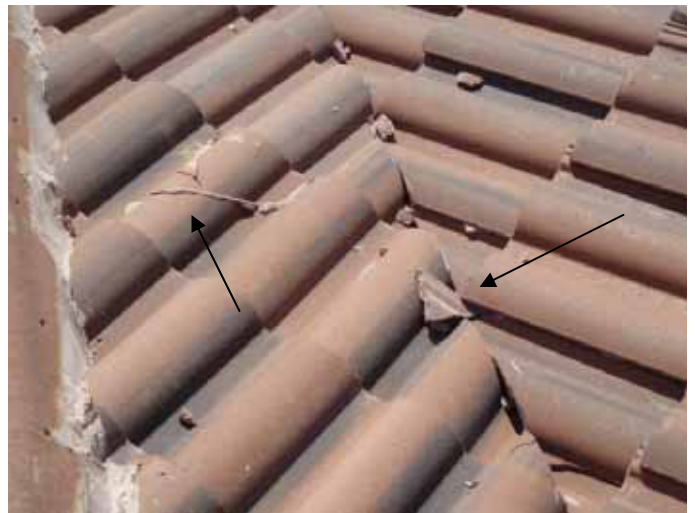
The broken roof tiles should be removed & replaced, not "glued" back together. All construction debris should be removed from the roof.

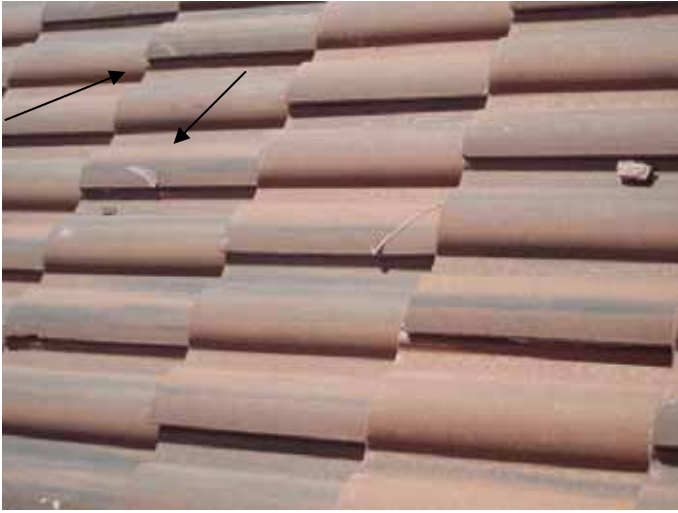
There were broken & incorrectly repaired tiles on the roof at multiple locations.

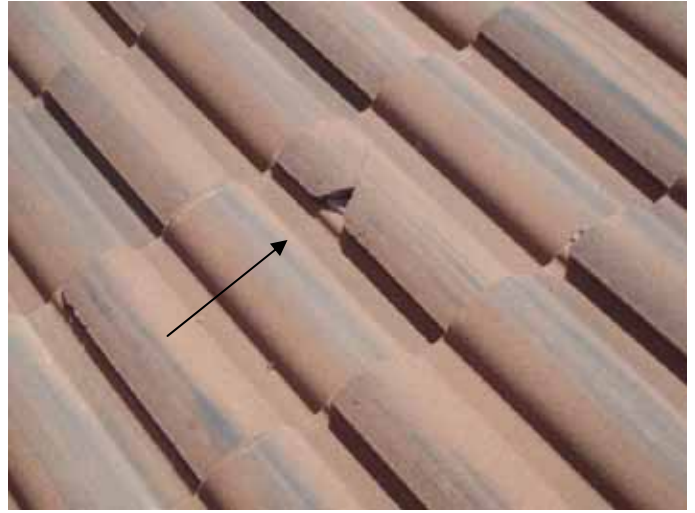
Loose & incorrectly installed roof tiles & construction debris can become windborne projectiles during a hurricane.

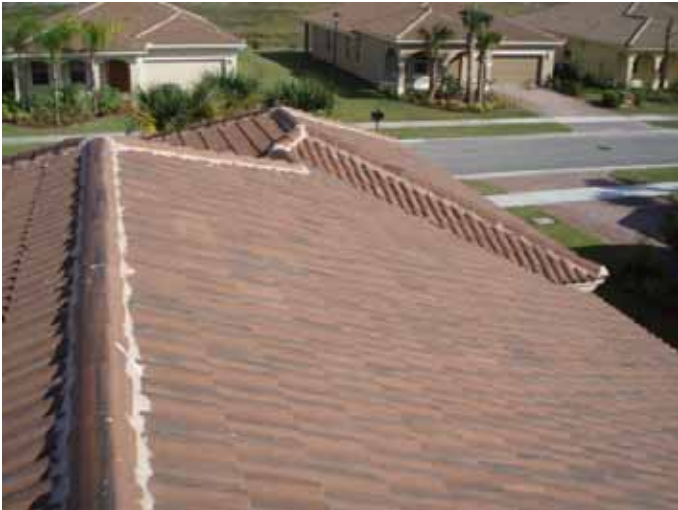
Location of the previous photos.

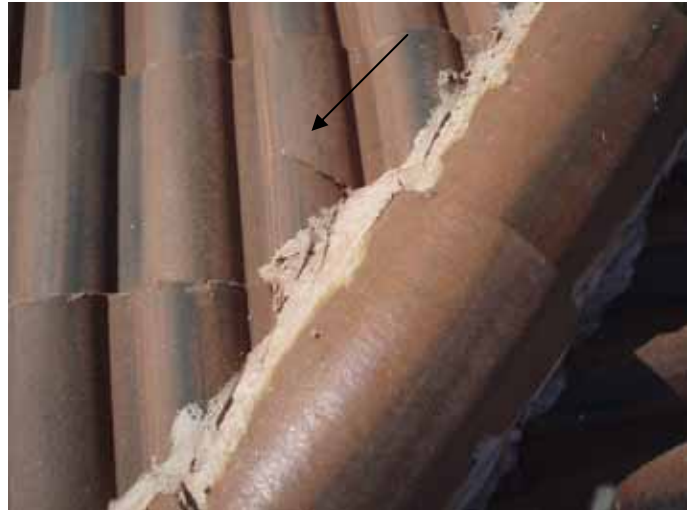
There were cracked & broken tiles on the roof at multiple locations.

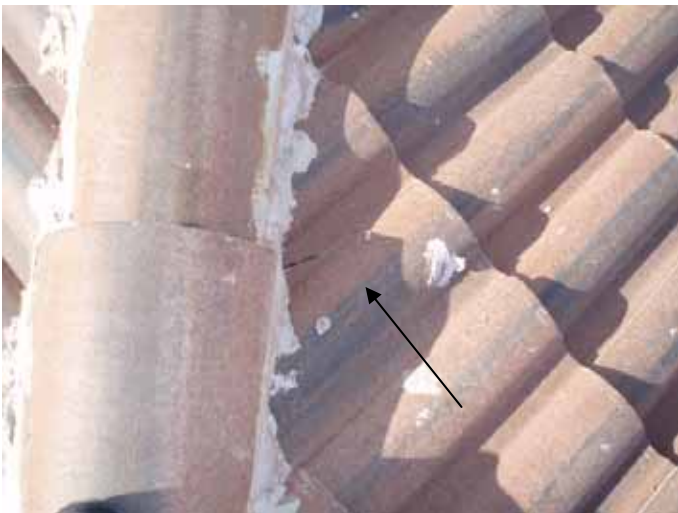
Loose & incorrectly installed roof tiles & construction debris can become windborne projectiles during a hurricane.

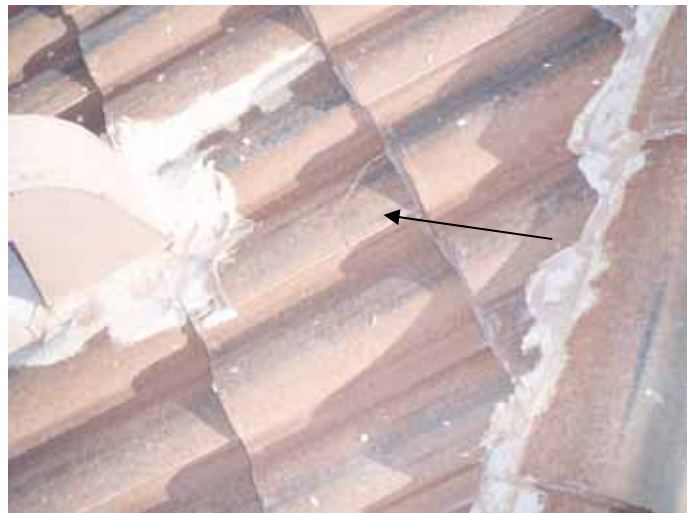
The broken roof tiles should be removed & replaced, not "glued" back together.

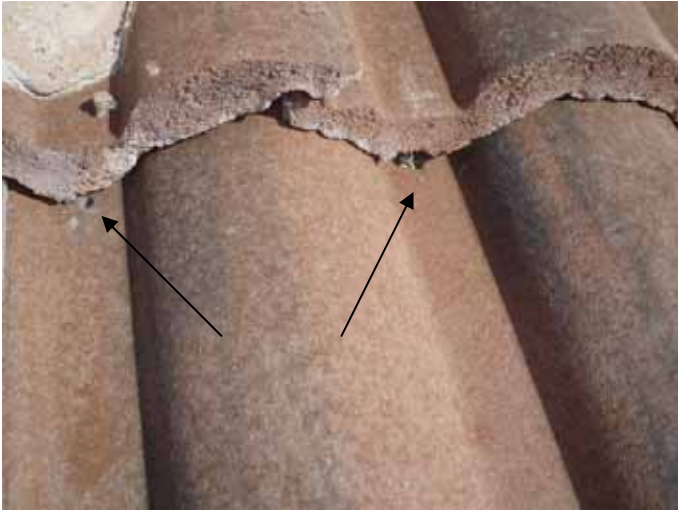
There were several exposed anchor nails at the roof tile over the back of the house. None of the anchor nails should be exposed.

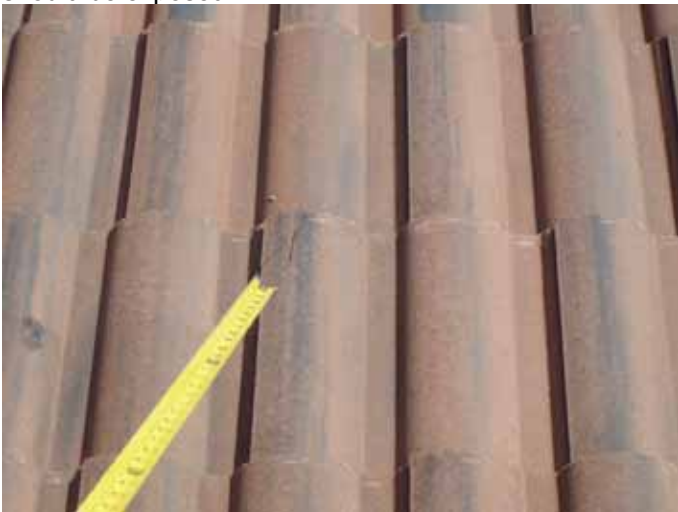
There were broken tiles that were incorrectly "glued" back together on the roof. The broken roof tiles should be removed & replaced, not "glued" back together.

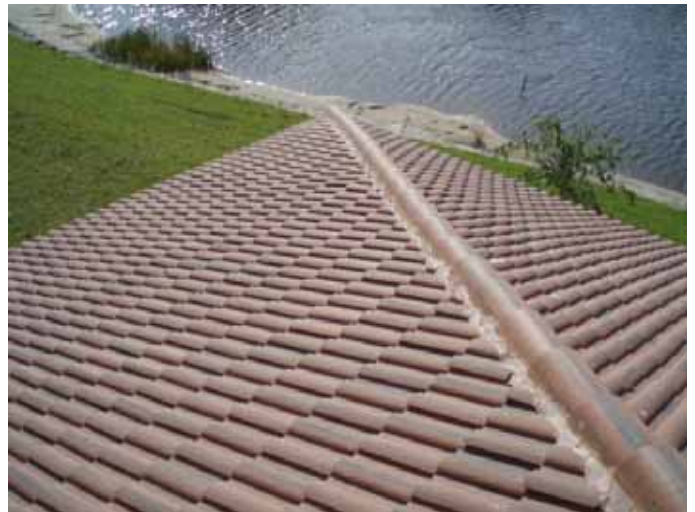
Location of the previous photos.

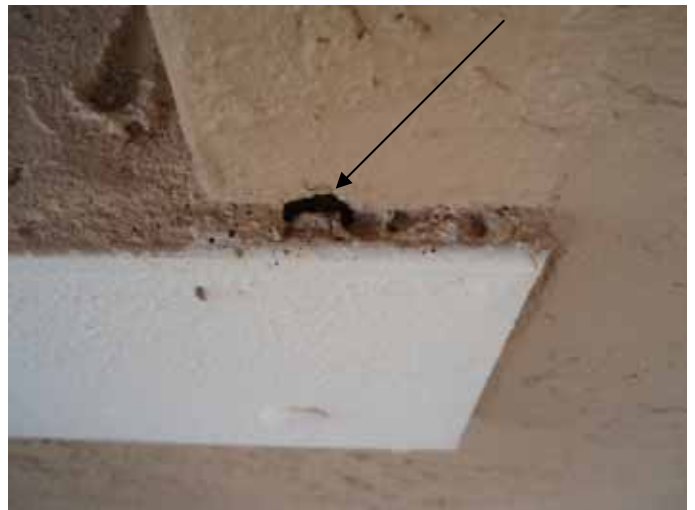
There were exposed areas with missing stucco at the window trim. These locations should be correctly sealed to prevent water & pest intrusion.

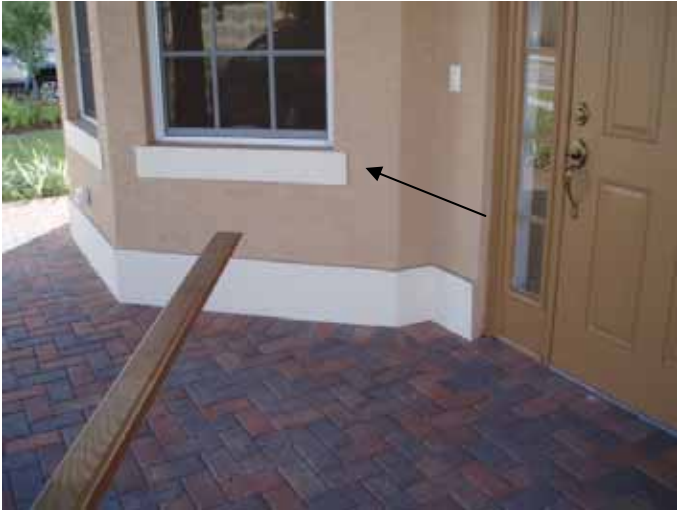
Location of the previous photos at the front entry way.

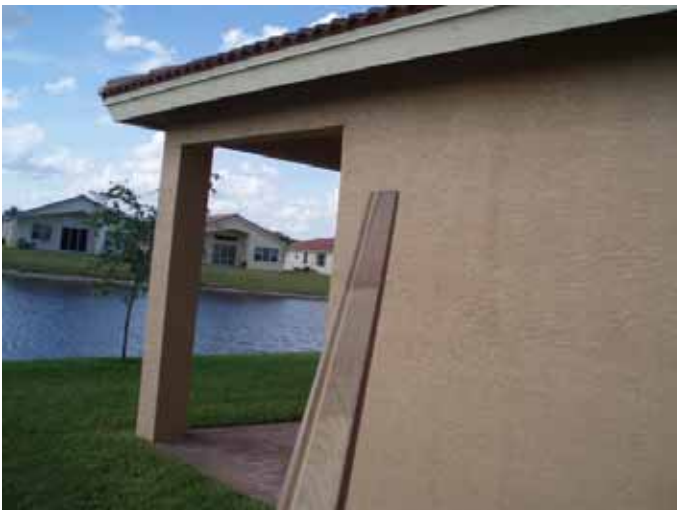
We recommend core sampling at these locations to verify the thickness of the exterior stucco & compliance with ASTM C 926.

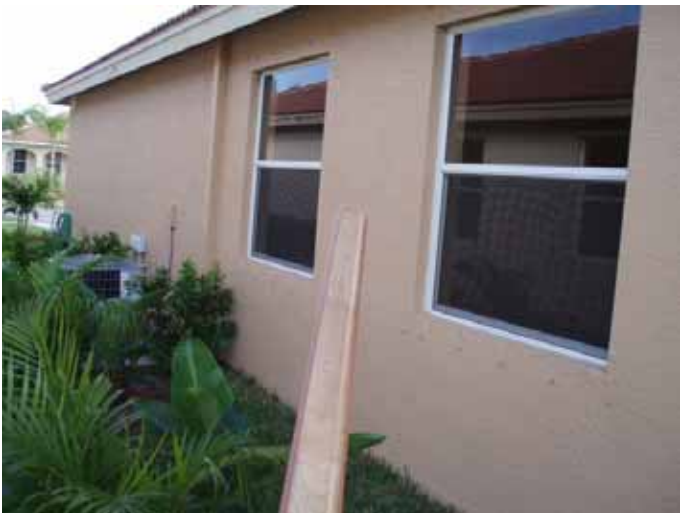
We recommend core sampling at these locations to verify the thickness of the exterior stucco & compliance with ASTM C 926.

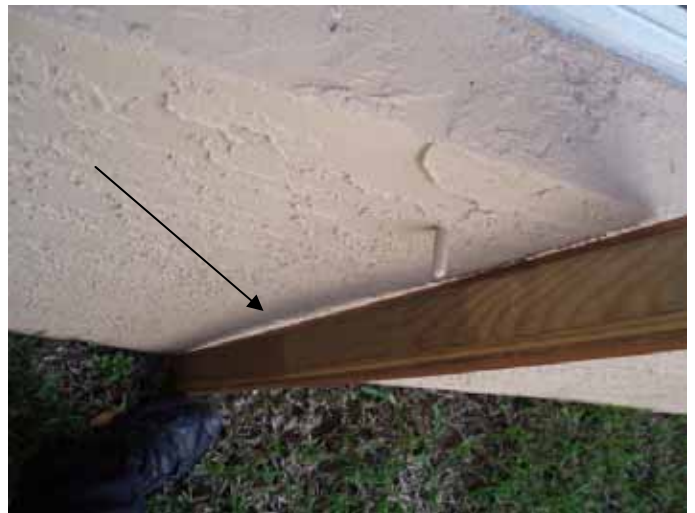
The stucco at some at the walls was concave or curved in & does not appear to be the correct thickness. §2509.1.1, ASTM C 926

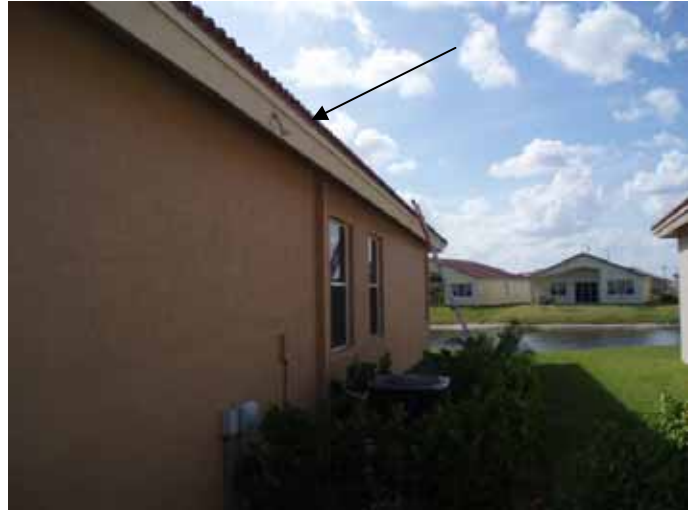
Location of the previous photo. The rain sensor was loose &/or not correctly installed to operate properly. The rain sensor should be parallel to the ground.

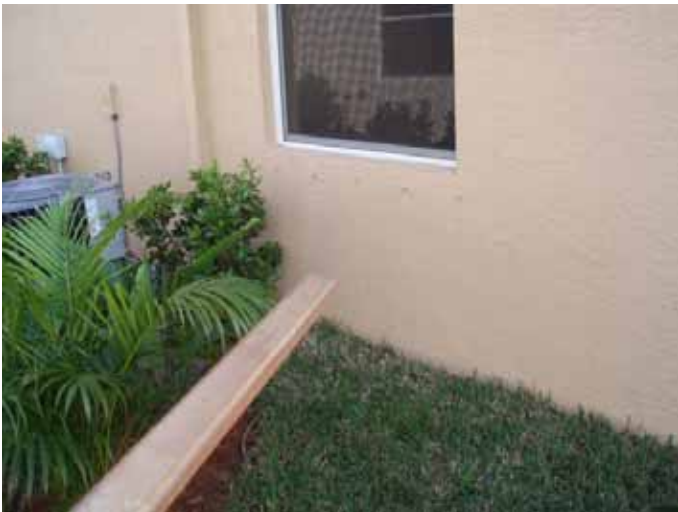
We recommend core sampling to verify the thickness of the exterior stucco & compliance with ASTM C 926 at the locations identified.

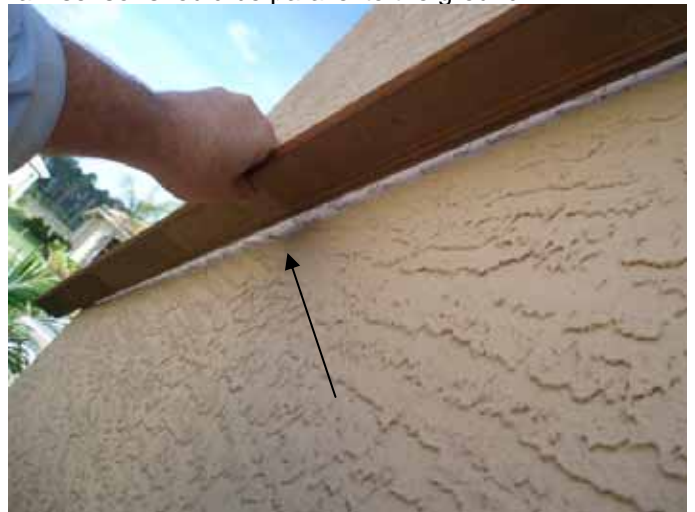
Some of the stucco work appears to be uneven & not the proper depth. ASTM C 926, §2504.2 §1403.1.3

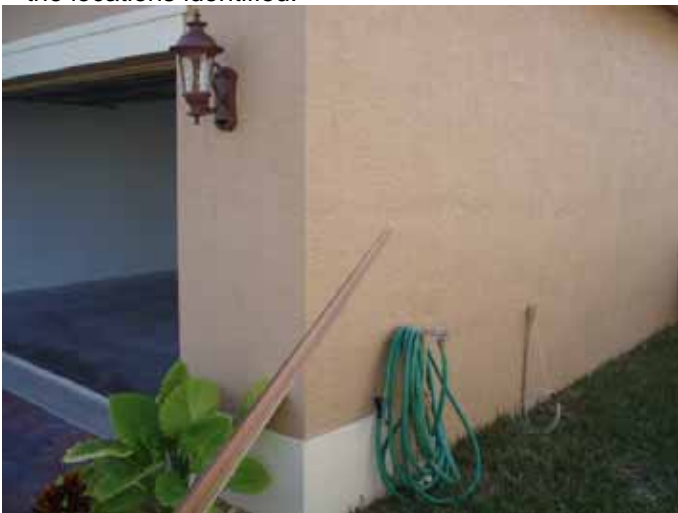
Location of the previous photo. We recommend core sampling to verify the thickness of the exterior stucco & compliance with ASTM C 926.

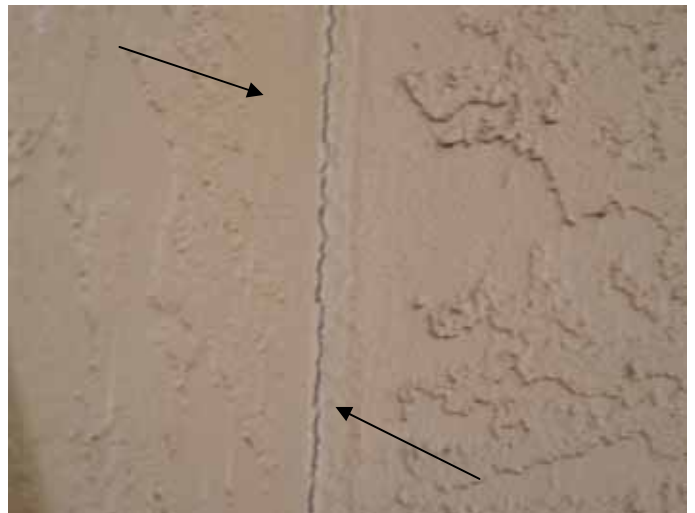
There were unsealed cracks & openings in some of the exterior stucco walls.

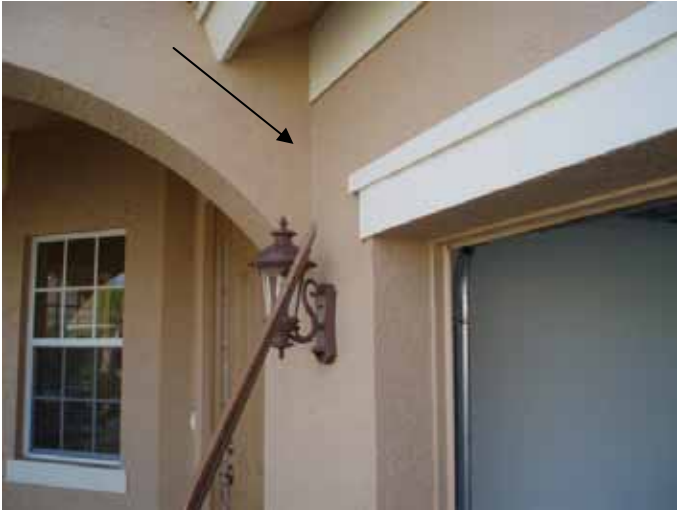
Location of the previous photo. All cracks & openings in the exterior should be sealed to prevent water & pest intrusion.

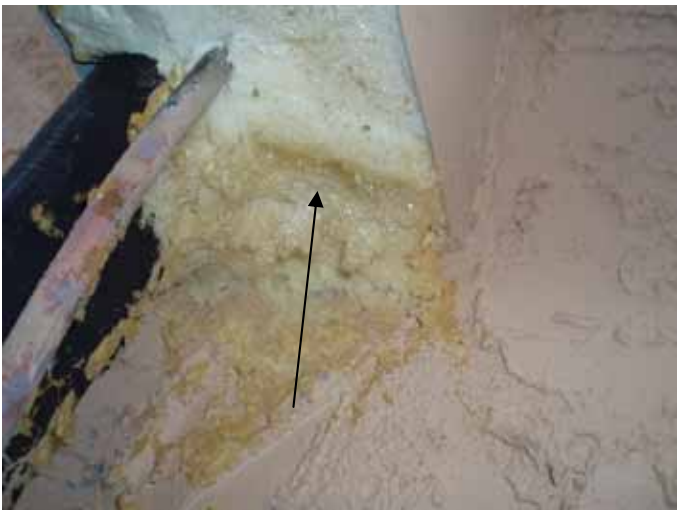
There were unsealed openings in the foam at the bottom of the AC refrigerant line cover. The expandable foam is not designed to be exposed to U.V. Sunlight.

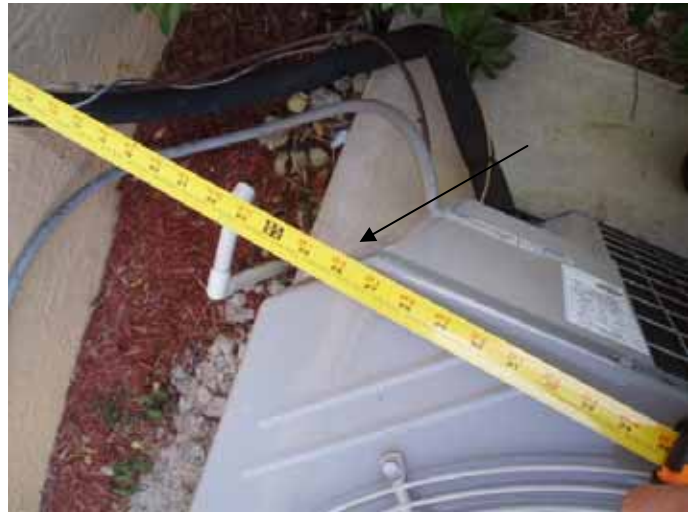
36 inch working space clearance is required at the electrical component access panels. Per 2002 NEC & the manufacturer.

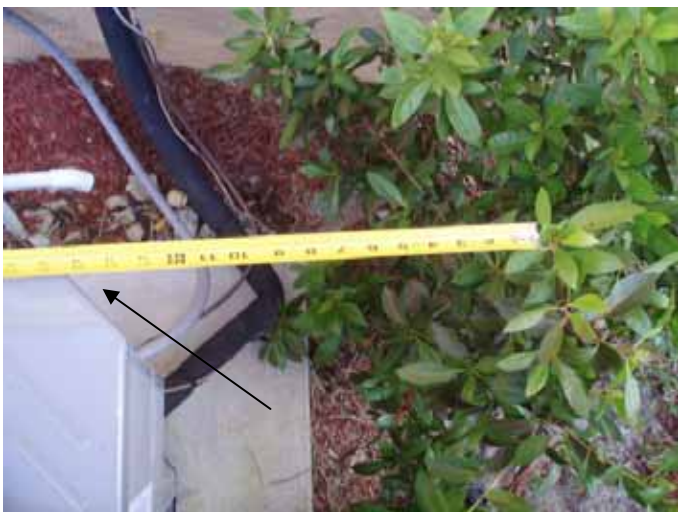
The AC condensing unit was turned the wrong way. 36 inch working space clearance is required at the electrical component access panel.

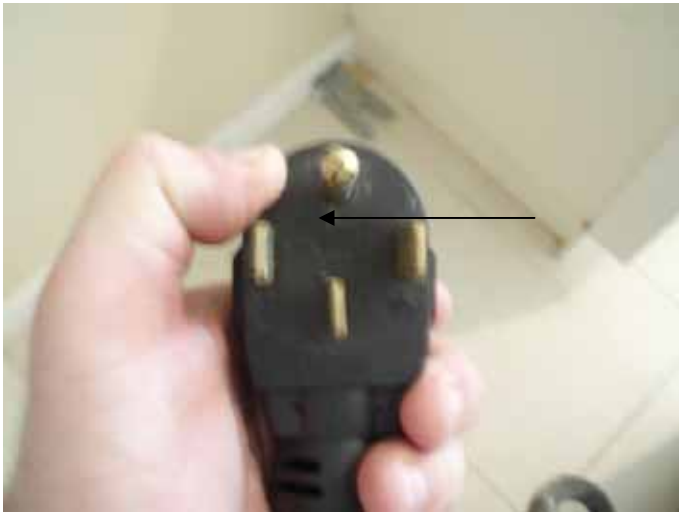
A 40 amp rated cord is used at the range & recommended by the manufacturer.

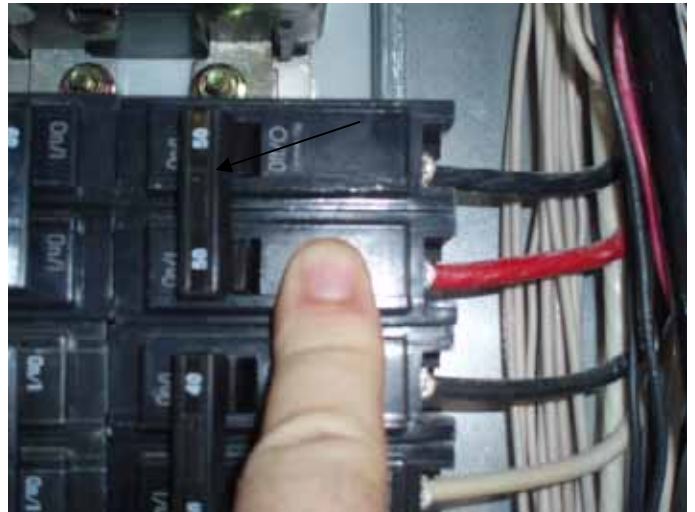
The range is installed with an electrical cord rated at 40 amps. The 50 amp overcurrent protection breaker in the main distribution panel is too big.
2002 NEC

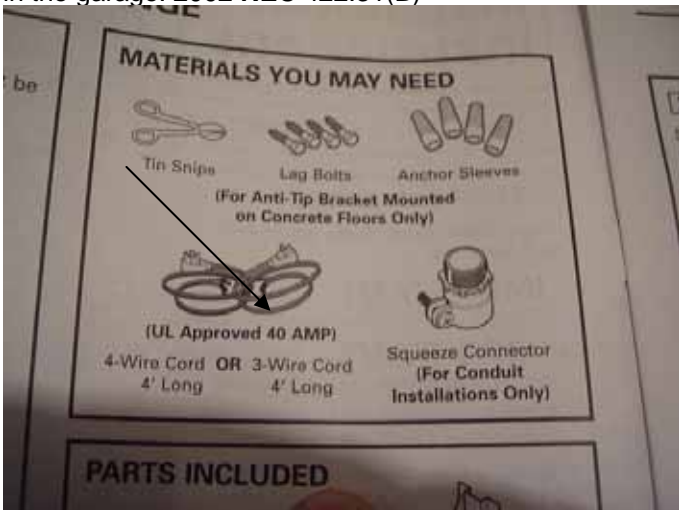
A 40 amp rated cord is used at the range & recommended by the manufacturer.

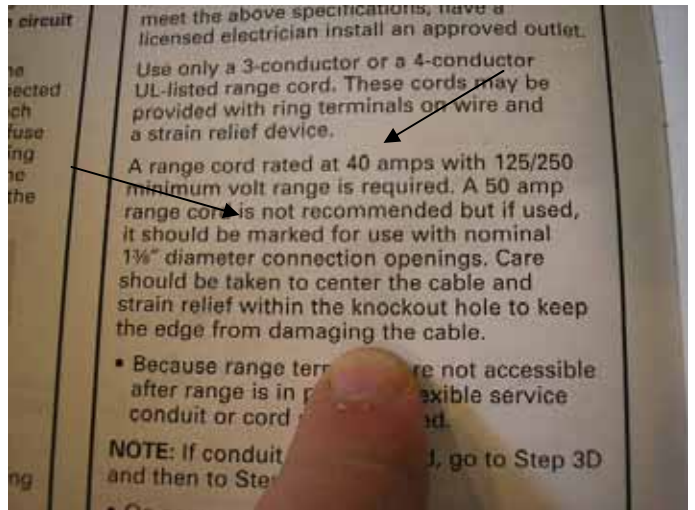
The range is installed with an electrical cord rated at 40 amps. The 50 amp overcurrent protection breaker in the main distribution panel is too big. §M304.1

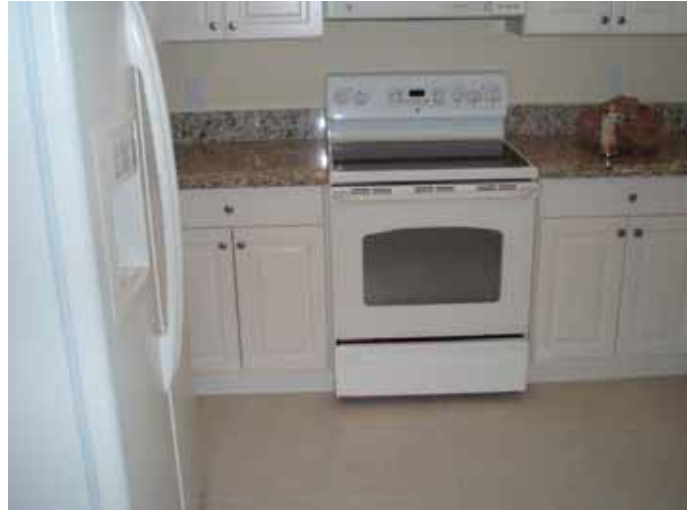
Location of the previous photo/s at the range in the kitchen.

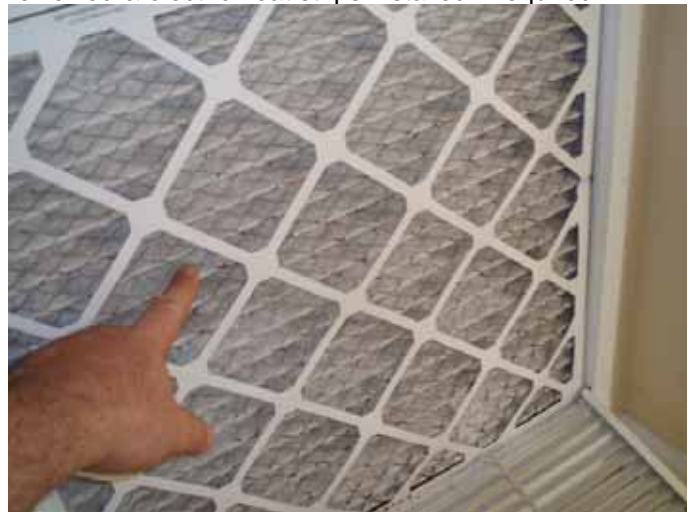
Note: the AC filters were installed backwards. There was rust &/or corrosion on the wire mesh on the filters.

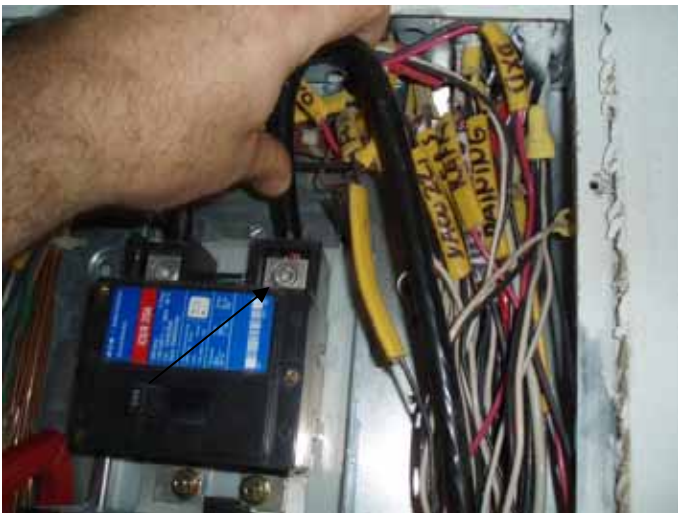
The terminal lug was loose & not correctly secured at the (HOT) ungrounded entrance conductor at the right side of the main distribution panel.

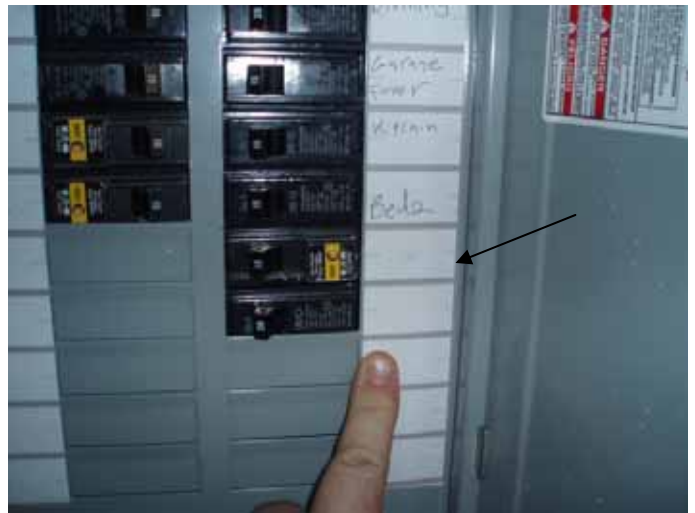
Some of the electrical circuits were not identified. All of the circuits in the main distribution panel should be correctly identified in the panel directory.

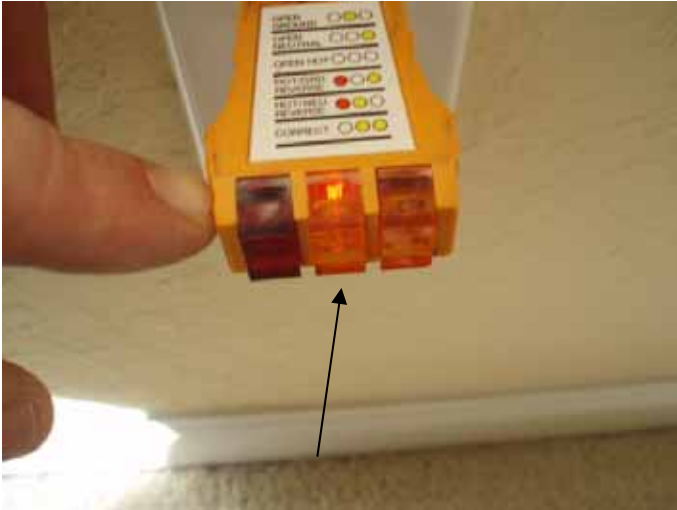
There were several receptacle outlets that tested loose or open ground in the master bedroom.

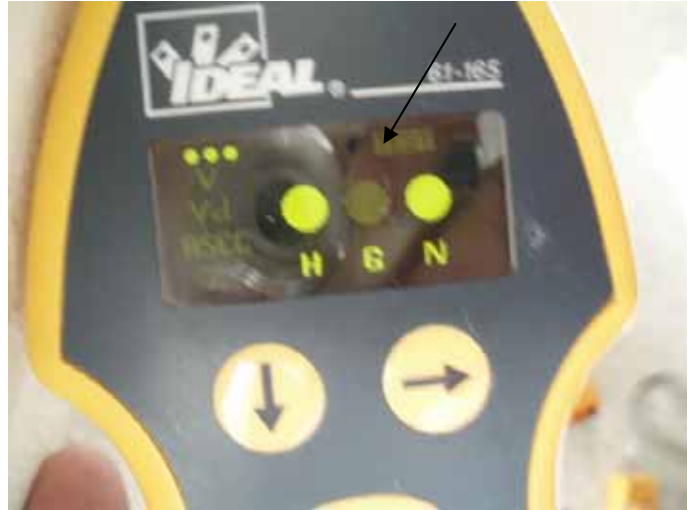
Two separate testing devices were used to evaluate the receptacle outlet.

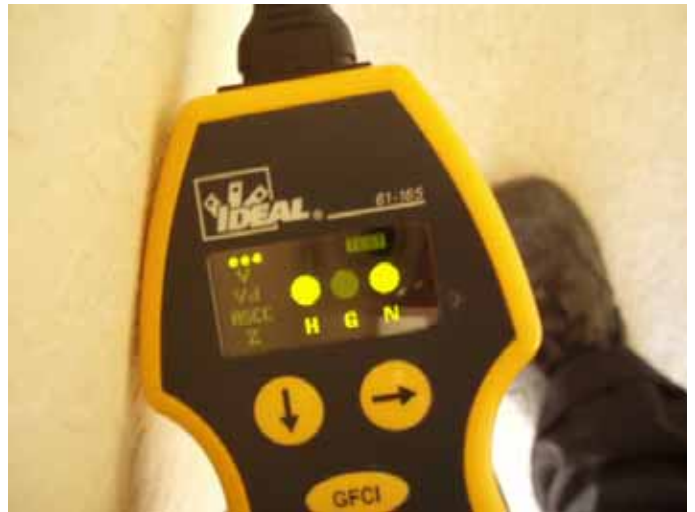
There were several receptacle outlets that tested loose or open ground in the master bedroom.

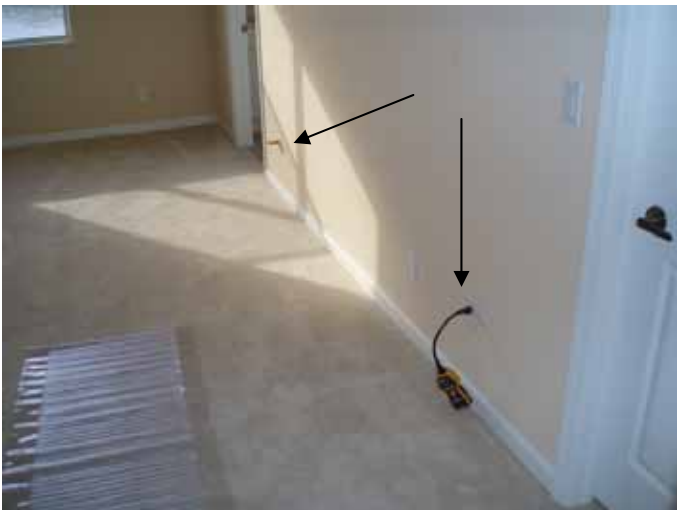
Location of the previous photos.
