Inspection Report of 1743 Jamesport Dr Port St. Lucie FL 33953 Prepared for Sharon Keller

The State of Florida requires the builder to build in compliance with the Florida Building Code.

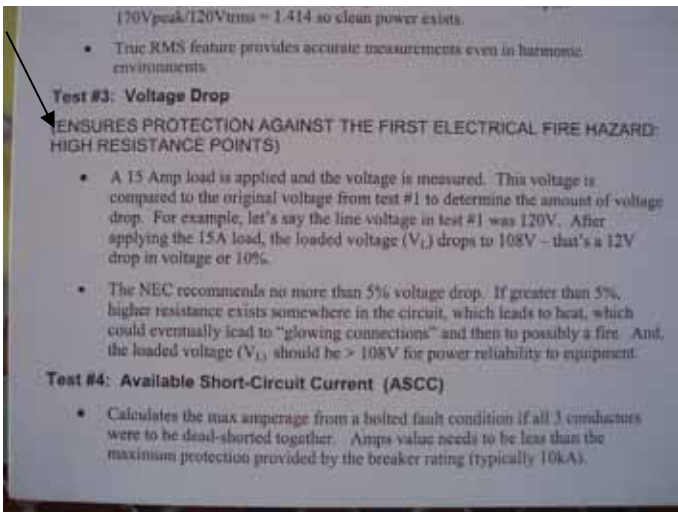
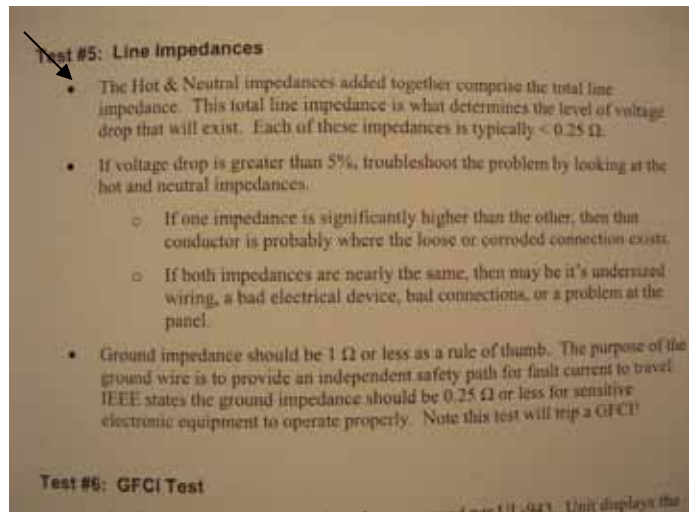
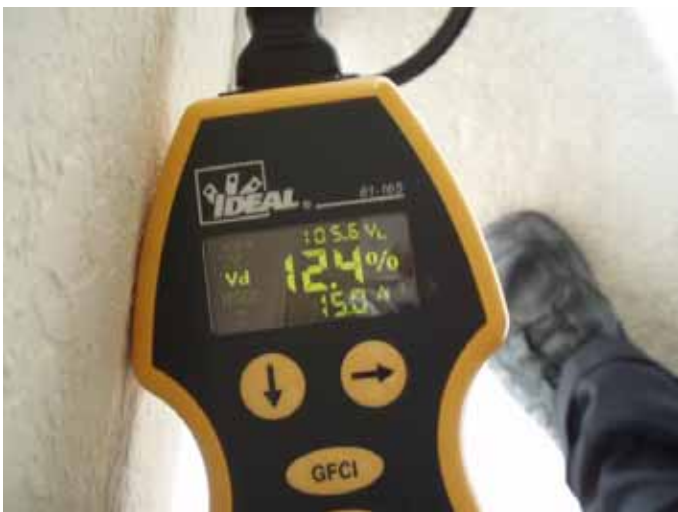
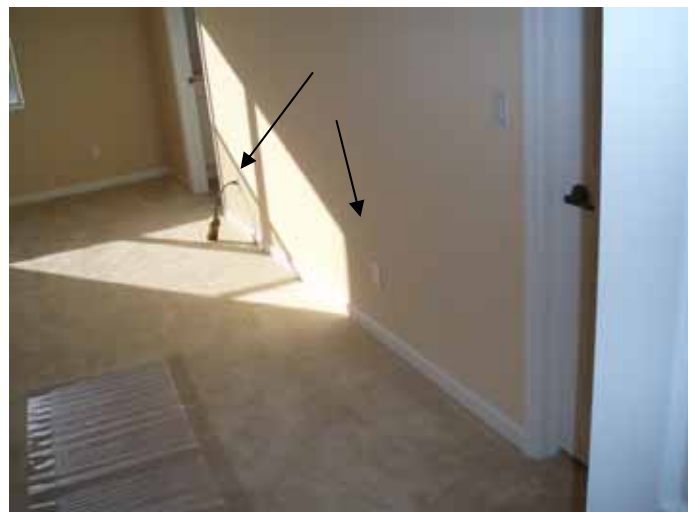
The voltage drop at some of the outlets exceeds 10%. 2002(NEC) 210.19 Conductors. We believe that any voltage drops over 10% require further investigation.

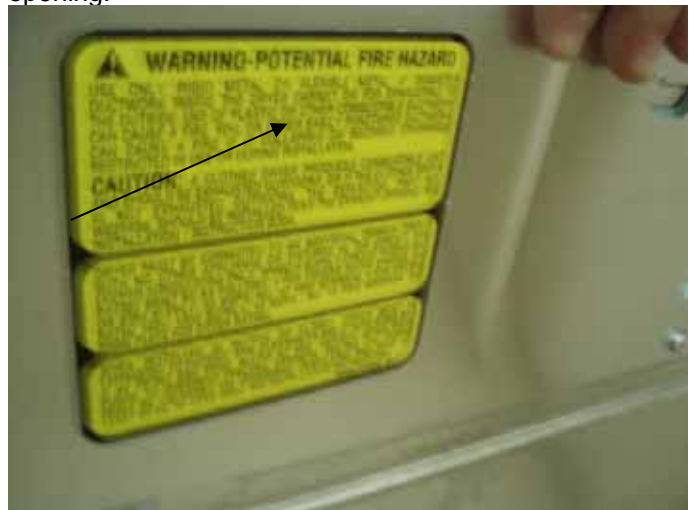
The manufacturer states the use of this duct can be a fire hazard. We recommend replacing the duct with a semi-rigid duct as per the CSPC article below.

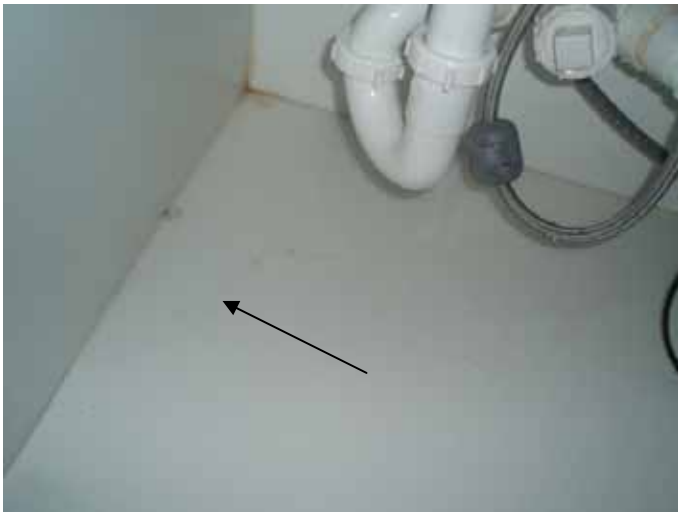
Water leaked from the sink basin to the cabinet below in the kitchen.

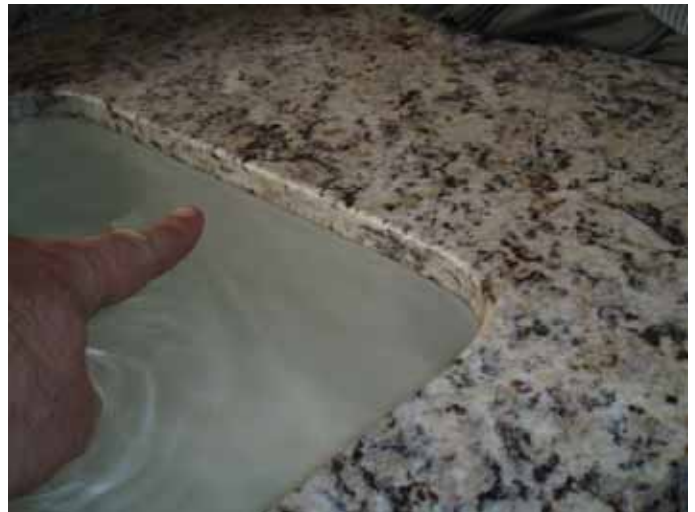
The sink was not correctly sealed at the counter top.

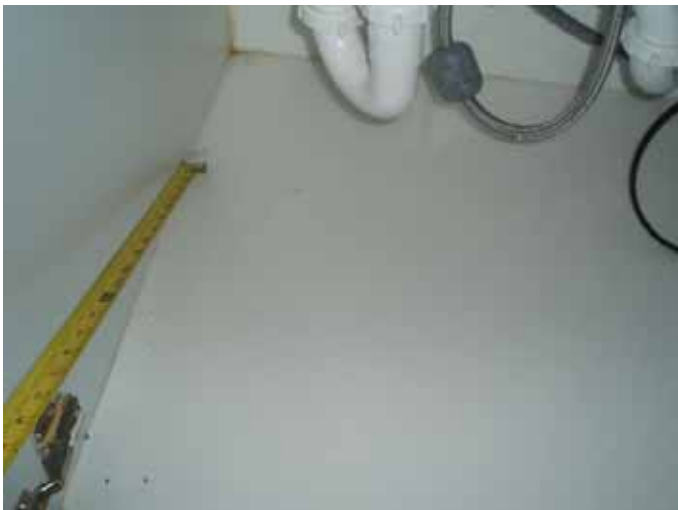
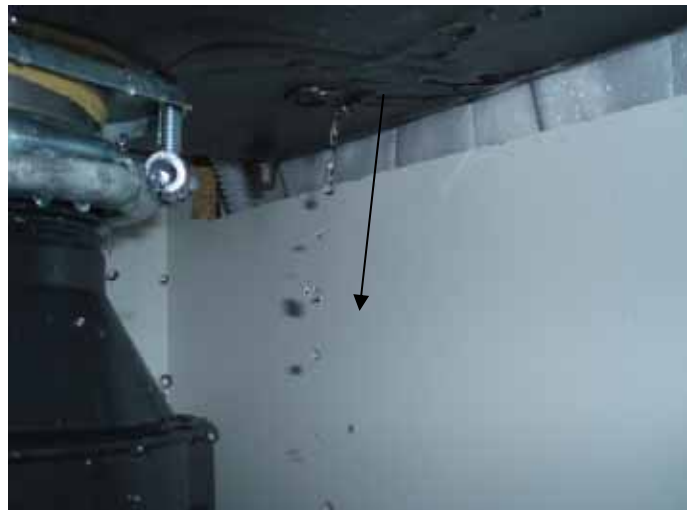
Most of the water was leaking from the right side of the kitchen sink.

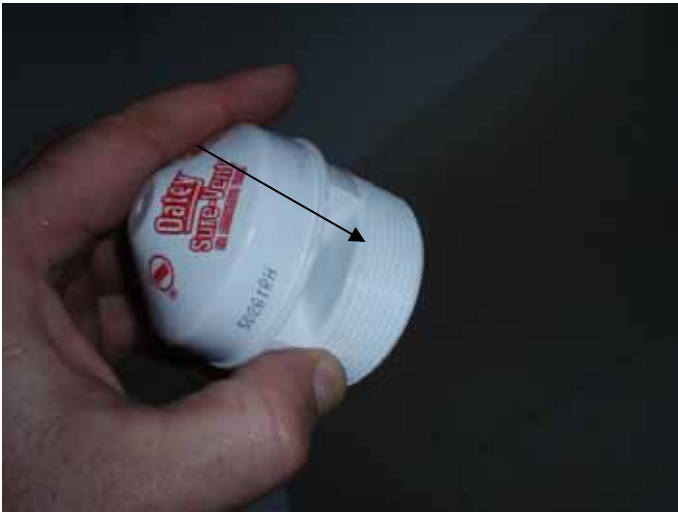
The manufacturer typically requires teflon tape to be installed on the threaded section of the waste line air admittance valve (Sure-Vent).

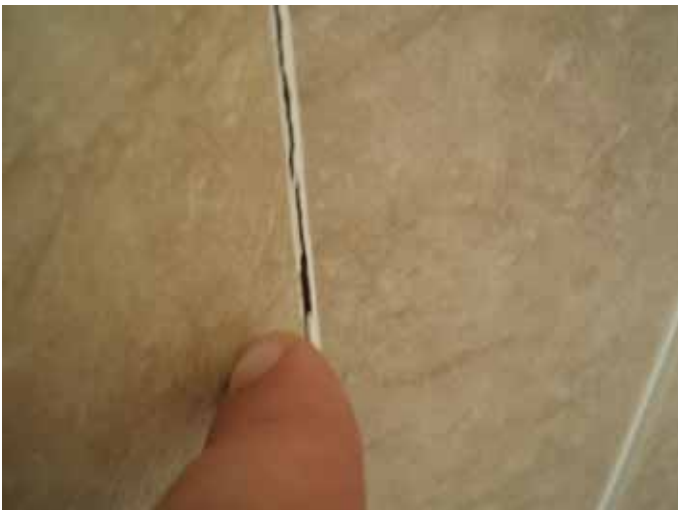
There were cracks & unsealed openings in the tile grout in the master bathroom.

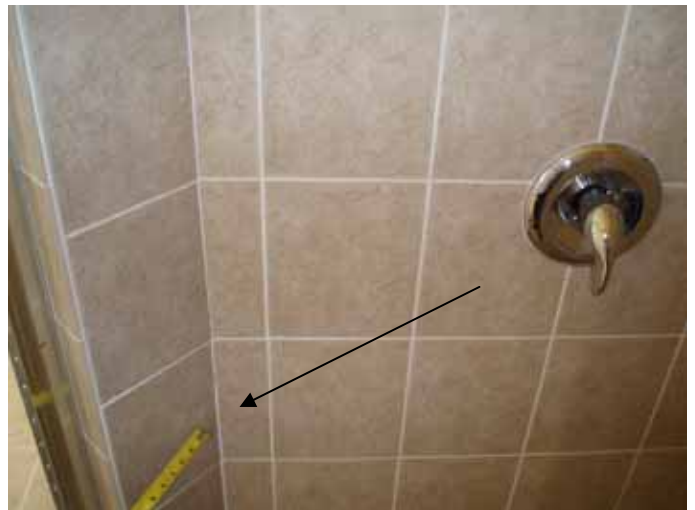
Location of the previous photo.

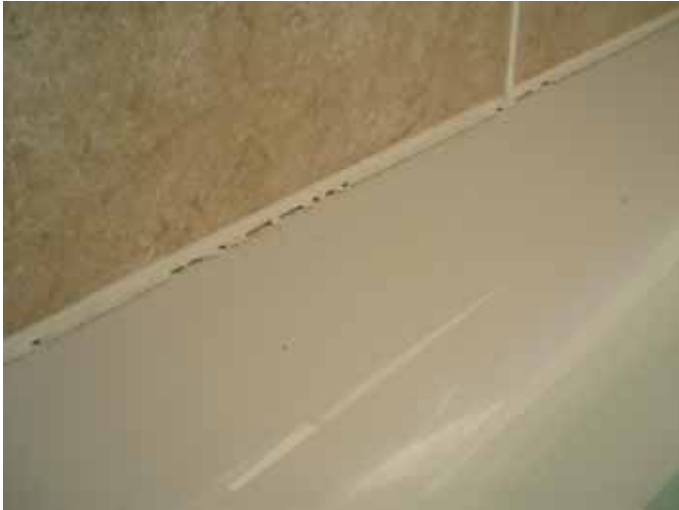
There were cracks & unsealed openings in the caulk around the tub in the master bathroom.

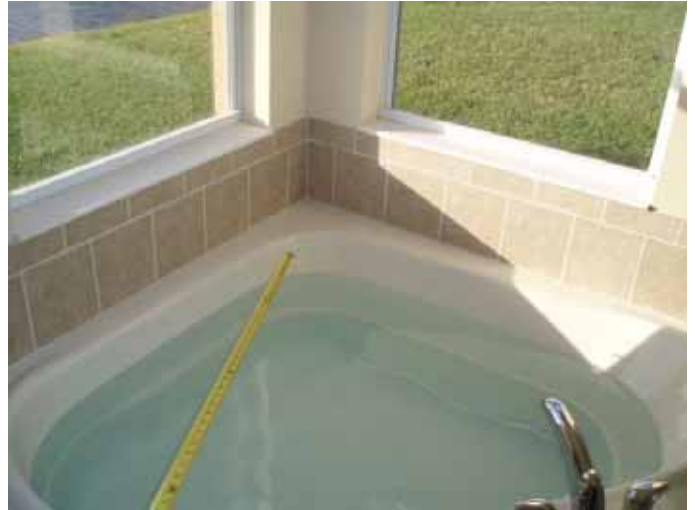
Location of the previous photo.

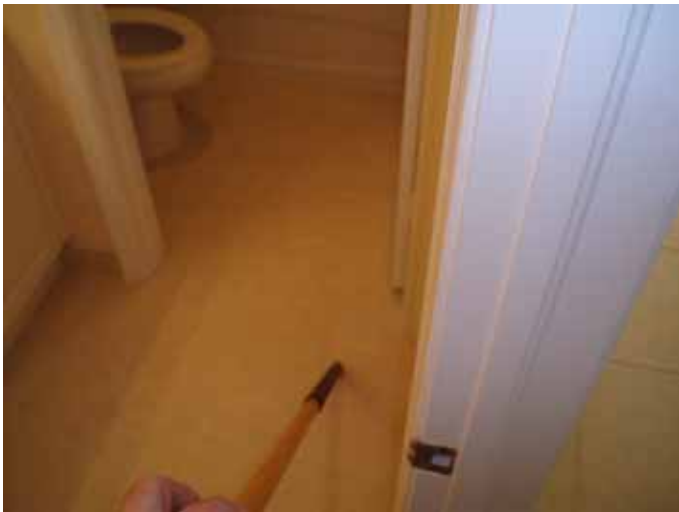
There were cracks in several of the floor tiles at the bedroom hallway & guest bathroom.

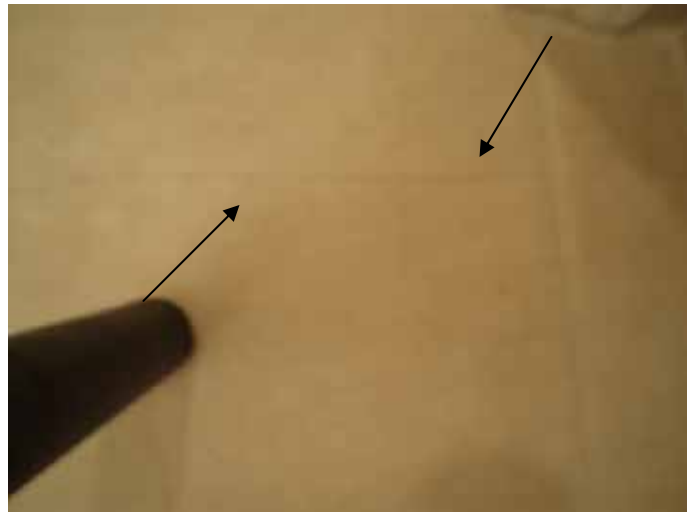
There were cracks in several of the floor tiles at the bedroom hallway & guest bathroom.

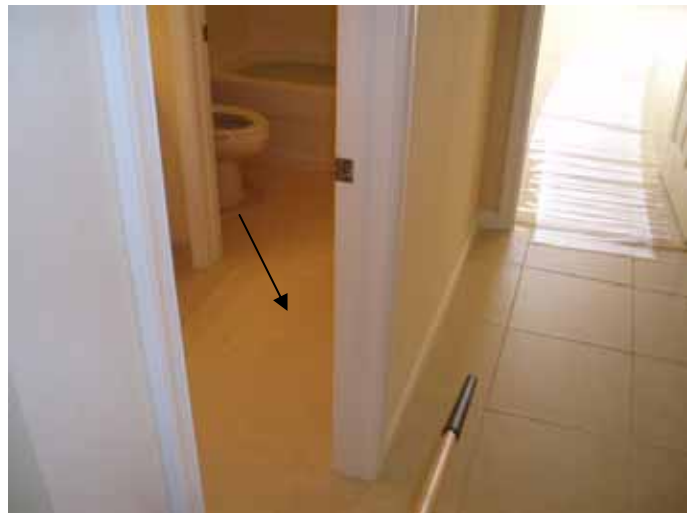
Location of the previous photos.

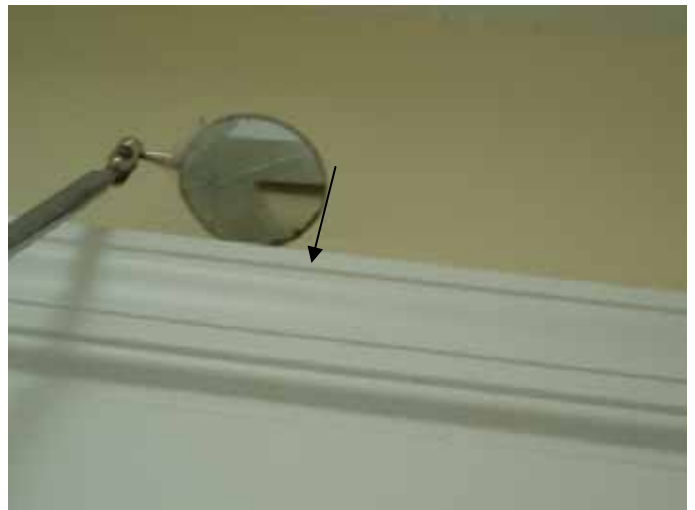
The top of the garage/laundry access door frame was not correctly sealed as required. §13-606.1.ABC.1.2.1

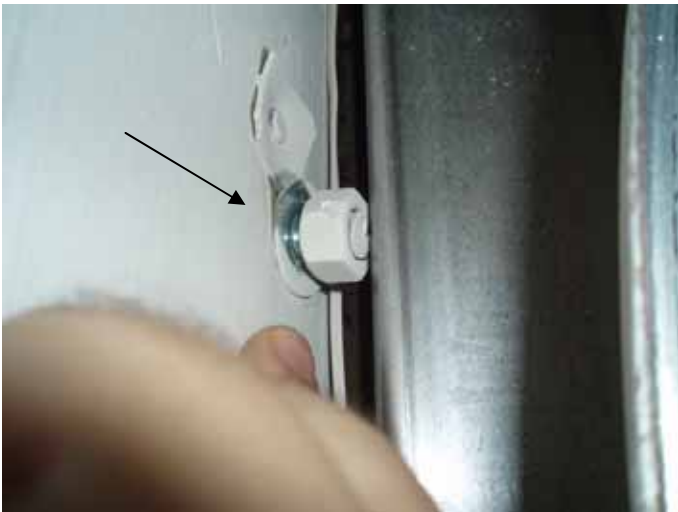
Some of the anchor nuts were loose at the garage door wood bucks.

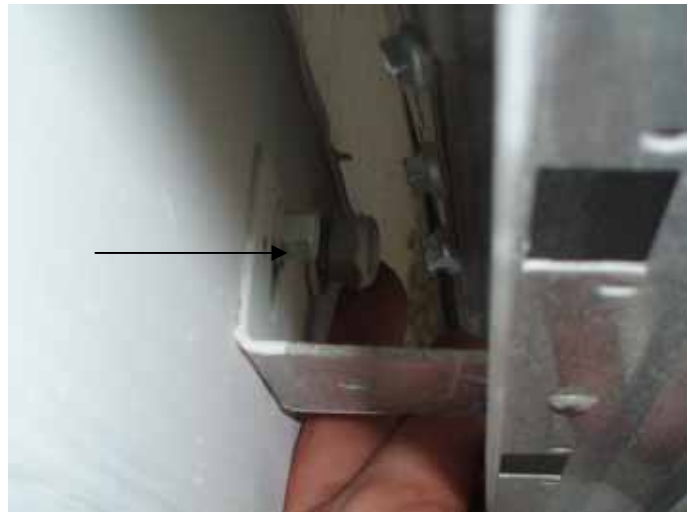
There should not be any loose anchor nuts at the garage door bucks.

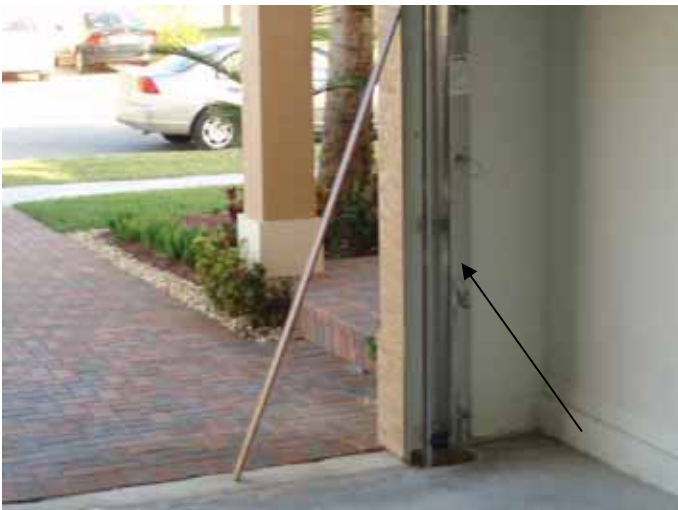
Location of the previous photos. All of the nuts & bolts for the 2"x6" garage door bucks should be correctly secured in place.

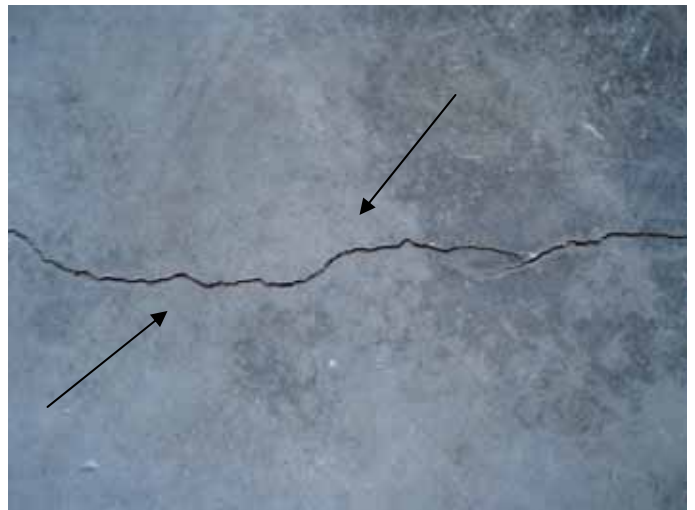
There were open cracks in the concrete in the garage floor.

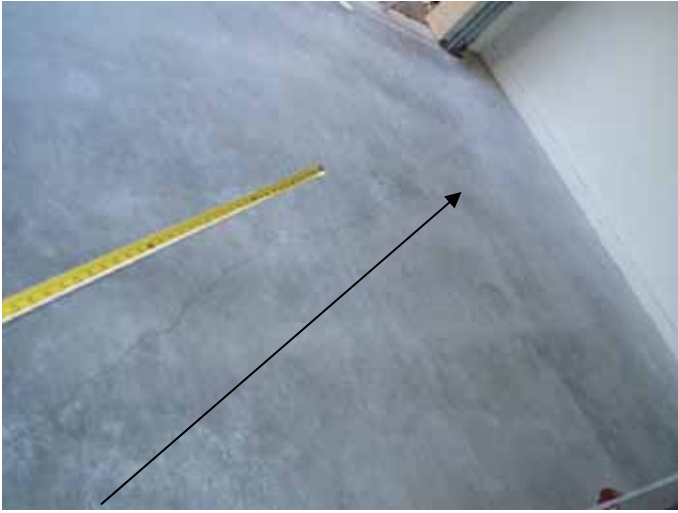
The cracks should be sealed & monitored for further shrinkage &/or settlement.

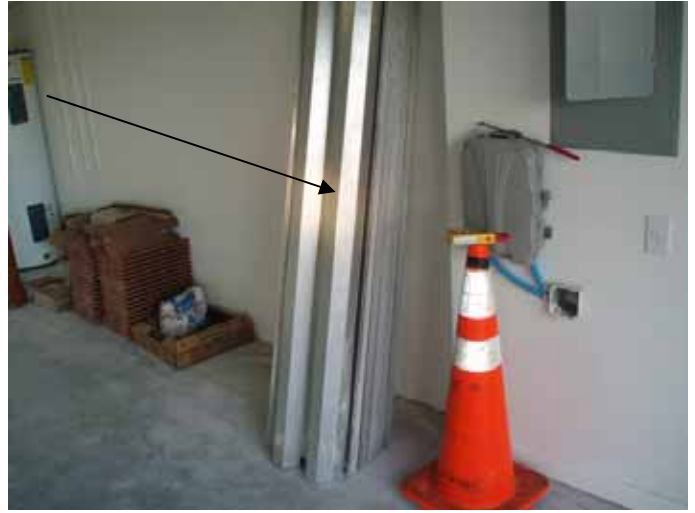
The storm shutter panels were not correctly secured in place. – Potential Hazard.

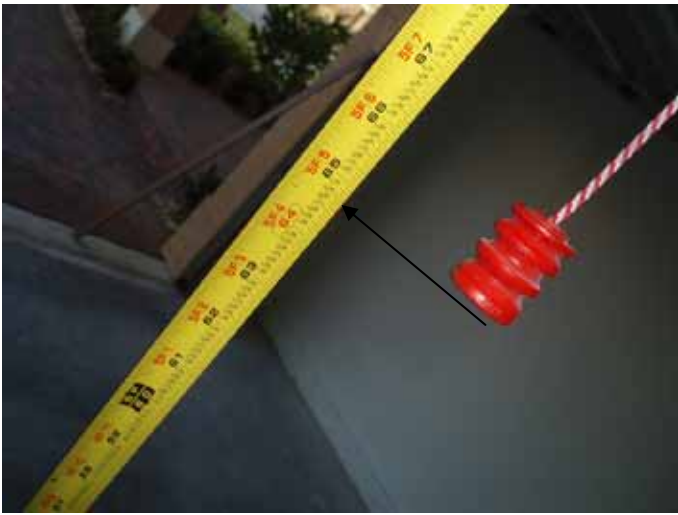
The red emergency release cord & handle were not set high enough above the garage floor. The handle should be set at 5 ft above the floor.

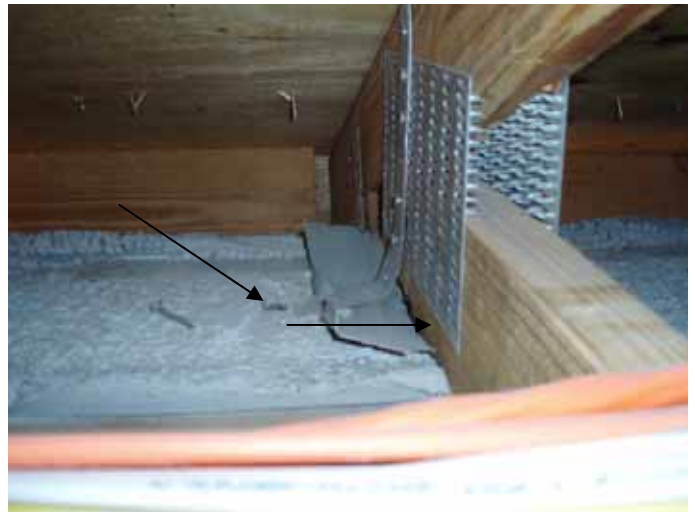
The truss anchor straps should be set into the concrete up to the embedment line placed on the strap by the manufacturer. FBC §2306.2, §1606.1.3

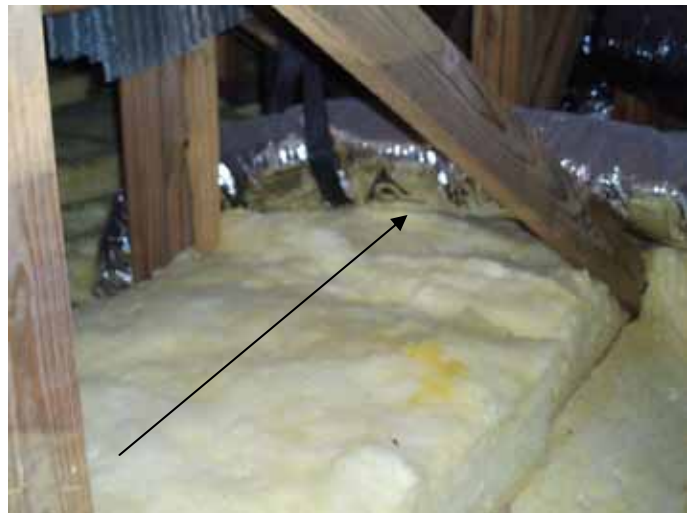
We recommend supporting the ductwork up off the attic insulation to help prevent problems associated with condensation.

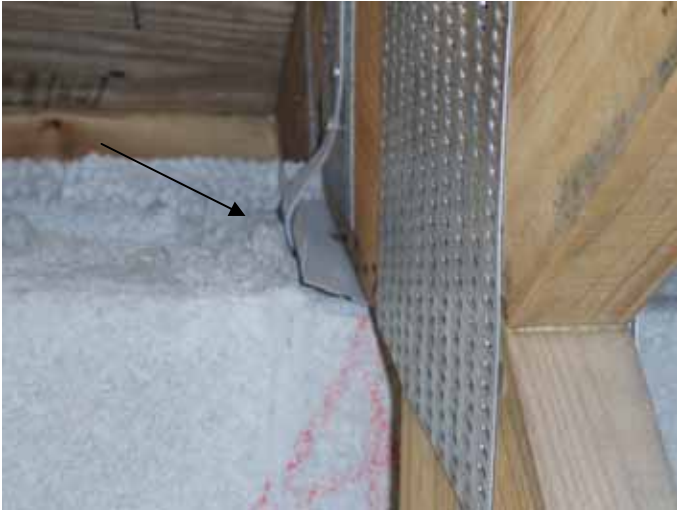
Many of the truss anchor straps were not correctly installed. The straps were offset 2" or more from the trusses.

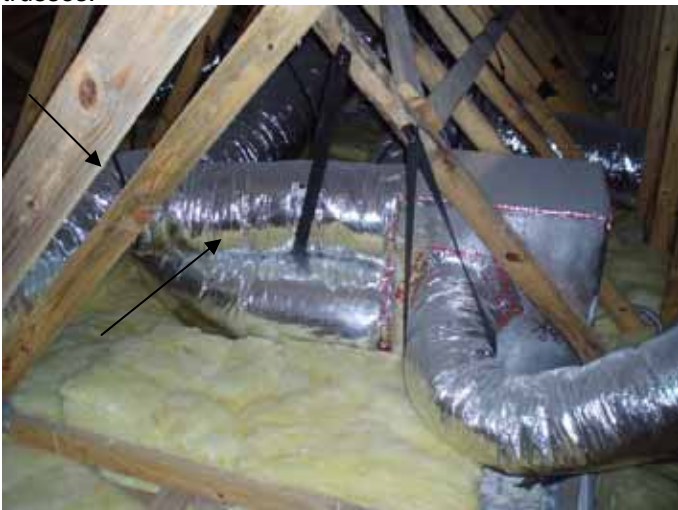
Some of the ducts were not correctly supported. Some of the support straps were twisted. We recommend the ducts be supported off other ducts & insulation.

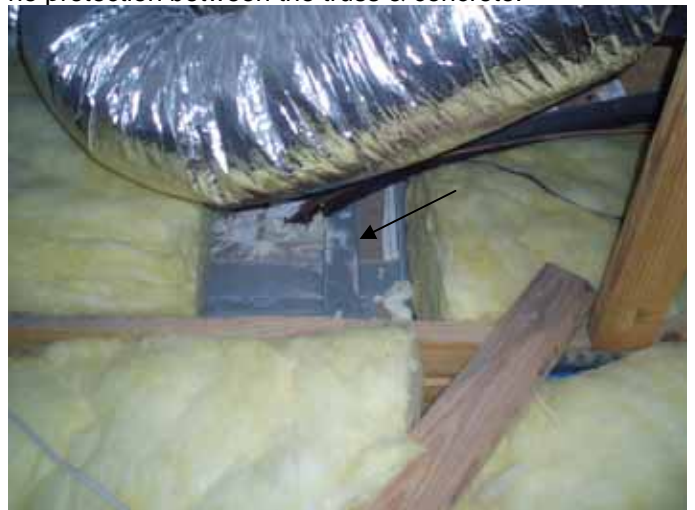
There were areas of the attic with displaced or missing insulation.

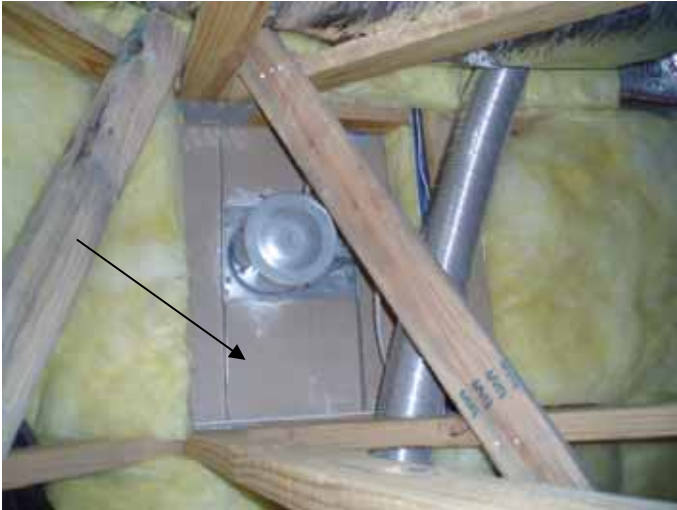
There were areas of the attic with displaced or missing insulation. All attic areas over conditioned space are required to be insulated.

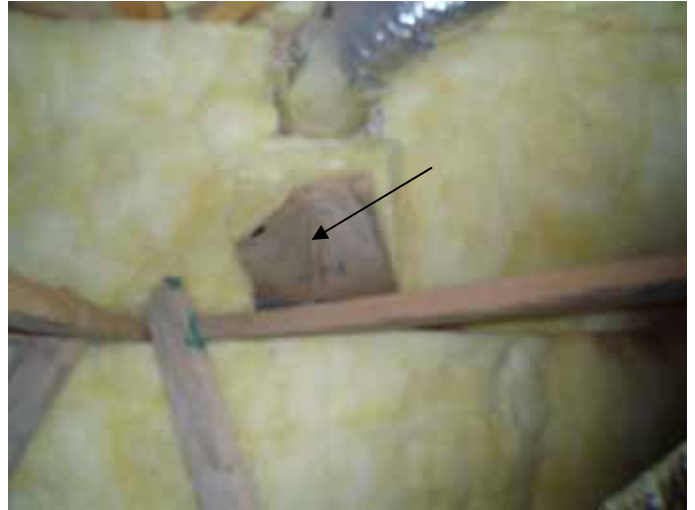
There was exposed kraft paper insulation backing in the attic. The manufacturer states the facing will burn & should not be exposed. §708.2

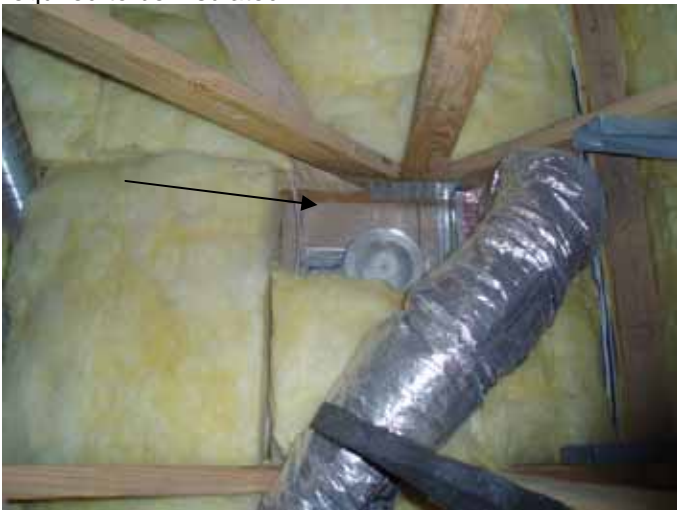
There were areas of the attic with displaced or missing insulation. All attic areas over conditioned space are required to be insulated. §13-604.1.A.1

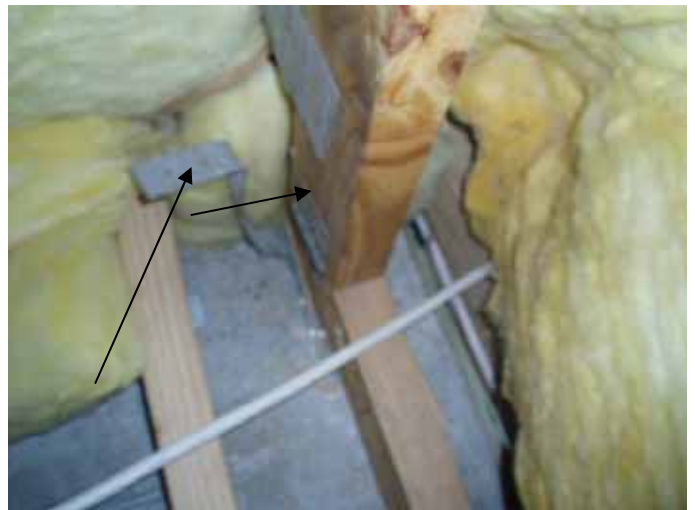
Many of the truss anchor straps were not correctly installed.

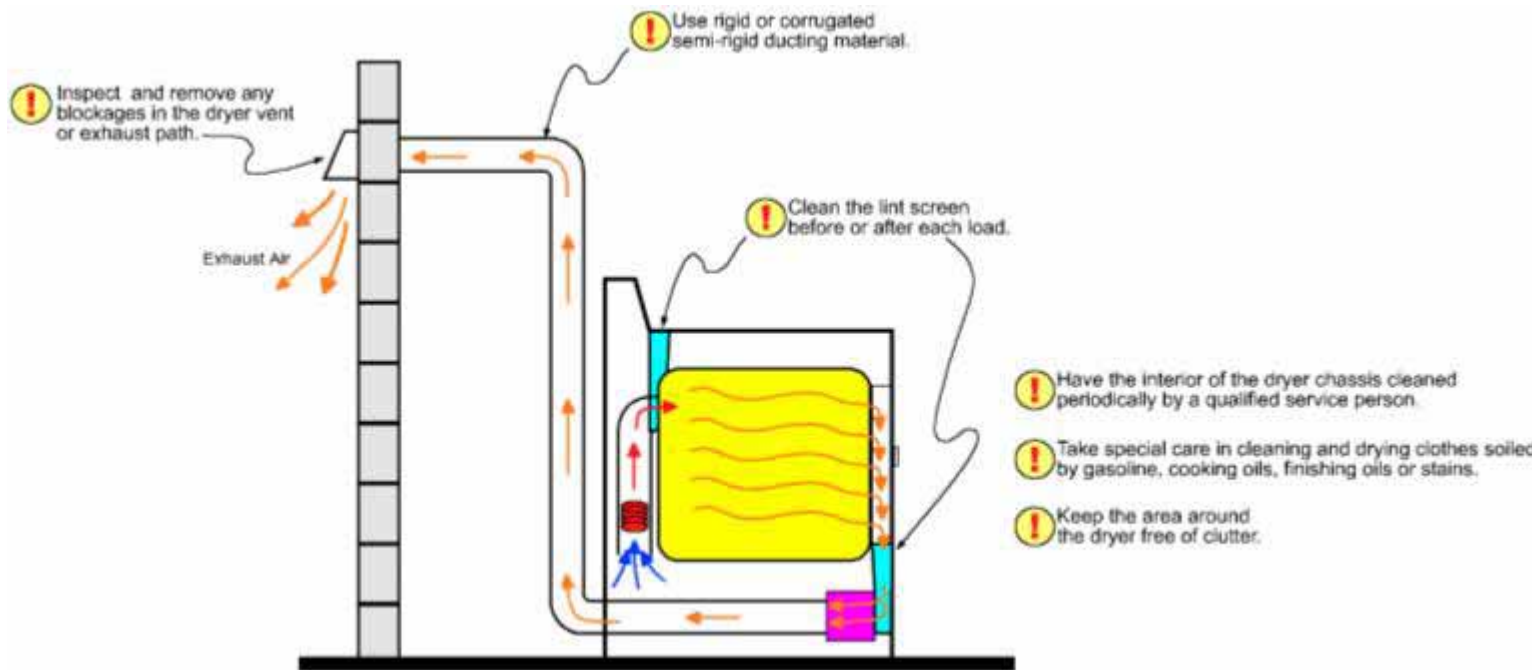
[Send the link for this page to a friend!](#) Consumers can obtain this publication and additional publication information from the [Publications section](#) of CPSC's web site or by sending your publication request to info@cpsc.gov.
