**Inspection Report of 1895 Jamesport Circle PSL, Fl 33953
Prepared for Yen Ho**

The State of Florida requires the builder to build in compliance with the Florida Building Code.

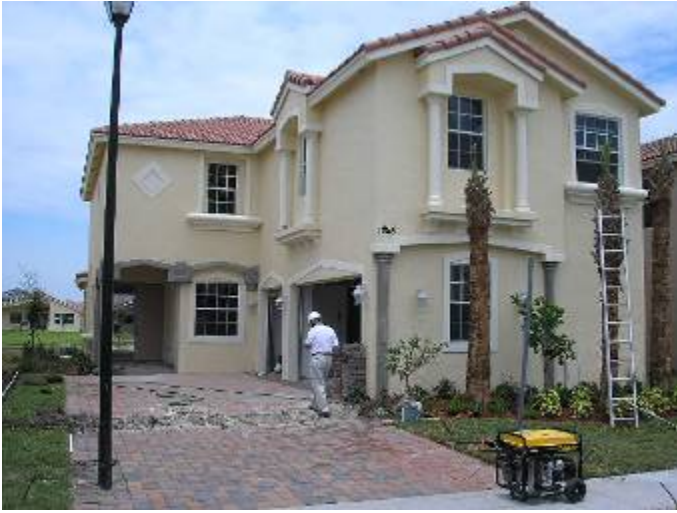
Site photo. The front of the house faces towards the east.

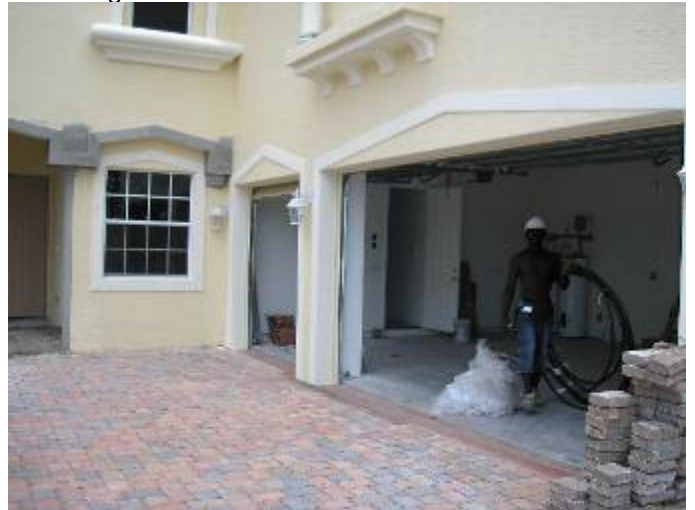
Location of the previous photos.

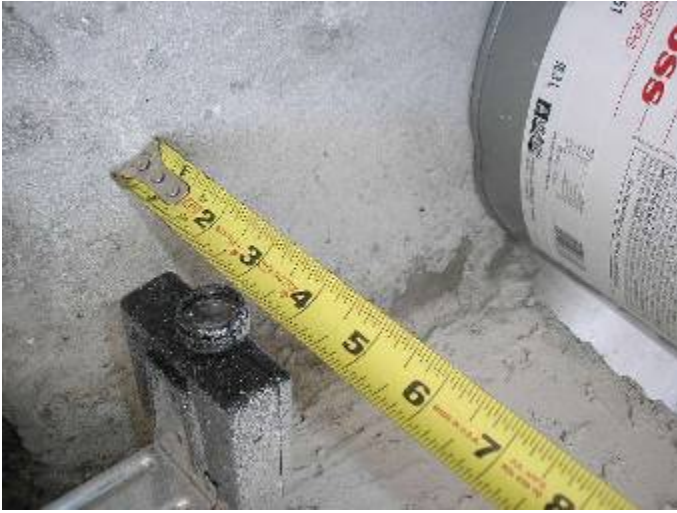
The garage vehicle photo eye sensors are located too close to the floor. The photo eyes should be 6" above the floor per manufacturer's installation instructions.

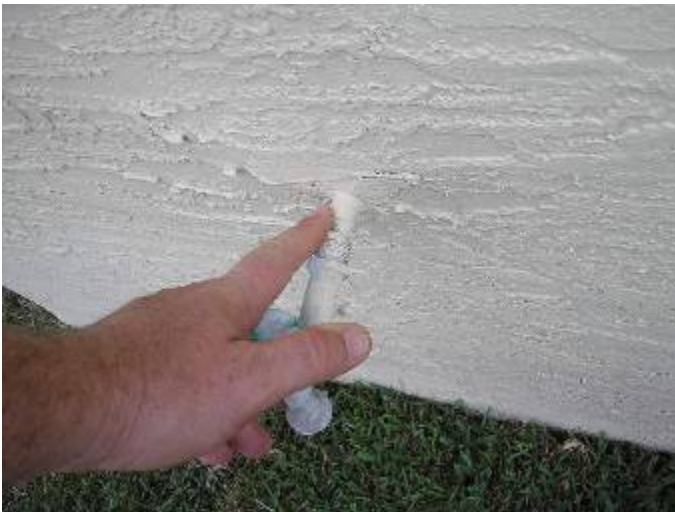
The hose bib supply piping was not correctly secured or sealed at the wall. Sheathing is required to protect the copper piping & was not visible. §P305.1

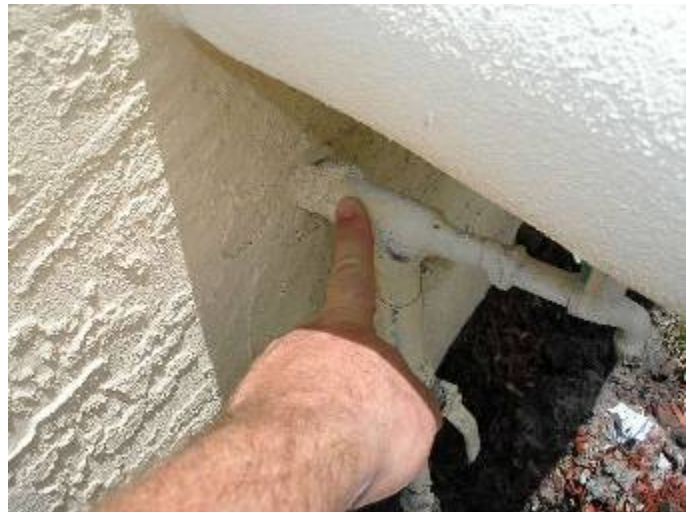
The main water supply piping was not correctly sealed at the wall. Sheathing is required to protect the copper piping & was not visible. §P305.1

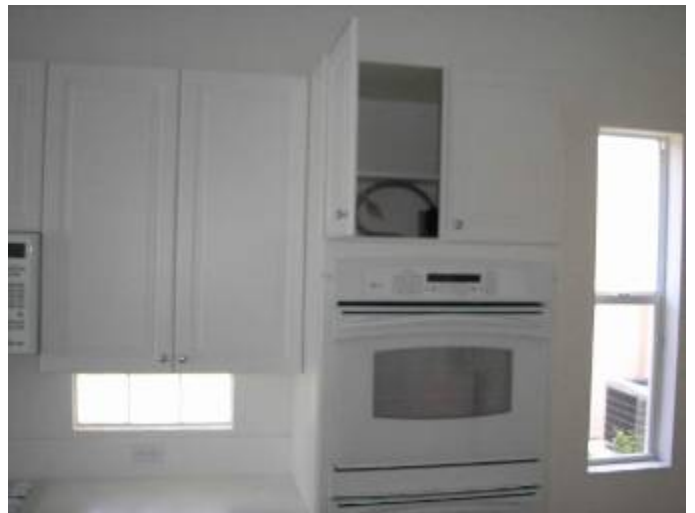
Location of the previous photos.

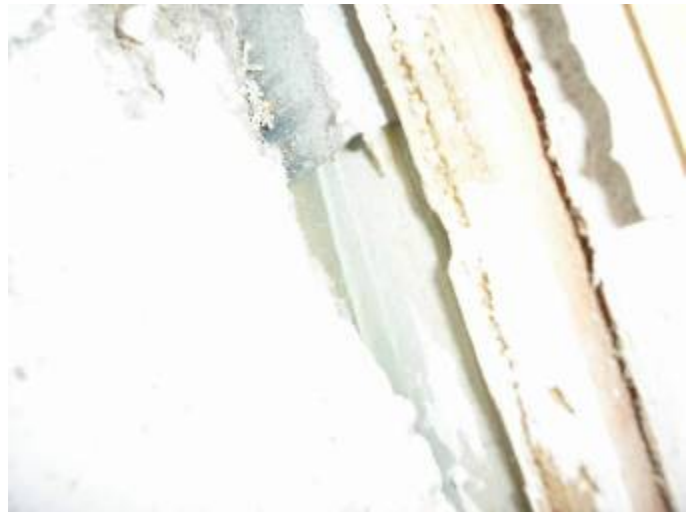
The trim is not correctly sealed at the bottom at locations around the wall in the garage. §13-606.1.ABC.1.2

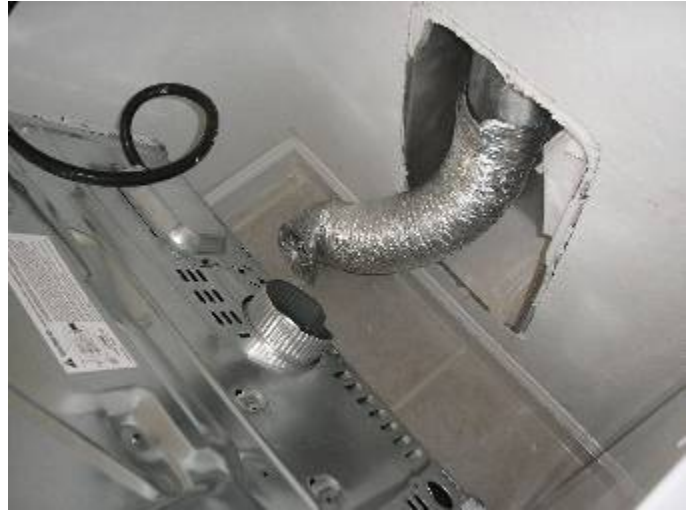
The foil dryer vent duct material is a fire hazard per UL & manufacturer. Replace with rigid or heavy flex duct material in accordance with manufacturer's instructions.

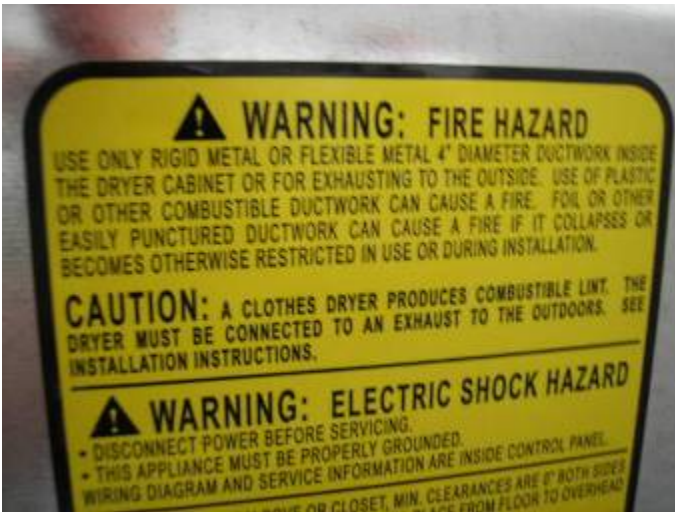
The thin aluminum foil dryer vent duct material is a fire hazard per UL & manufacturer. See warning label on back of the dryer. §M304.1

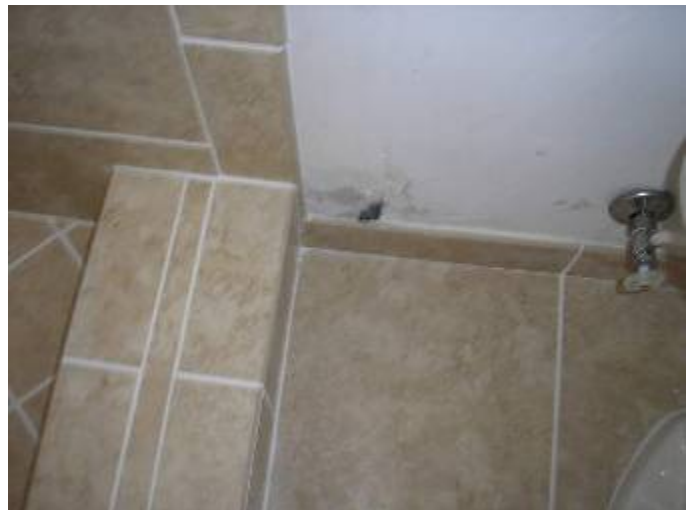
There is damage at the drywall at the guest bathroom wall.

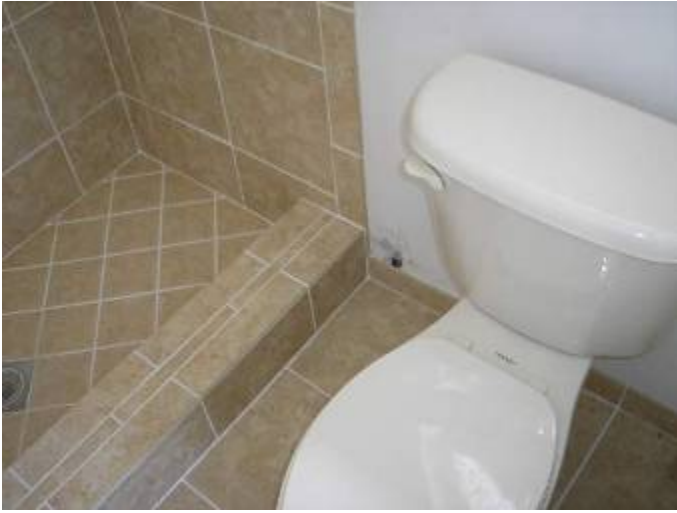
Location of the previous photo.

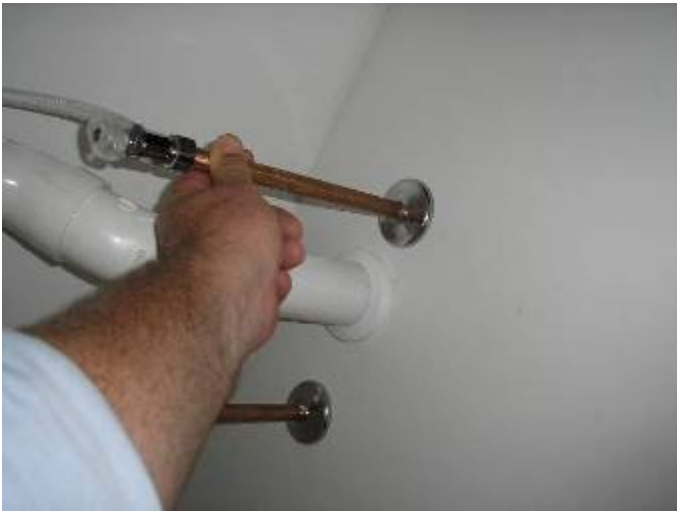
Some of the plumbing supply piping is loose & not correctly secured at the sink cabinets & behind the walls at the water closets (toilets).

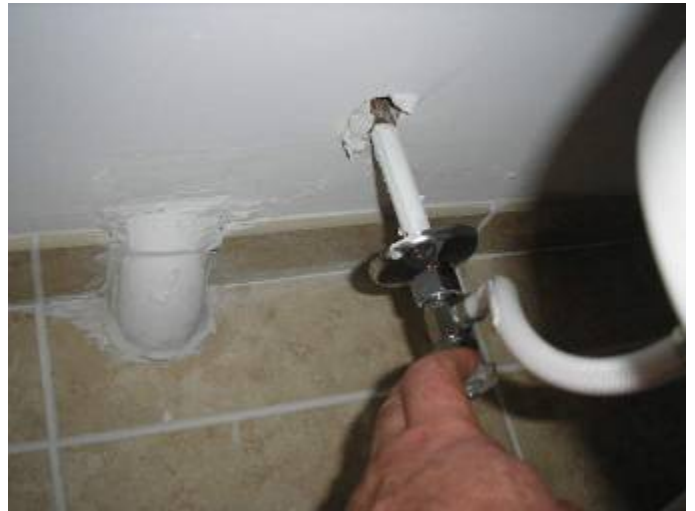
Why is the plumbing waste line coming through the wall & floor? Verify this installation with the architects drawings.

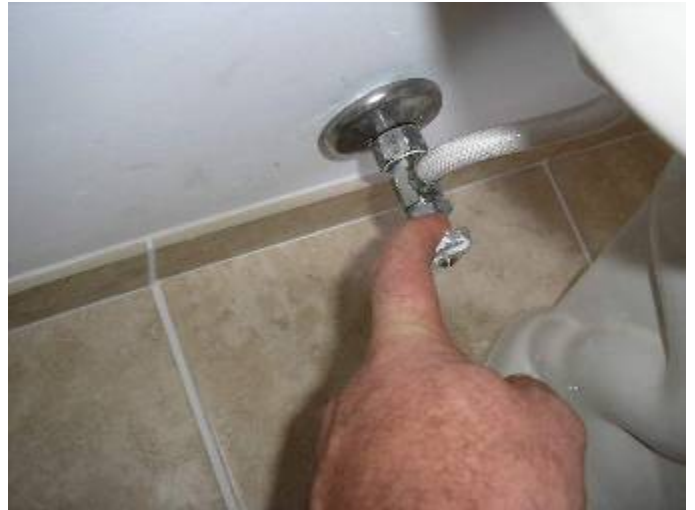
Some of the plumbing supply piping is loose & not correctly secured at the sink cabinets & behind the walls at the water closets (toilets).

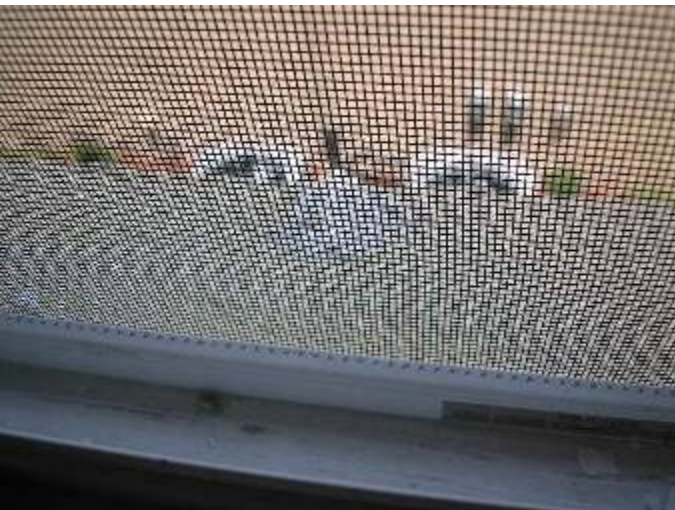
There is construction debris that needs to be removed on the exterior window sills.
