Inspection Report of 5305 SE Jennings Lane Stuart Fl 34997 Prepared for James & Teresa Dooner

The State of Florida requires the builder to build in compliance with the Florida Building Code.

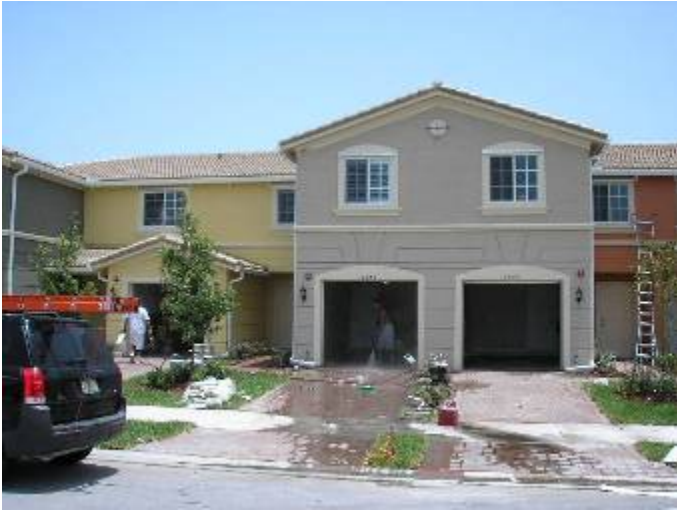
Site photo. The front of the house faces towards the west.

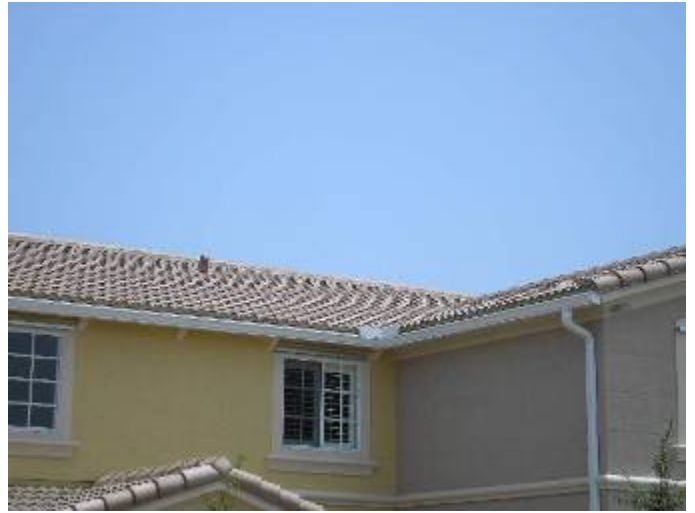
We were not permitted to go on or view the roof from a ladder. We recommend a complete review of the roof after closing.

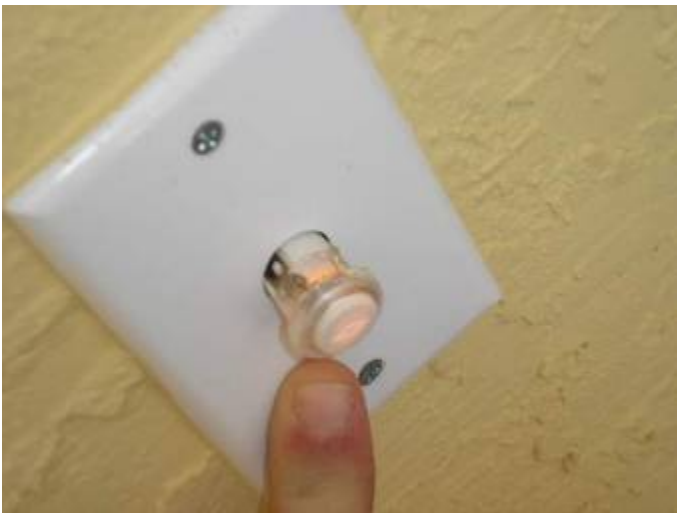
The door bell switch was loose at the wall.

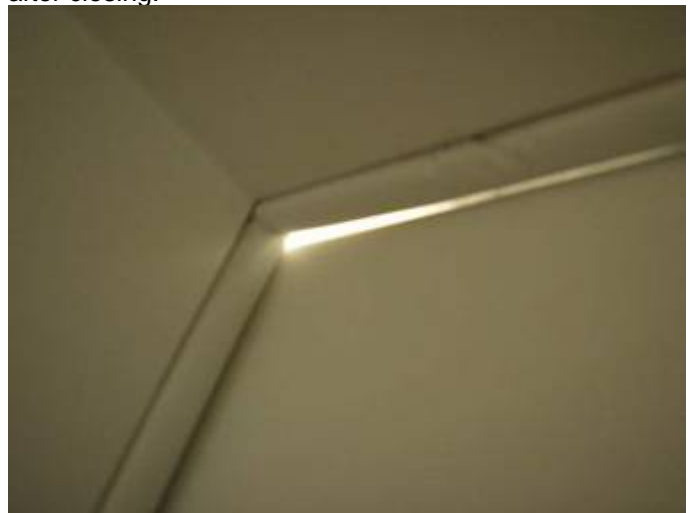
There are gaps with daylight & AC loss at the front door & frame. FBC §13-606.1.ABC.1.2

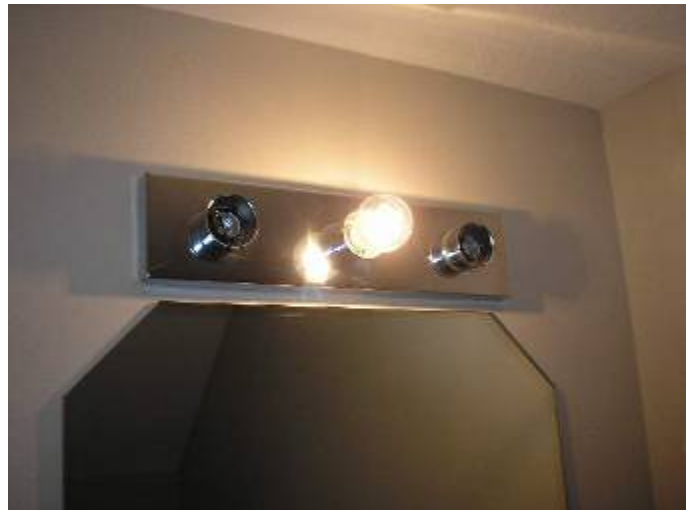
Some of the bulbs are not installed or burnt out.

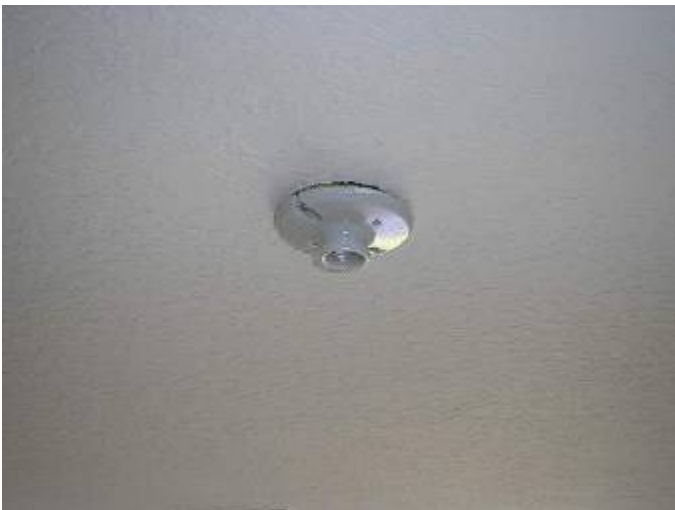
The drywall is not completely sealed around some of the fixture receptacle & fixture outlets.

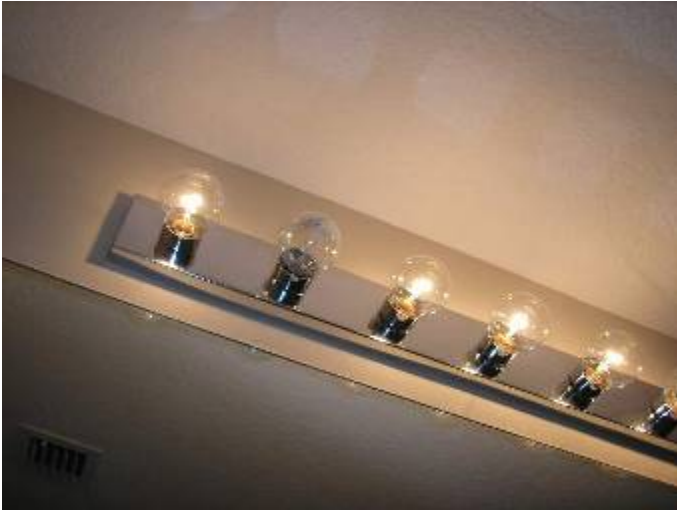
Some of the bulbs are not installed or burnt out.

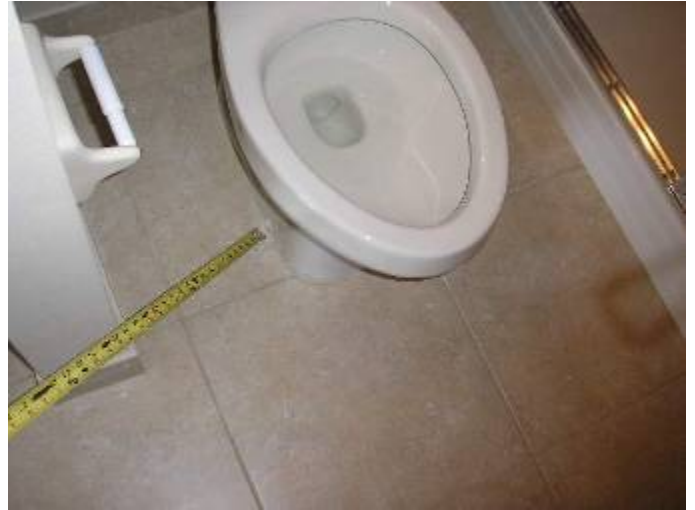
The toilet is loose & not correctly secured or sealed at the 2nd floor guest bathroom floor.

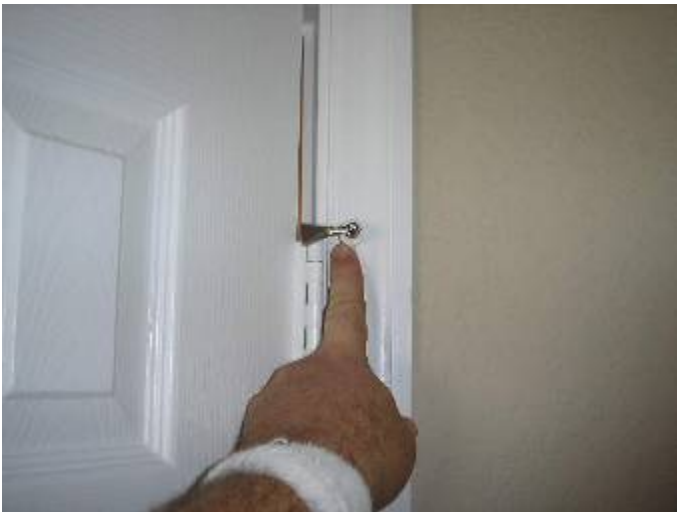
Some of the door stops are not working or installed correctly.

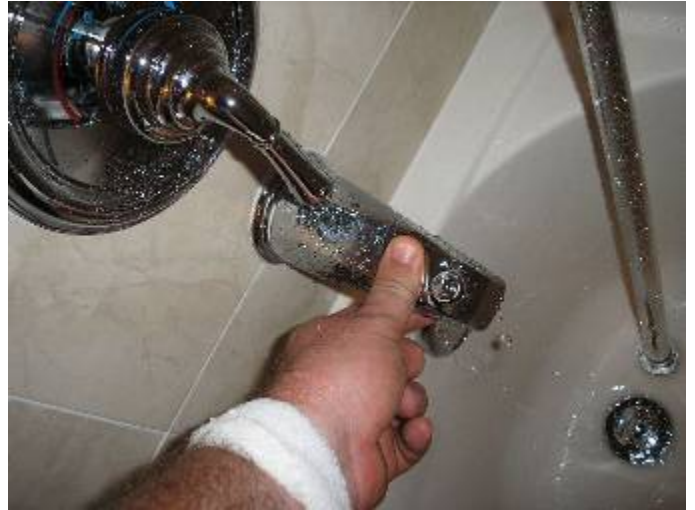
The tub spout is loose or not correctly secured at the wall.

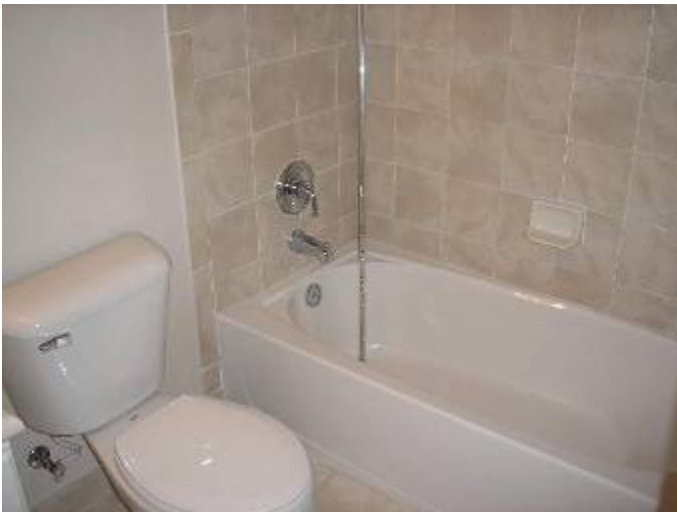
Location of the previous photo/s.

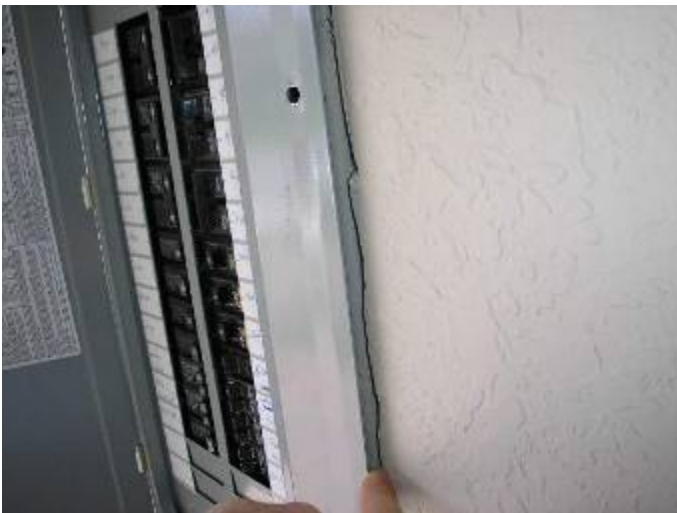
Several screws were missing from the electric panel cover in the garage.

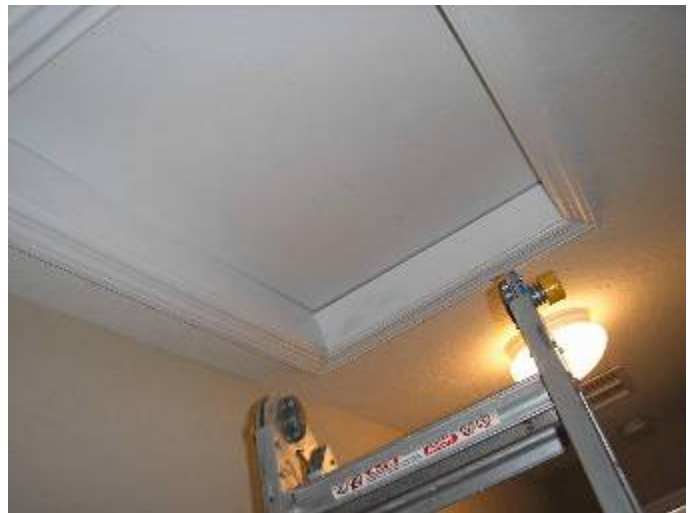
Attic inspection begins.

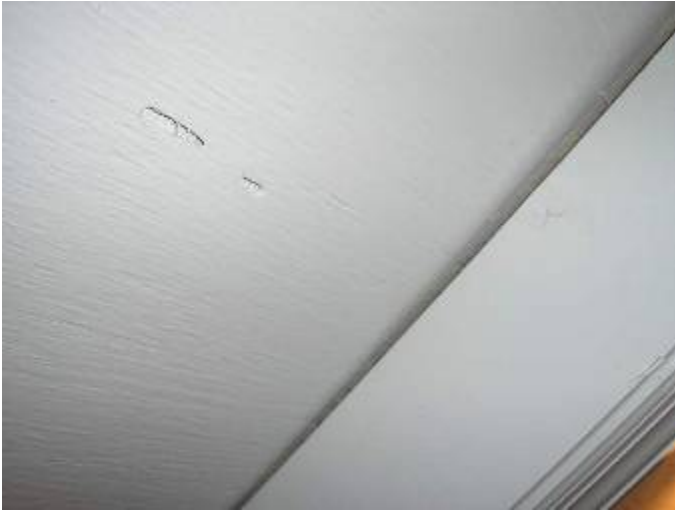
There was damage at the attic access cover.

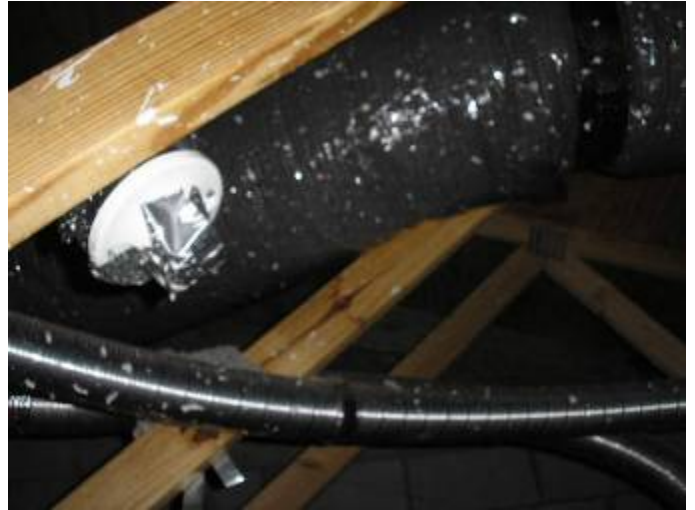
There was duct tape over the light fixture in the attic.

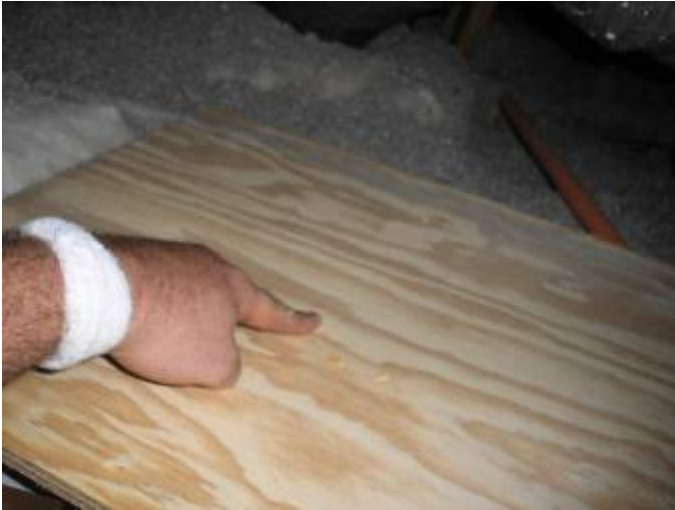
There is no insulation at the back of the attic hatch cover.

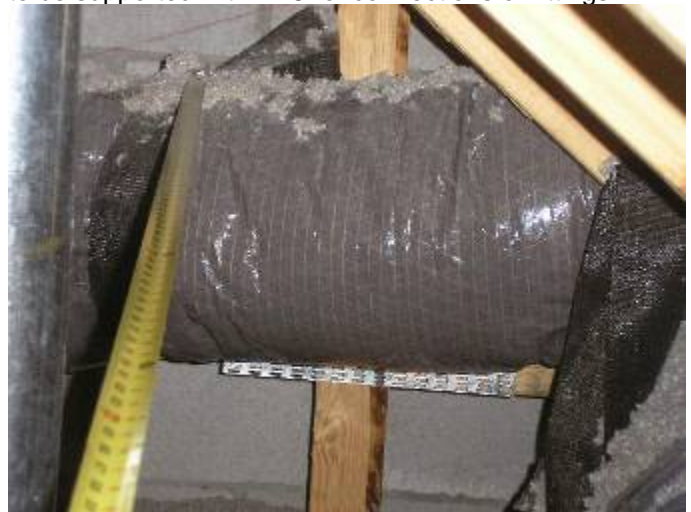
Some of the AC ductwork is not correctly installed or supported in the attic. The ducts are sagging & also need to be supported within 18" of connections or fittings.

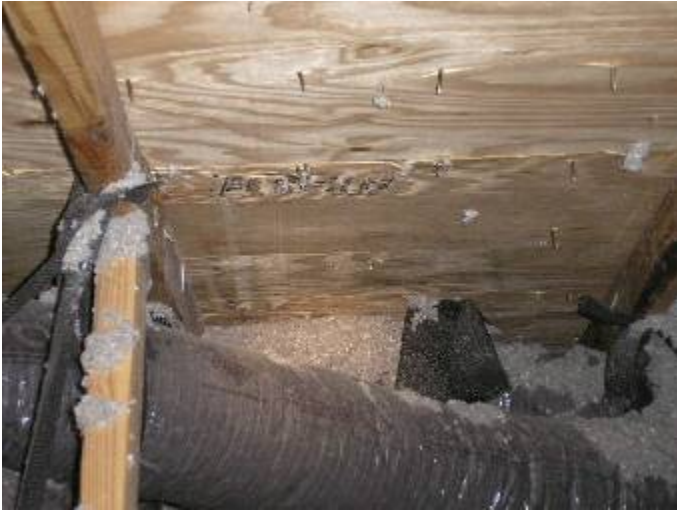
The AC duct appears to be wedged against the roof sheathing and tile nails. We were not permitted to leave the ladder to verify this & other conditions.

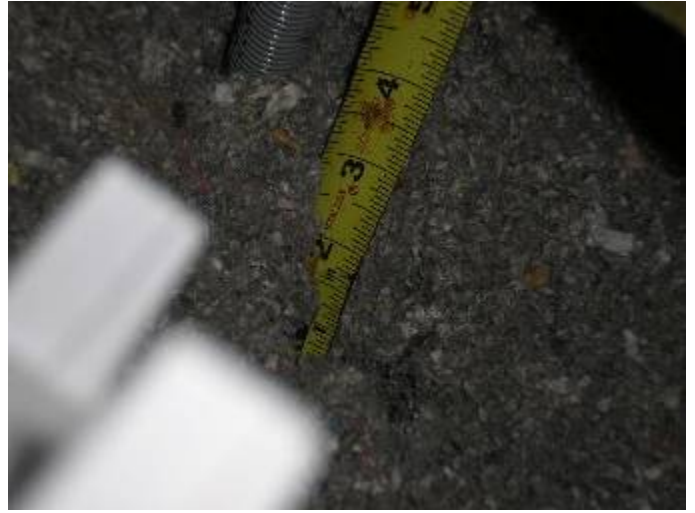
There were some locations where the attic insulation was not the correct depth.

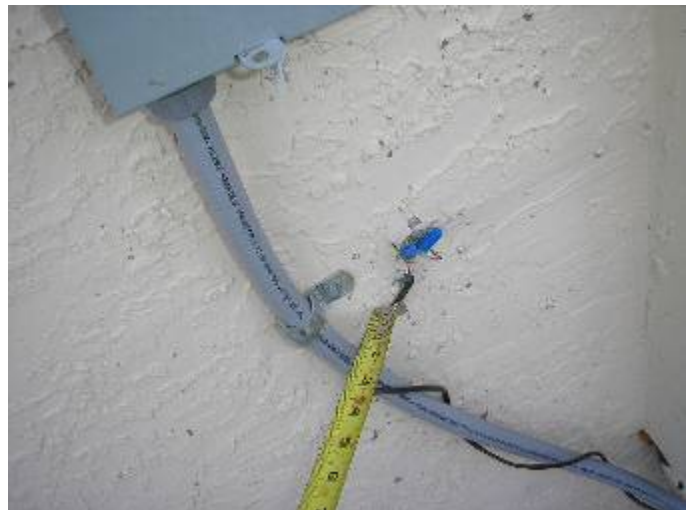
The low voltage wiring & connection are not correctly protected from damage.

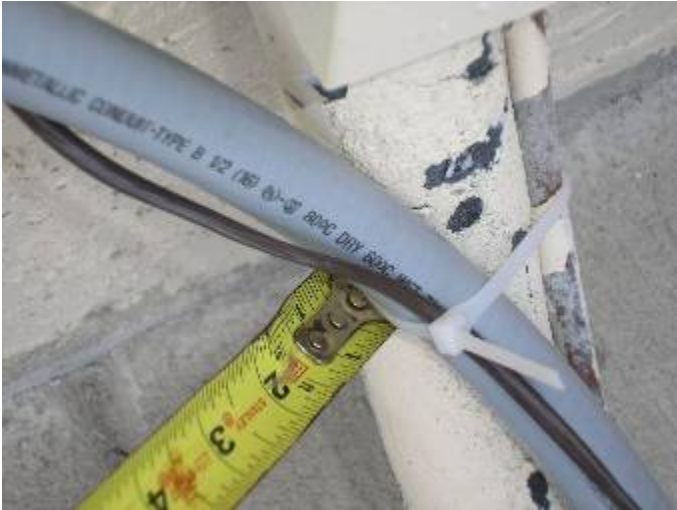
The clear or white plastic tie straps are not designed for use at exterior locations. The straps will be damaged by the U.V. sunlight.

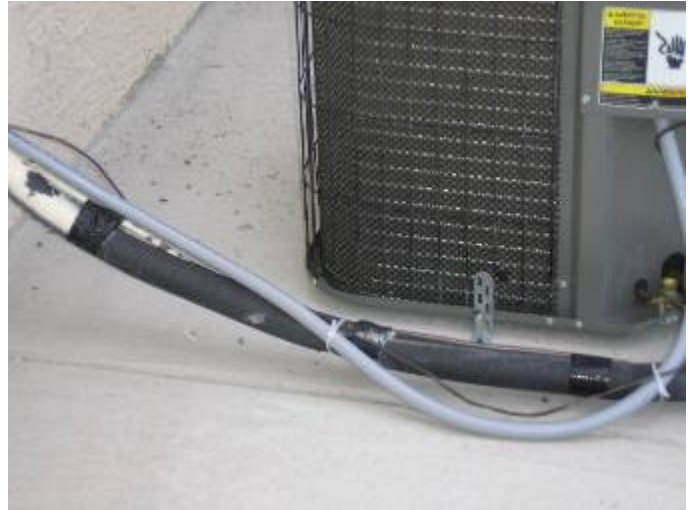
The clear or white plastic tie straps are not designed for use at exterior locations. The straps will be damaged by the U.V. sunlight.

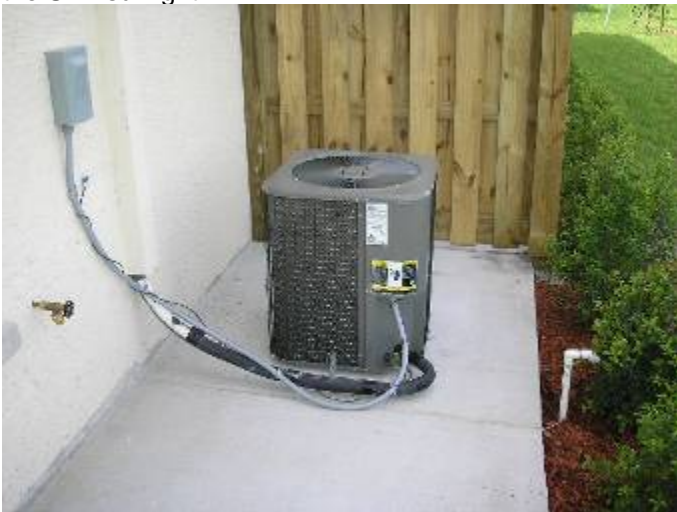
Location of the previous photo/s.

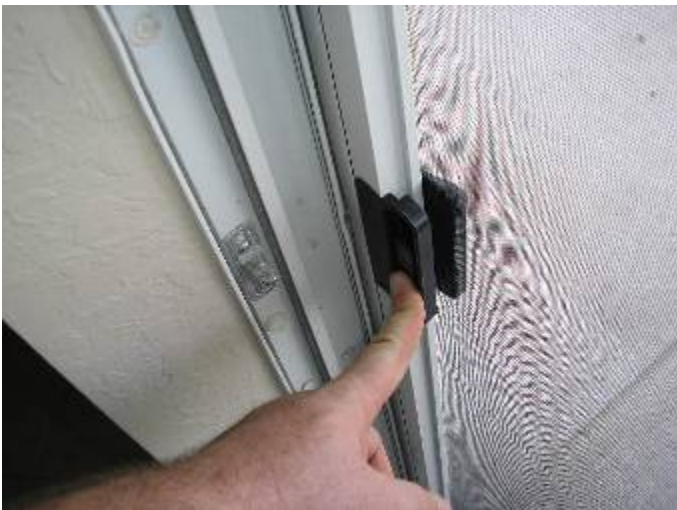
The sliding screen door sticks at the lock/latch.

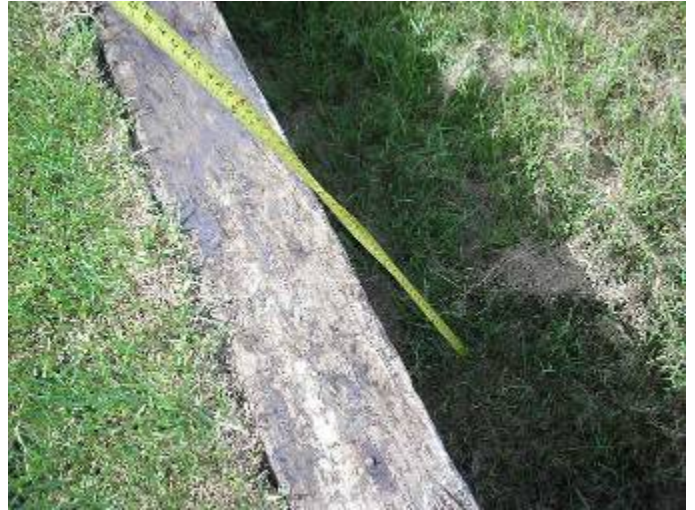
The railroad tie wall is almost 3 feet high, has no railing & presents a tripping/safety hazard at the back of the building. FBC §1617.4.4

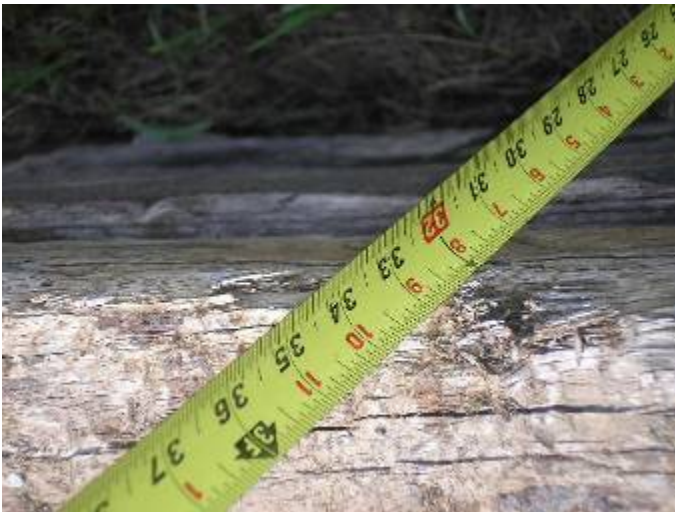
The railroad tie wall is almost 3 feet high, has no railing & presents a tripping/safety hazard at the back of the building. FBC §1617.4.4

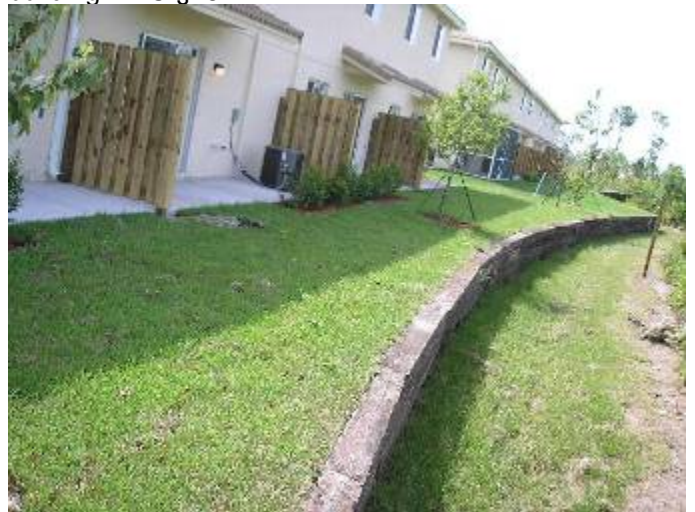
The railroad tie wall is almost 3 feet high, has no railing & presents a tripping/safety hazard at the back of the building. FBC §1617.4.4

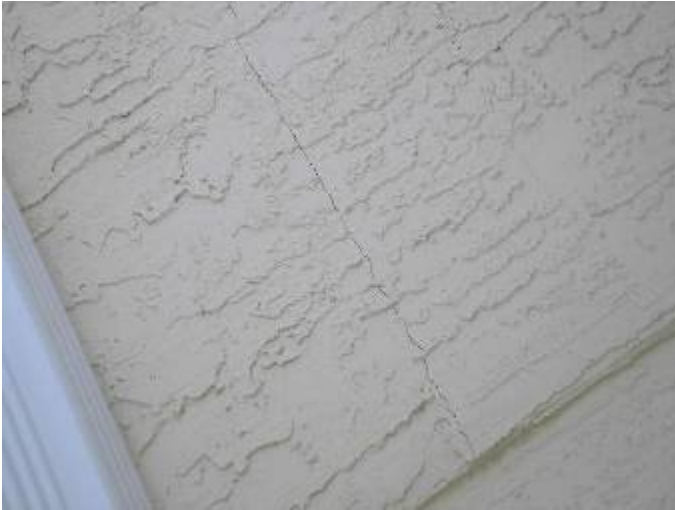
There are cracks in the stucco at the wood framed upper level exterior wall that can allow water penetration through the wall. §13-C4.1.4

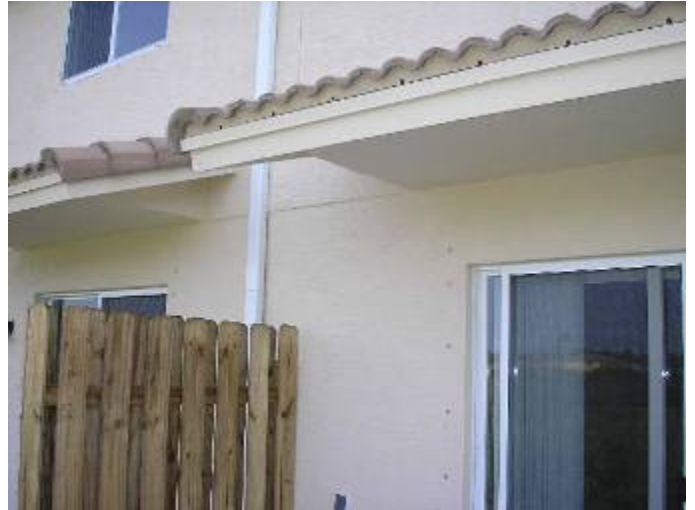
Location of the previous photo/s

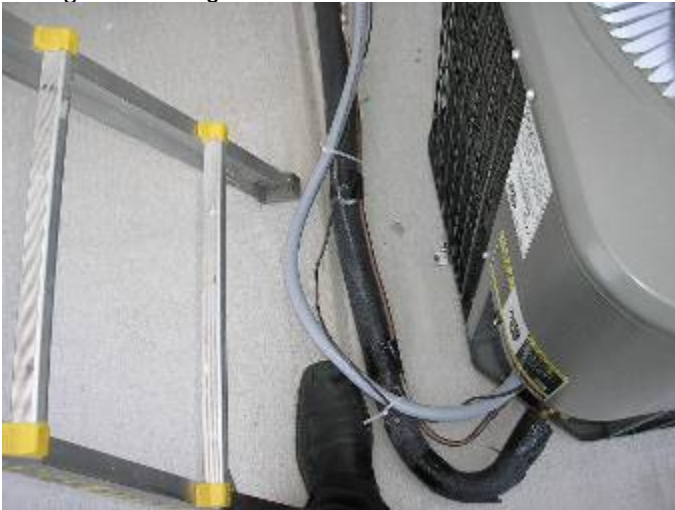
Broken roof tiles cannot be “glued” back together

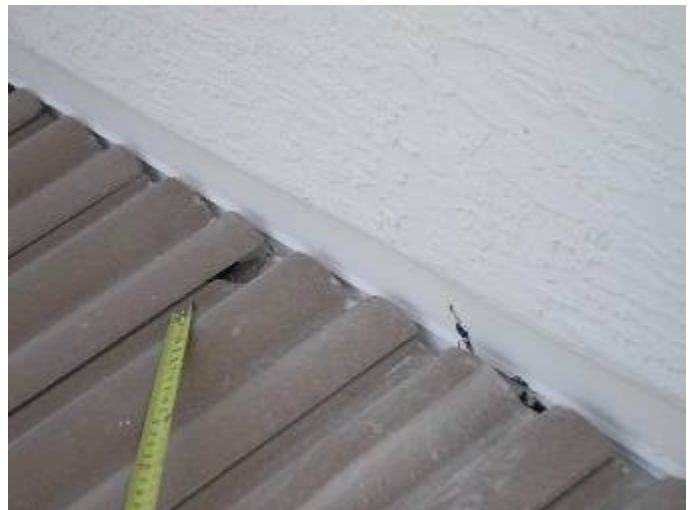
There should not be any broken tiles on the new roof. The tiles need to be removed & replaced; not “glued” back together.

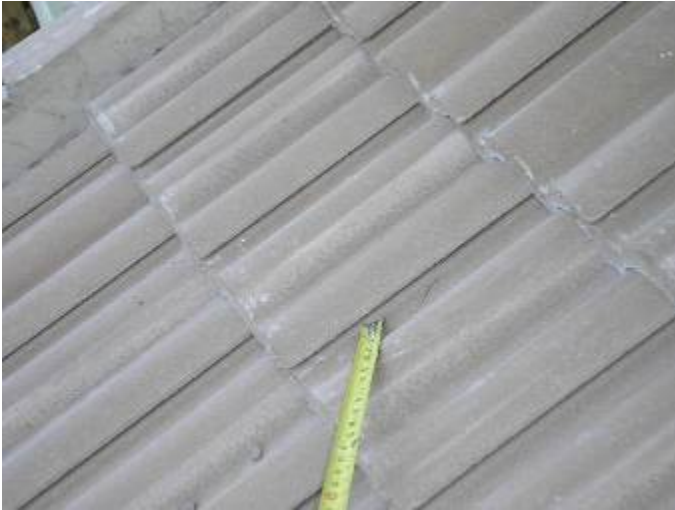
There were several broken tiles on the roof over the rear patio. There should not be any broken tiles on the new roof. The tiles need to be removed & replaced.

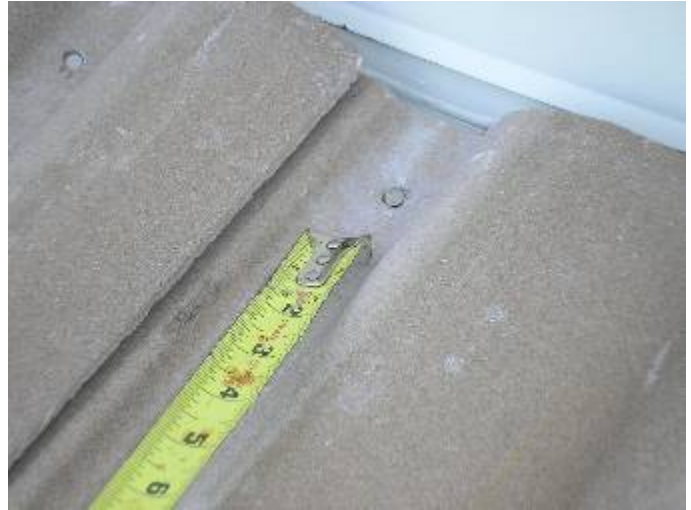
There are exposed nails at the wall abutment tiles. The nails should be covered to prevent expansion & contraction from the heat of the sun.

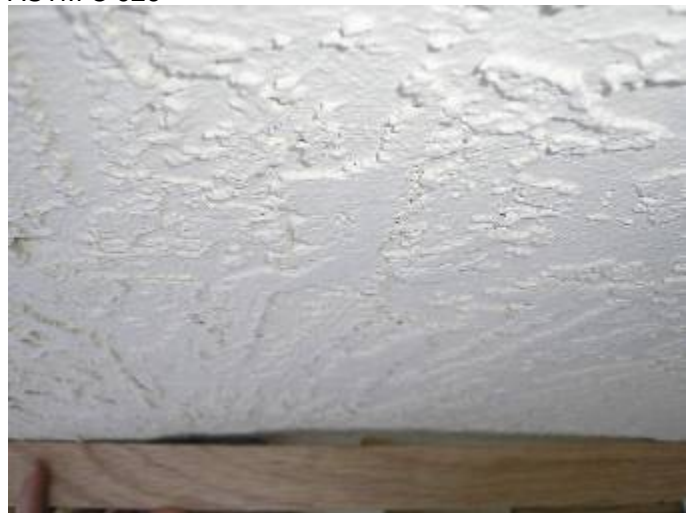
We recommend core sampling to verify the thickness of the exterior stucco & compliance with ASTM C 926.

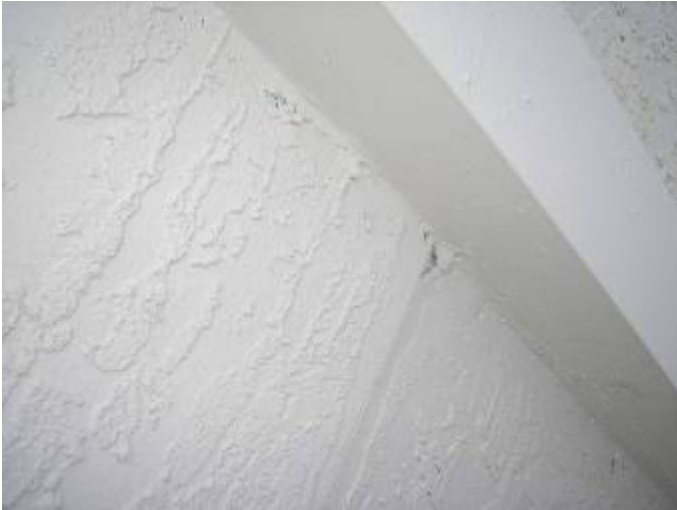
Some of the stucco work appears to be uneven, curved in/concave & not the proper depth. ASTM C 926, §2504.2 §1403.1.3

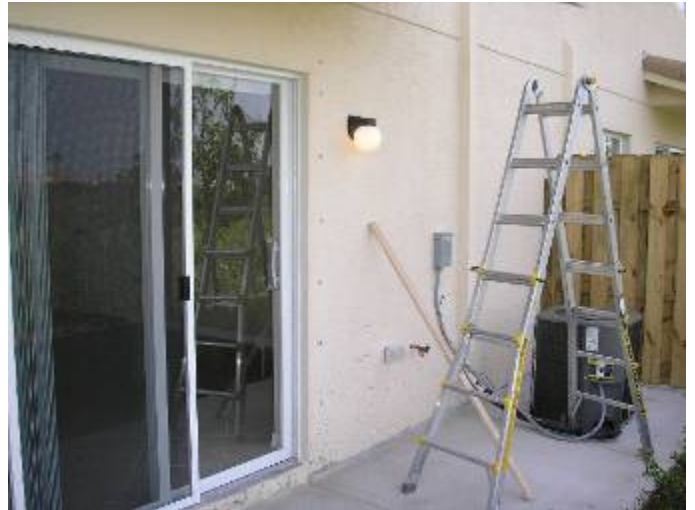
We recommend core sampling to verify the thickness of the exterior stucco & compliance with ASTM C 926.

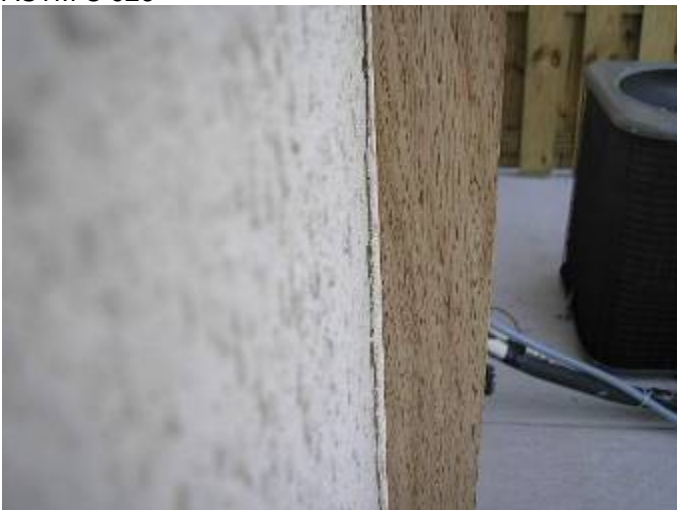
We recommend core sampling to verify the thickness of the exterior stucco & compliance with ASTM C 926.

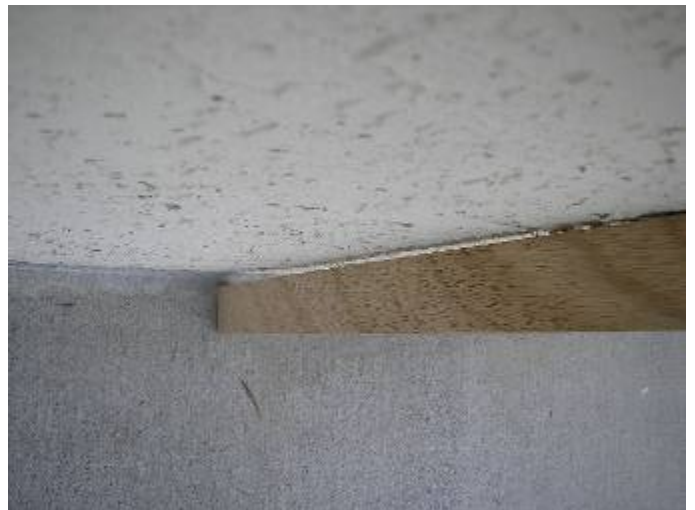
The stucco at some at the walls is concave or curved in & does not appear to be the correct thickness. §2509.1.1, ASTM C 926

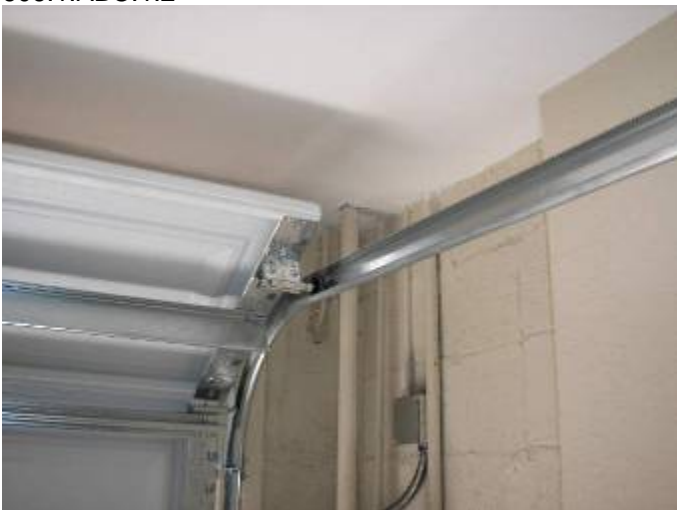
The drywall is not correctly sealed around the sprinkler system piping at the garage ceiling.

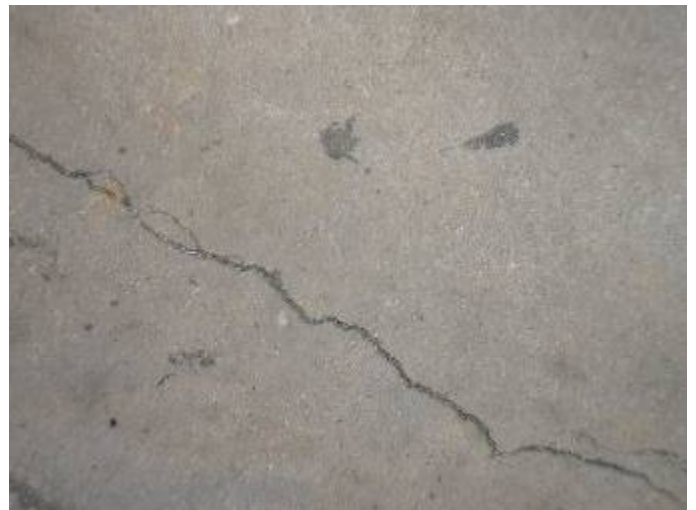
There is a crack in the concrete at the garage floor. The crack should be sealed & monitored for signs of further settlement.

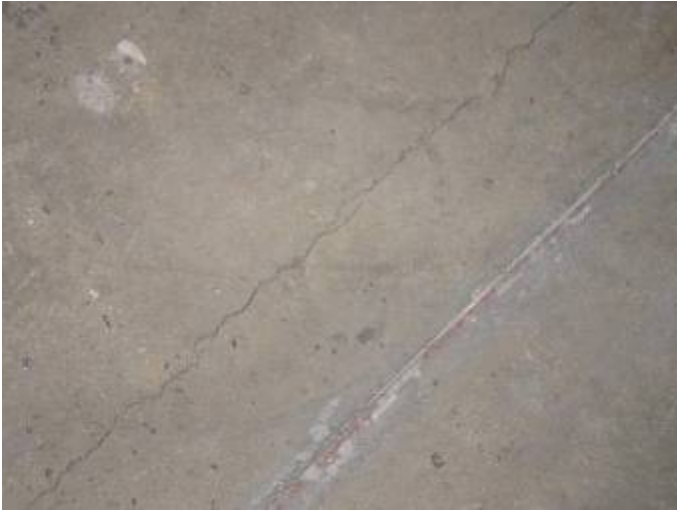
There is a crack in the concrete at the garage floor. The crack should be sealed & monitored for signs of further settlement.

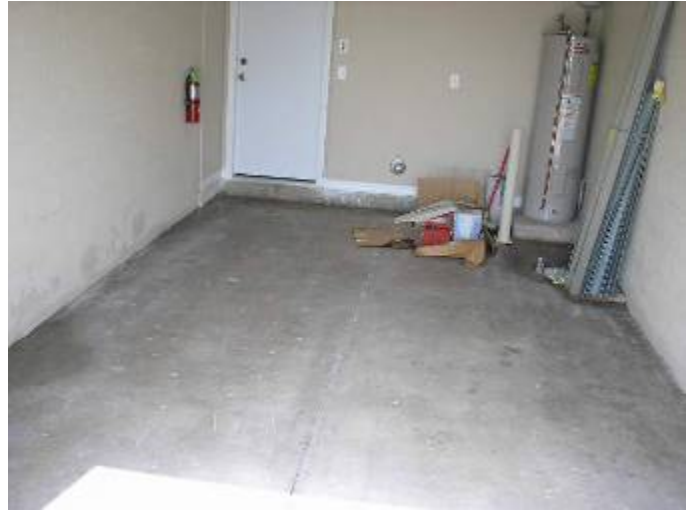
Location of the previous photo/s.
