## Inspection Report of 945 Fleming Way Stuart Florida 34997 Prepared for Dr Warren

**The State of Florida requires the builder to build in compliance with the Florida Building Code.**

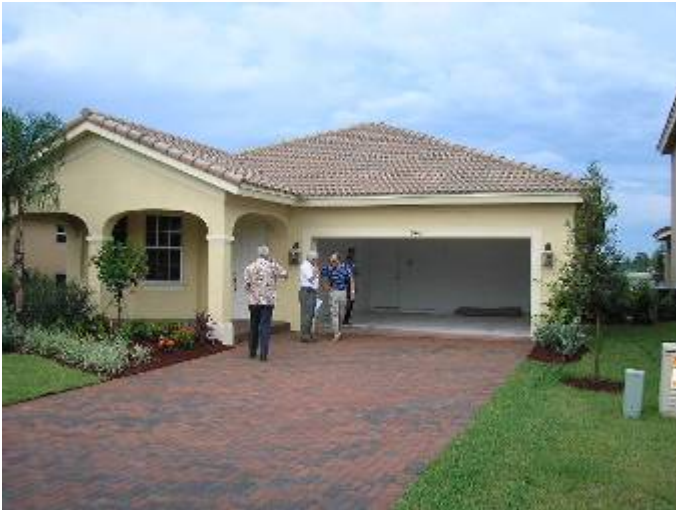
Site photo. The front of the house faces towards the south.

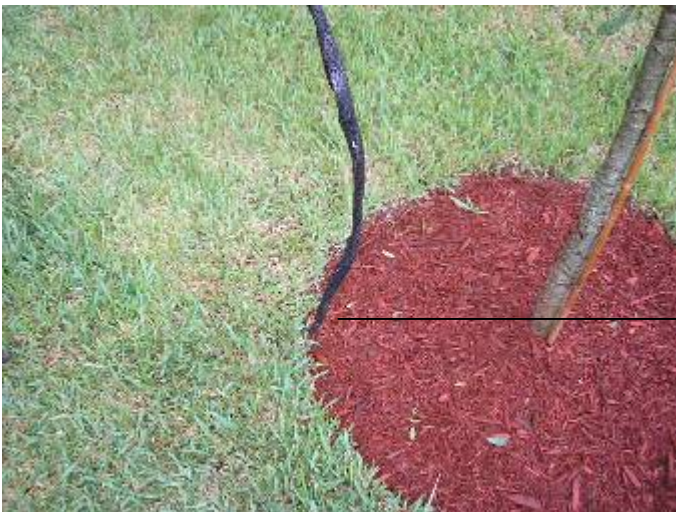
The strapping is loose & not correctly secured at some of the landscape trees.

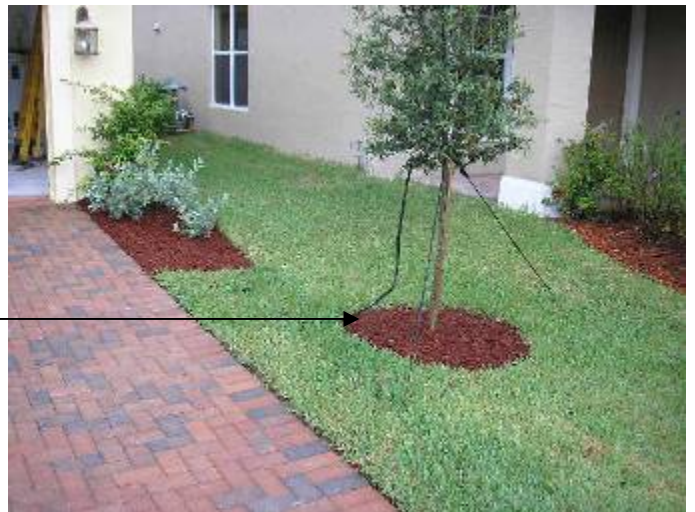
Location of the previous photo/s.

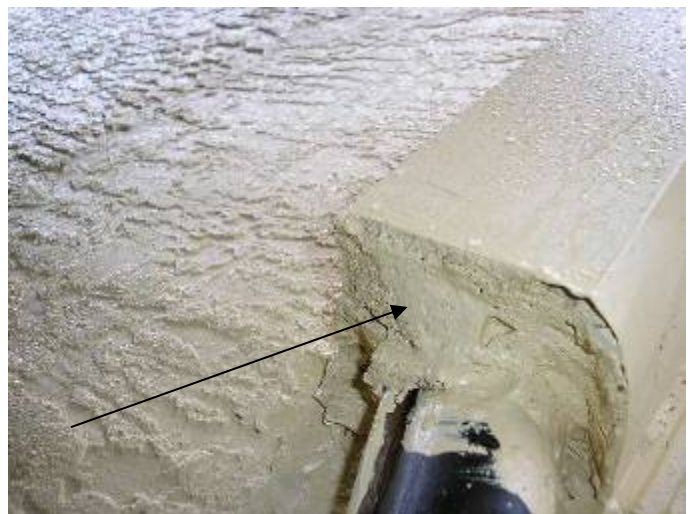
Cement, mortar or non-corrodible metal should be used to close the opening around the refrigerant line piping. §1205.1.2.2

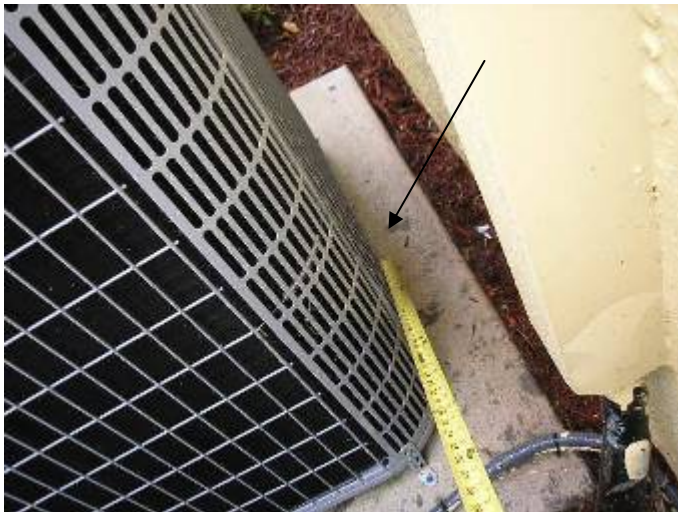
3 Anchors are required on each side of the condensing unit. M301.13.1 Obtain anchorage engineering specs or add anchors as required.

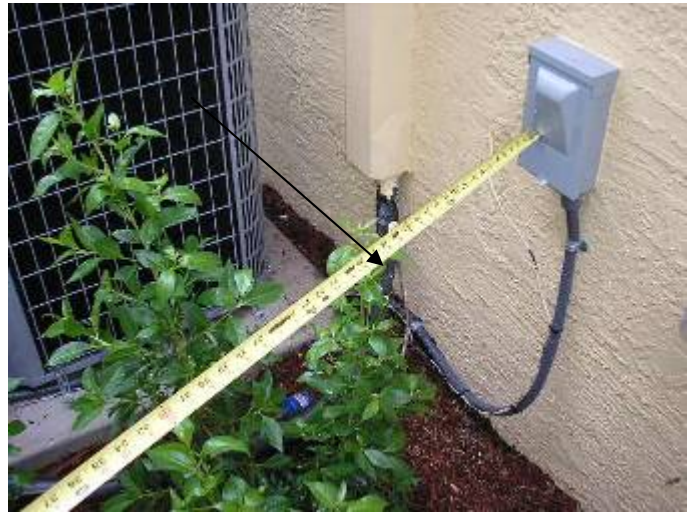
The landscape vegetation obstructs the required working space clearance at the AC disconnect electrical access cover. 36" clearance is required. 2002 NEC 110.26

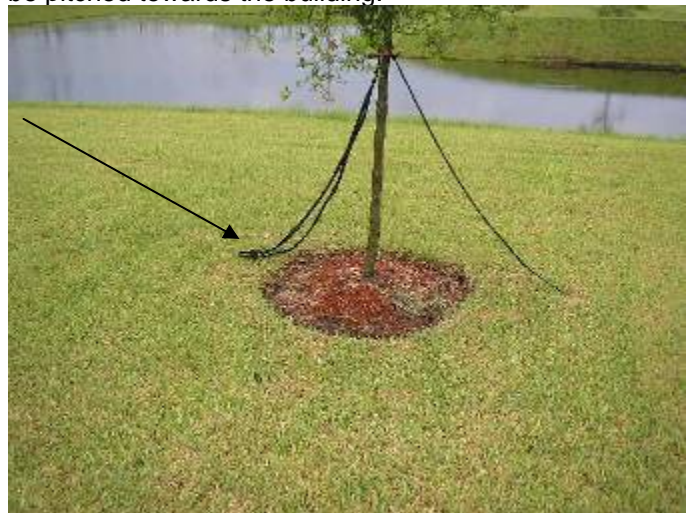
Some of the support straps were loose at the trees around the yard.

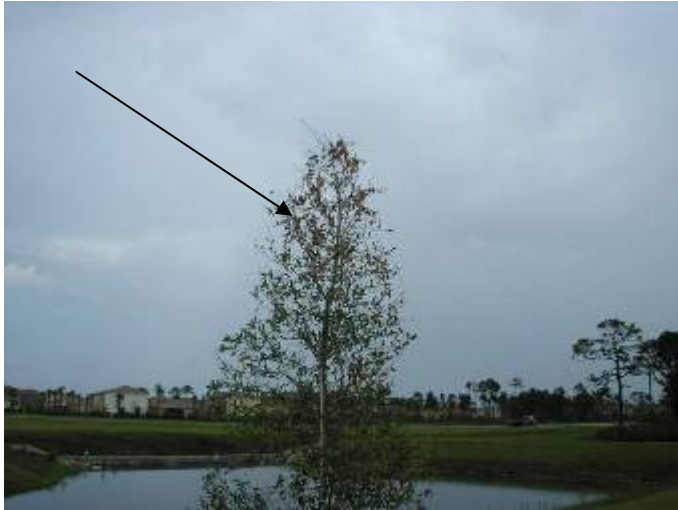
The top of the tree in the back yard is brown & should be monitored for further deterioration.

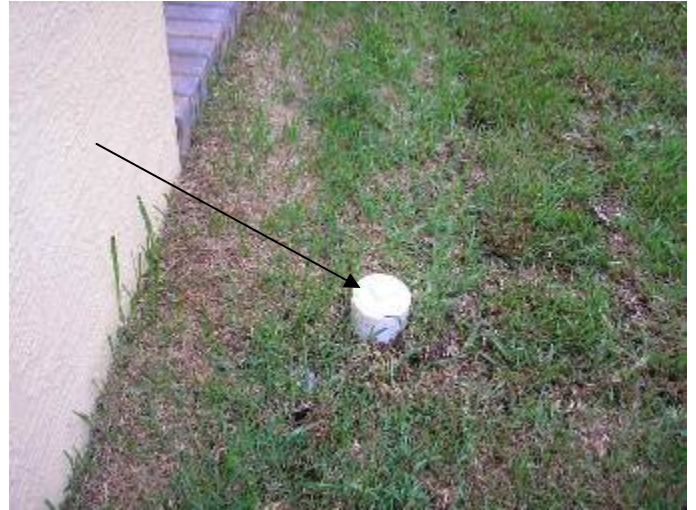
The plumbing waste line cleanout access is located in an area where pedestrian traffic is likely. The cleanout pipe is a trip hazard. §P708.2

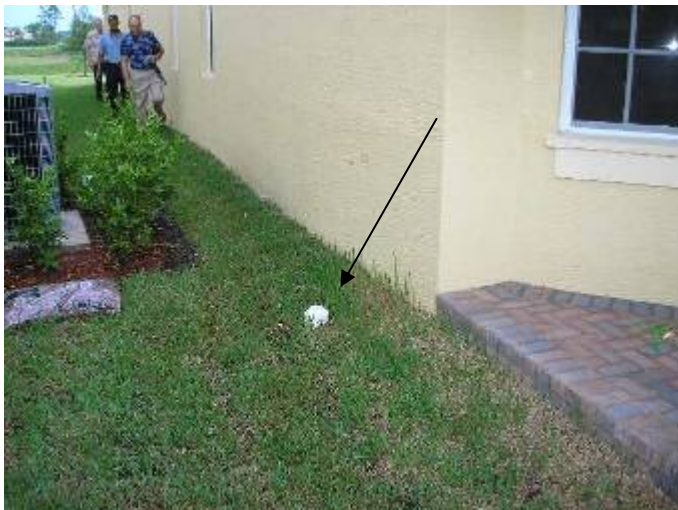
Location of the previous photo/s.

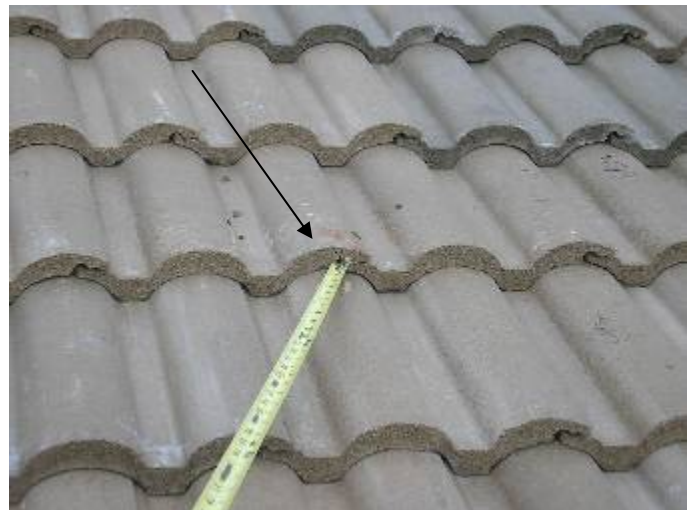
There were broken & incorrectly repaired roof tiles at several locations. The broken roof tiles should be removed & replaced, not "glued" back together.

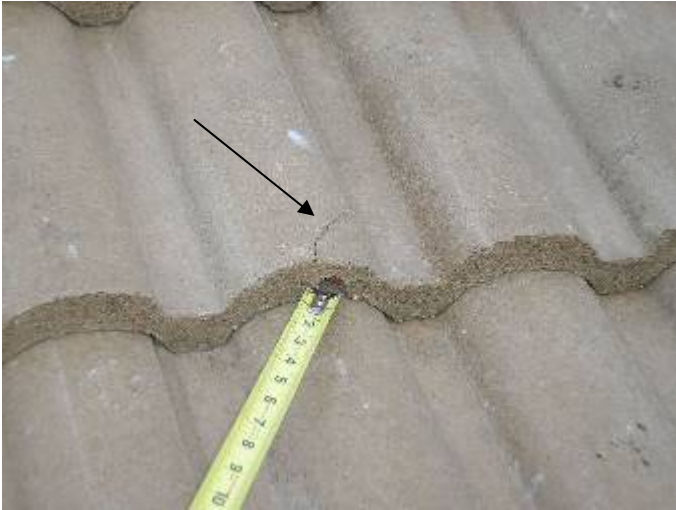
There were broken & incorrectly repaired roof tiles at several locations. The broken roof tiles should be removed & replaced, not "glued" back together.

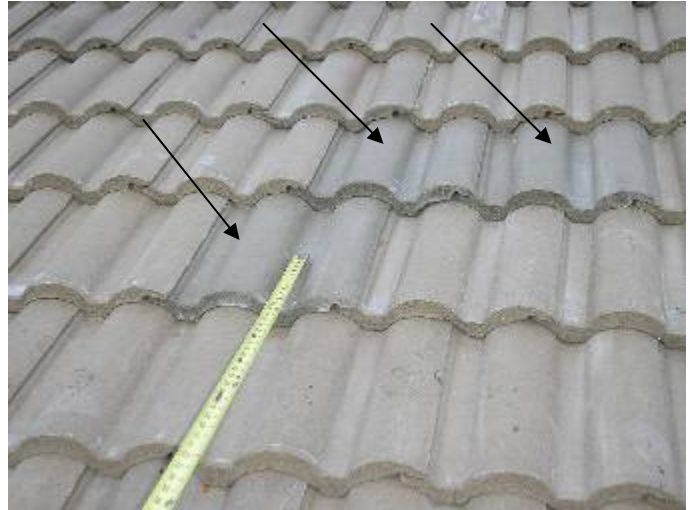
There are replacement tiles that do not match the original roof color. The tiles should be removed & replaced with matching color tiles.

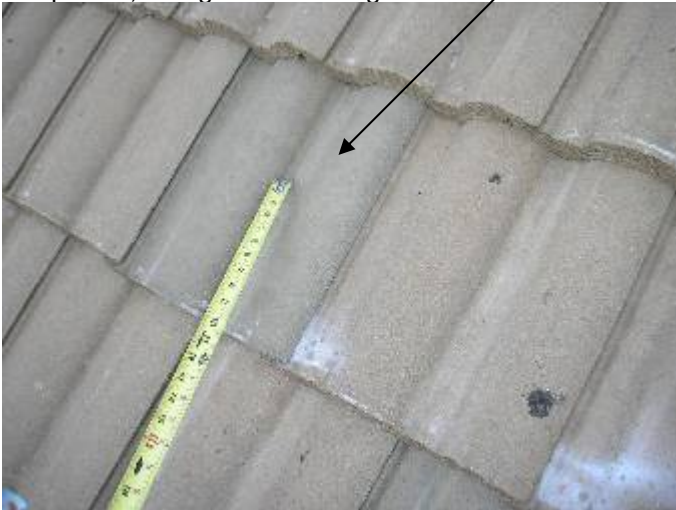
There are replacement tiles that do not match the original roof color. The tiles should be removed & replaced with matching color tiles.

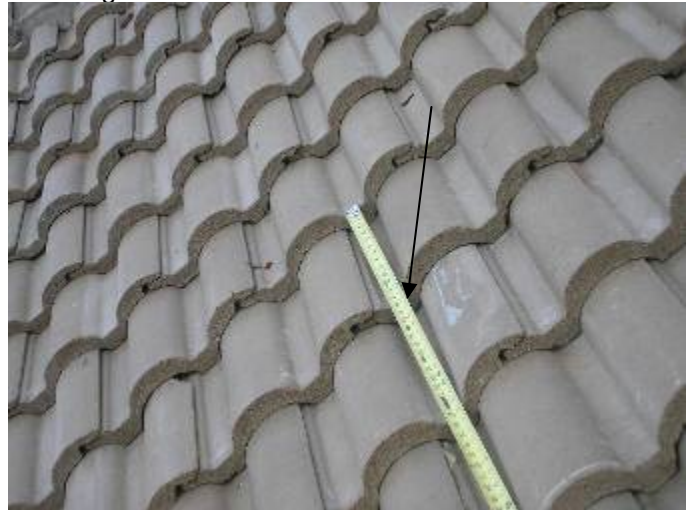
The roof tiles are 16 & 1/2" in length. There should be no more than 13 & 1/2 inches of exposed roof tile to allow for the correct headlap. §1518.8.11 See Below & builder response

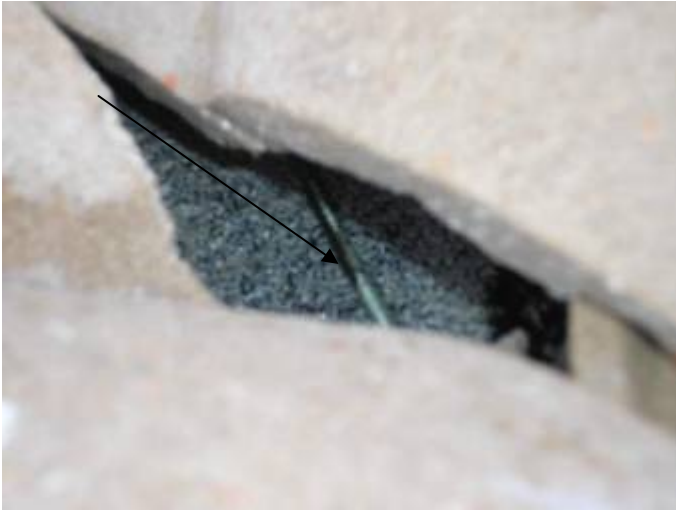
There appear to be cuts in the roof underlayment in the valleys. Any damaged roof underlayment should be correctly repaired.

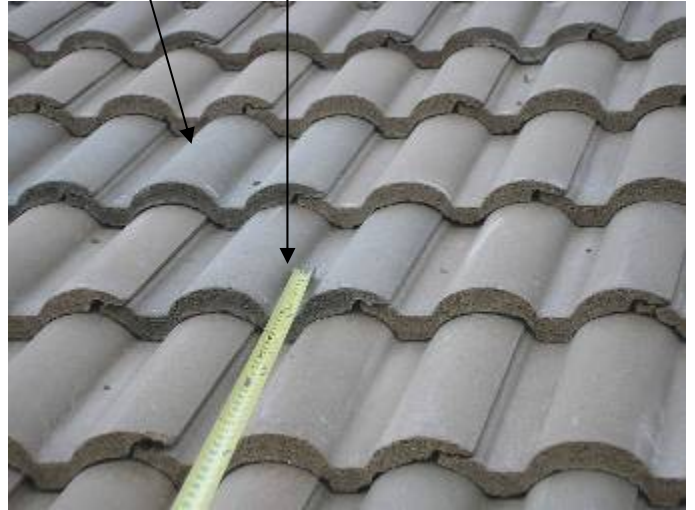
There are replacement tiles that do not match the original roof color. The tiles should be removed & replaced with matching color tiles.

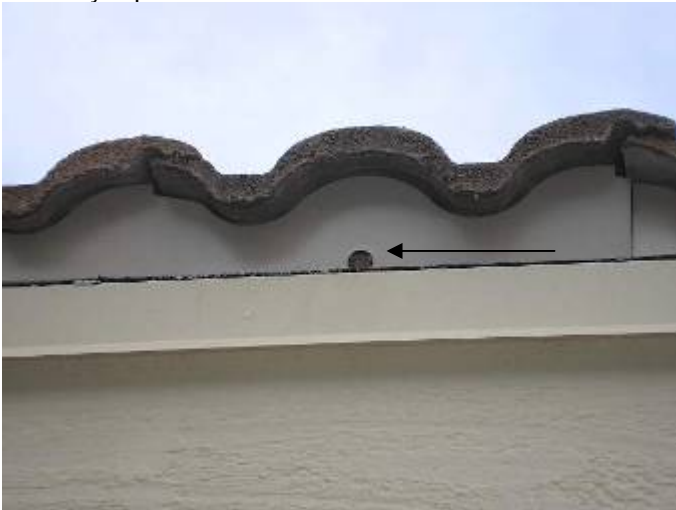
Some of the bird stop weep hole openings are blocked & obstructed with construction debris. All of the weep holes should be open & free of debris. §1518.8.9  
**Florida Building Code**

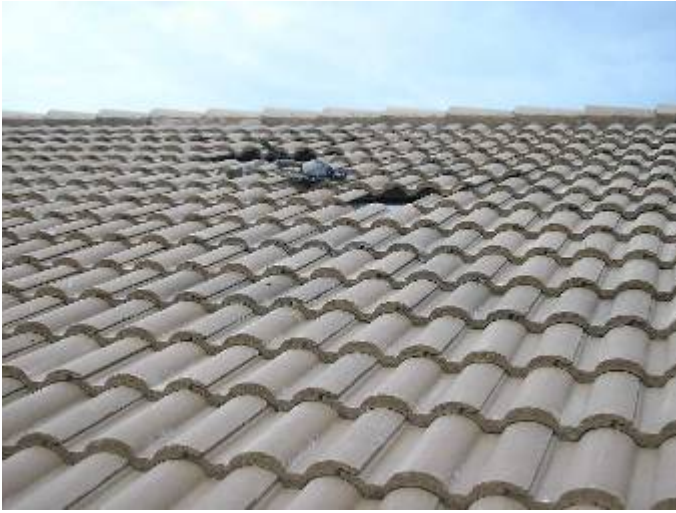
Note: Roof repair work was in progress during the time of the inspection.

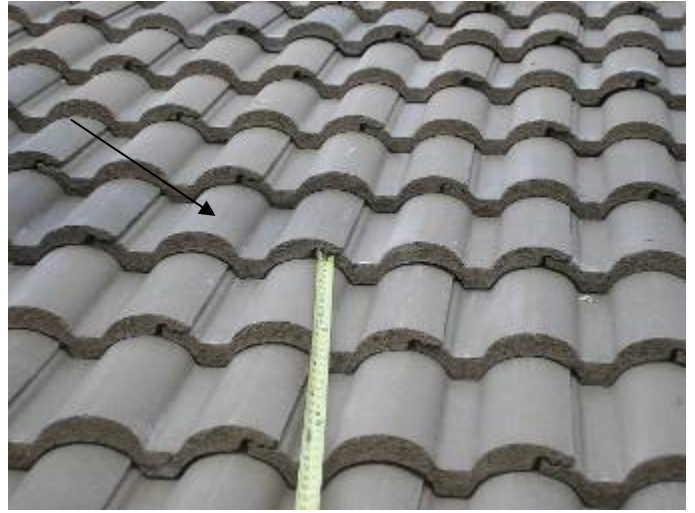
There are replacement tiles that do not match the original roof color. The tiles should be removed & replaced with matching color tiles.

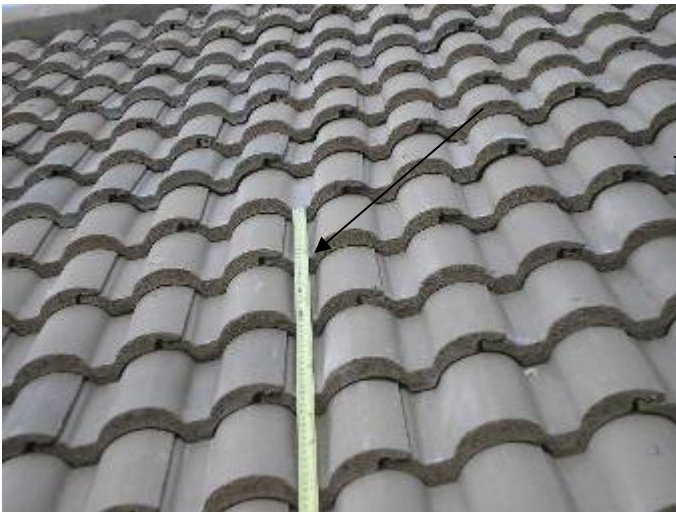
The tile exposure is 14 inches or more at some locations. The tile headlap or overlap is required to be 3 inches. §1518.8.11

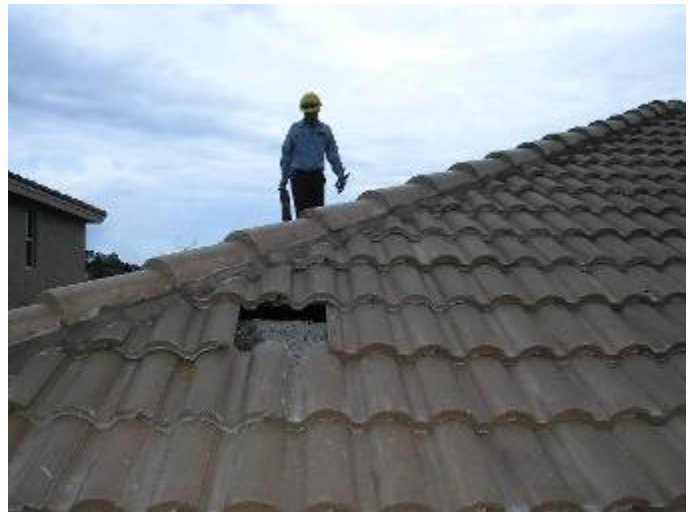
Note: Roof repair work was in progress during the time of the inspection.

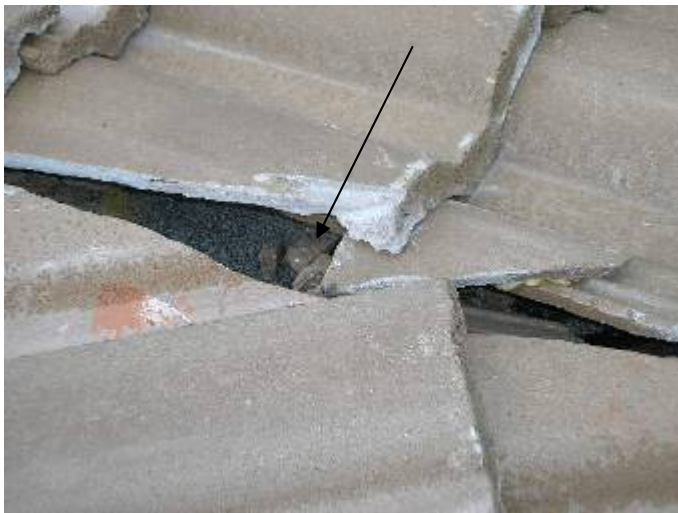
There is broken tile & debris in some of the valleys.

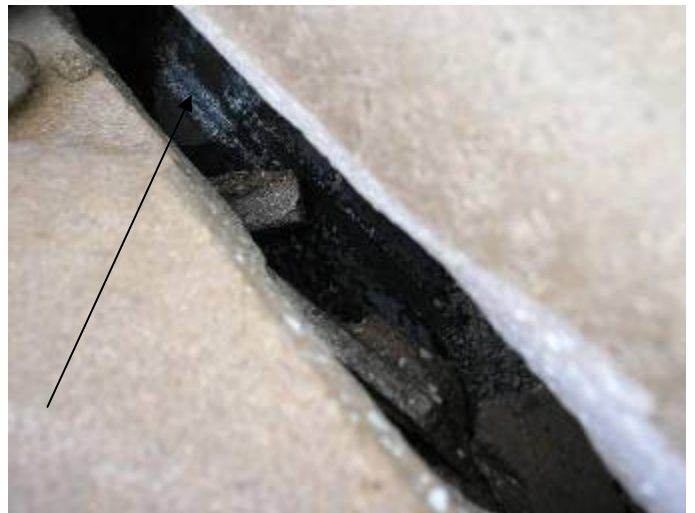
There appear to be cuts in the roof underlayment in the valleys. Any damaged roof underlayment should be correctly repaired.

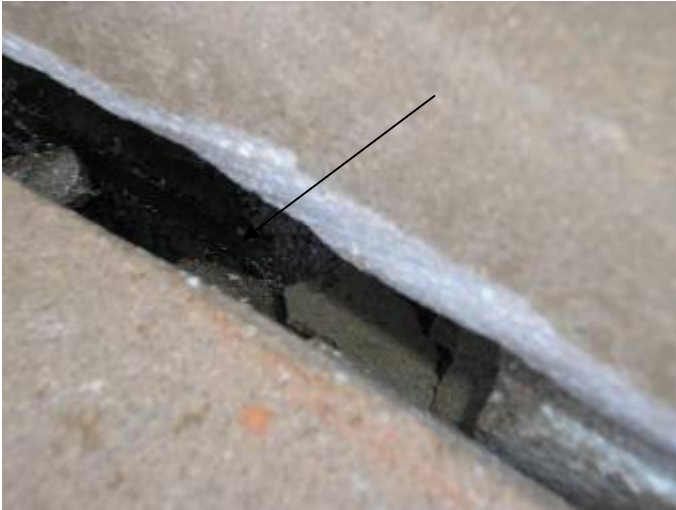
There appear to be cuts in the roof underlayment in the valleys. Any damaged roof underlayment should be correctly repaired.

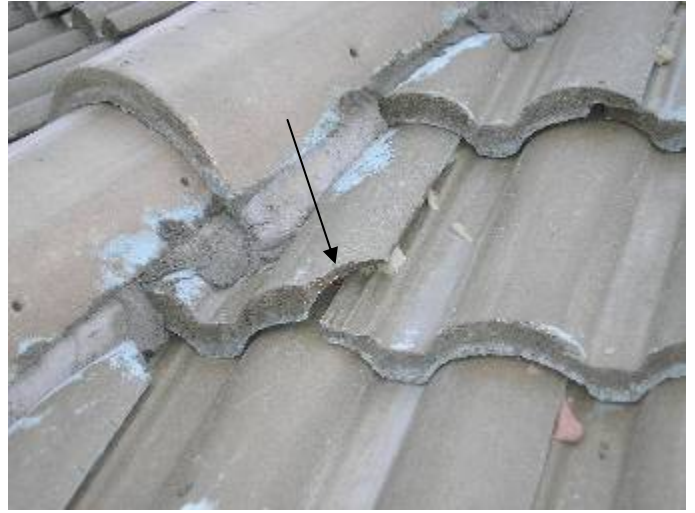
There were broken & incorrectly repaired roof tiles at several locations. The broken roof tiles should be removed & replaced, not "glued" back together.

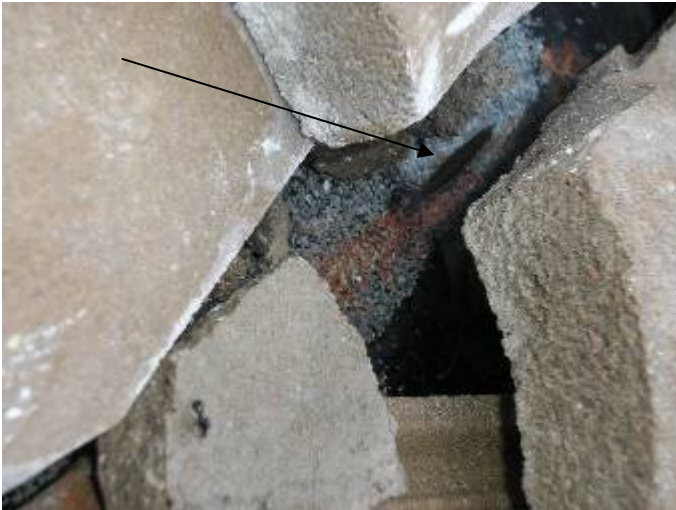
There appear to be cuts in the roof underlayment in the valleys. Any damaged roof underlayment should be correctly repaired.

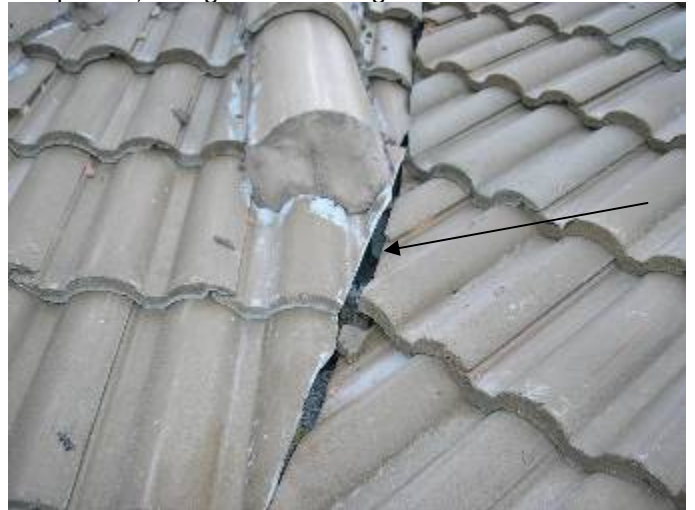
Location of the previous photo/s. All debris should be removed from the roof. There is exposed underlayment at some of the valleys R118-3.09

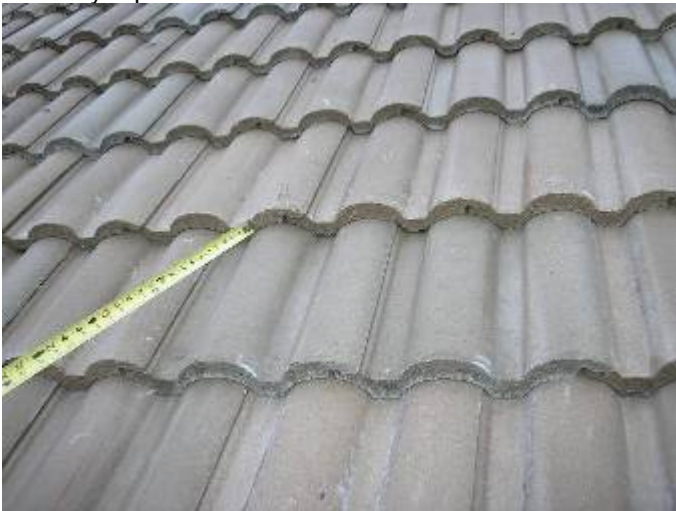
There were cracked & broken tiles on the roof at several locations.

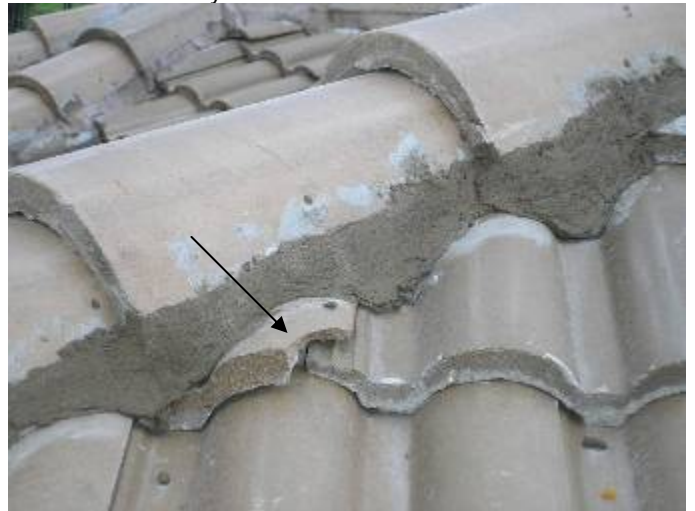
The broken tiles should be removed & replaced with new tiles.

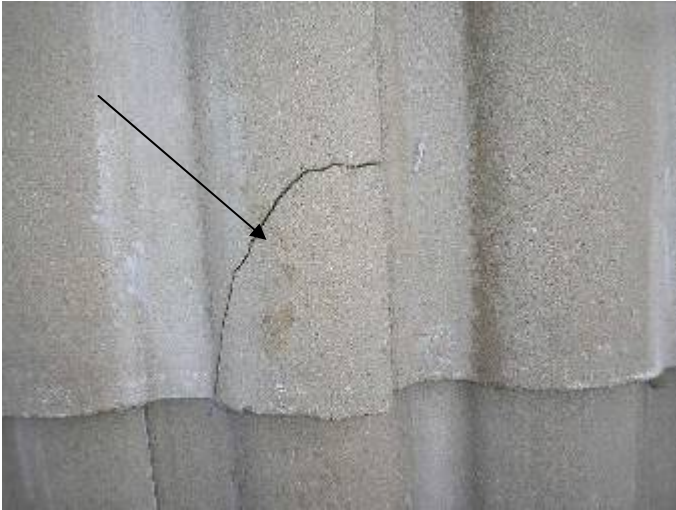
There were cracked & broken tiles on the roof at several locations.

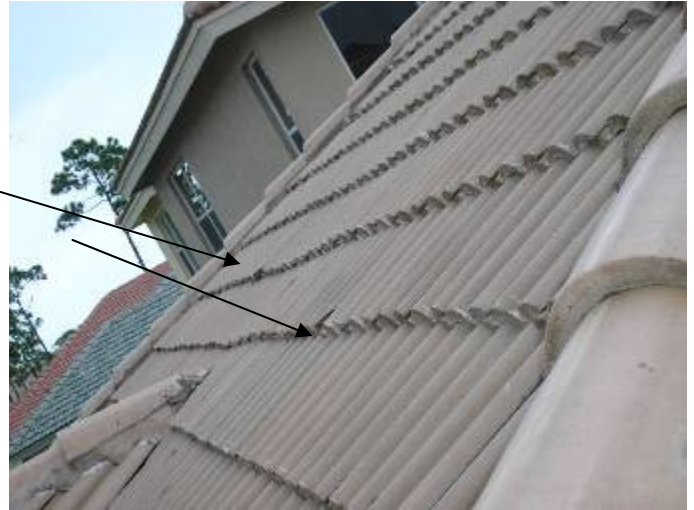
There were broken & incorrectly repaired roof tiles at several locations. The broken roof tiles should be removed & replaced, not "glued" back together.

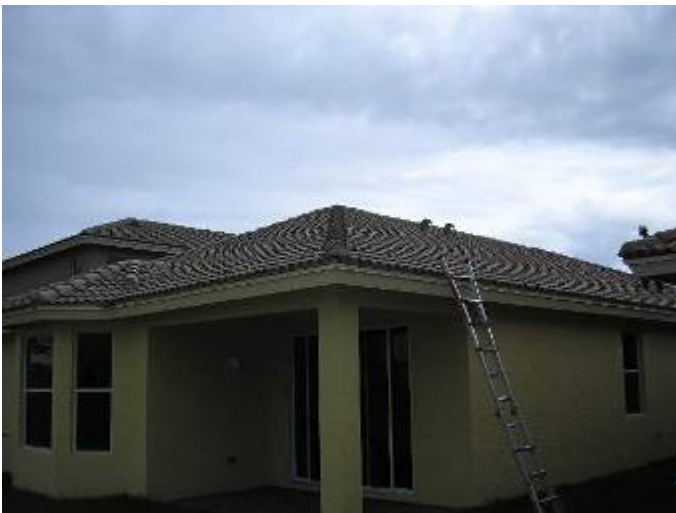
Location of the previous photo/s.

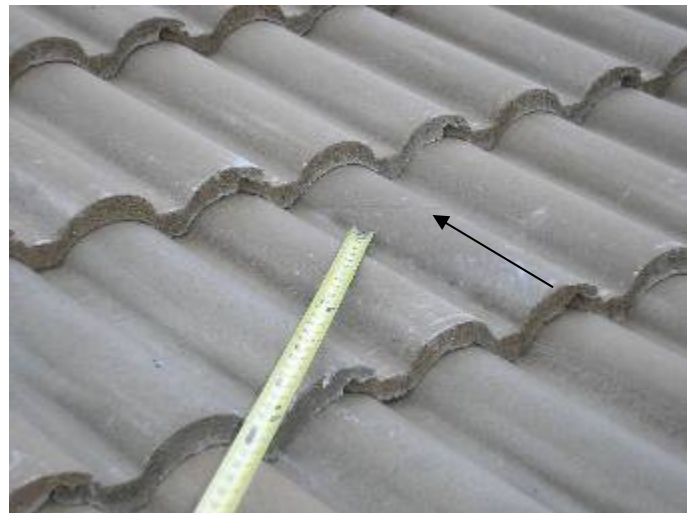
There were broken & incorrectly repaired roof tiles at several locations. The broken roof tiles should be removed & replaced, not "glued" back together.

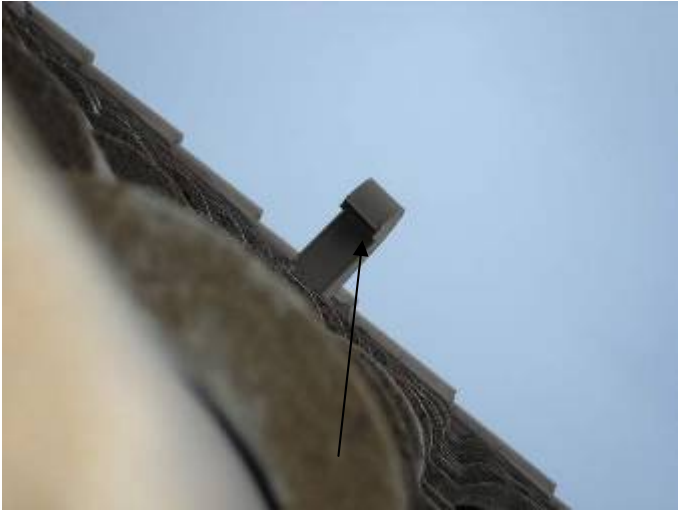
Some of the exhaust vent hoods do not appear to have the correct screening or dampers to prevent pest intrusion.

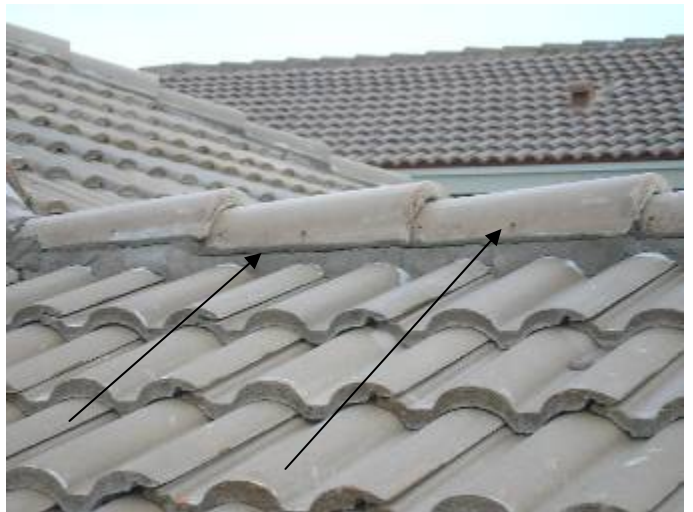
Some of the hip & ridge cap tiles do not appear to be correctly secured or bonded. We were not granted access to walk the roof to verify this condition.

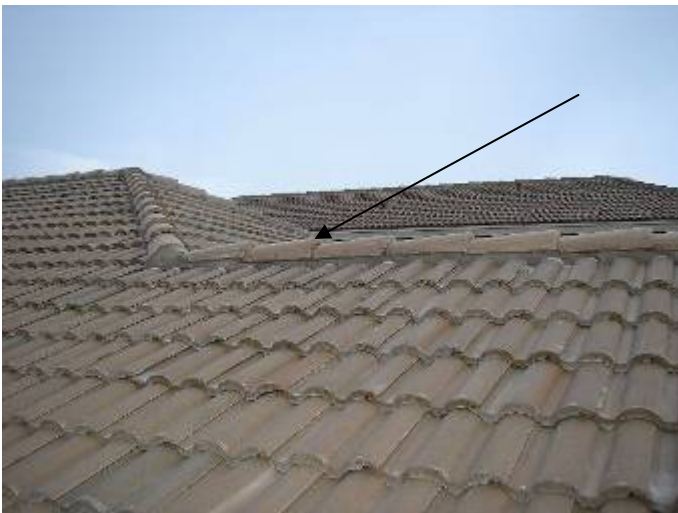
Location of the previous photo/s.

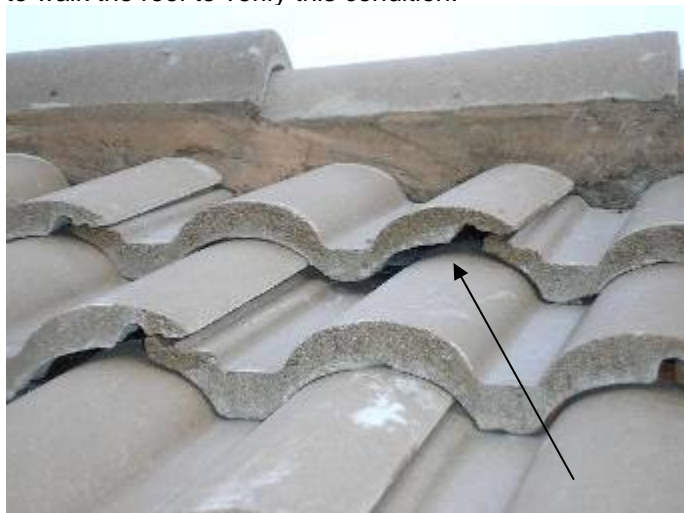
There were tiles that did not appear to be correctly set at multiple locations. We were not granted access to walk the roof to verify this condition.

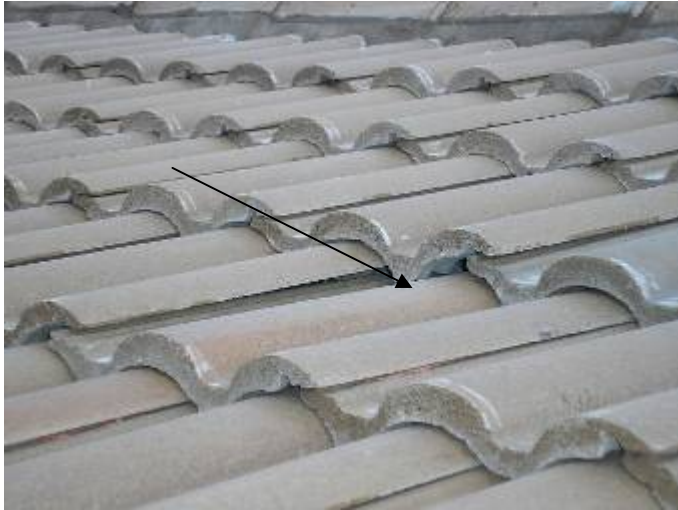
There were tiles that did not appear to be correctly set at multiple locations. We were not granted access to walk the roof to verify this condition.

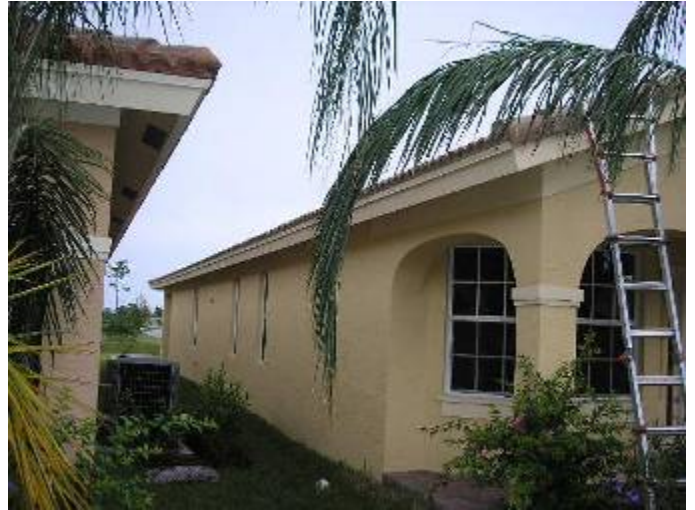
Location of the previous photo/s.

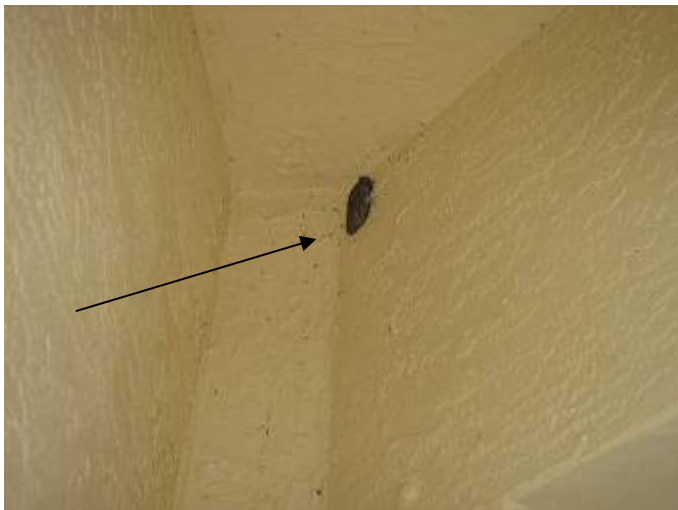
Wasps' nests should be removed from the exterior of the building. -Hazard.

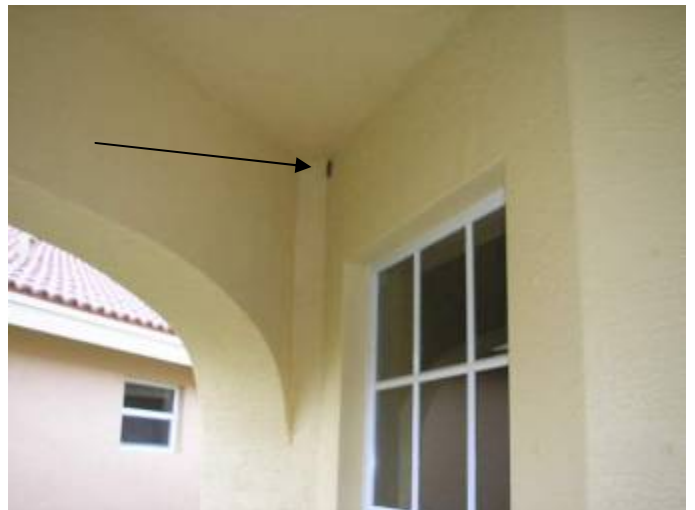
Location of the previous photo/s.

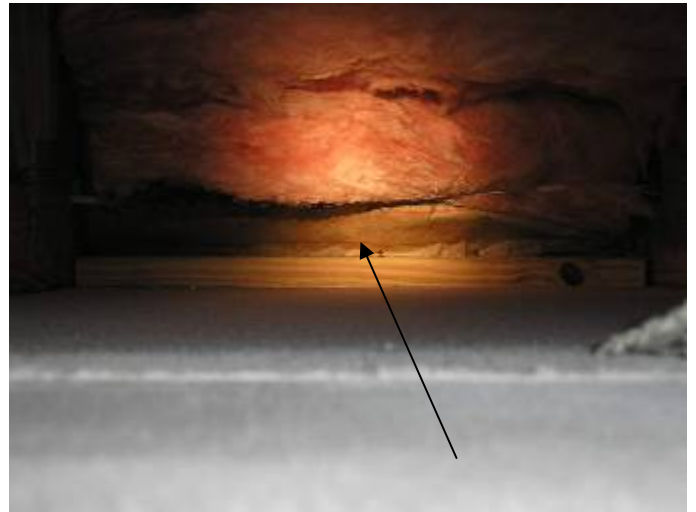
There is exposed kraft paper insulation backing in the attic. The manufacturer states the facing will burn & should not be exposed. §M304.1, §708.2

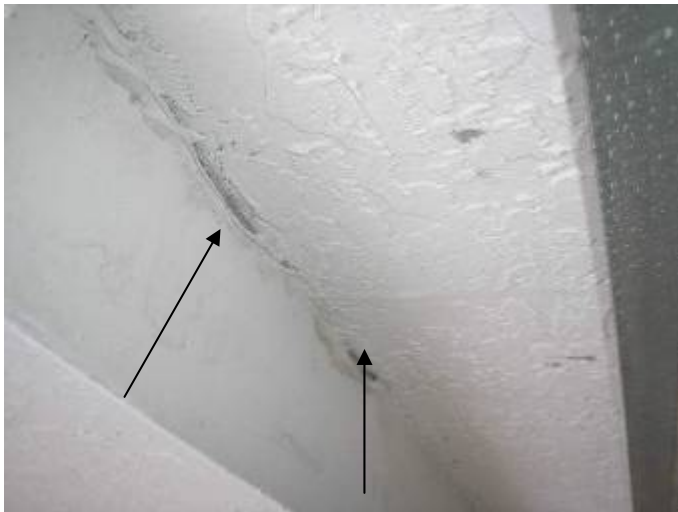
There were unsealed openings in the drywall under the electrical panel in the garage.

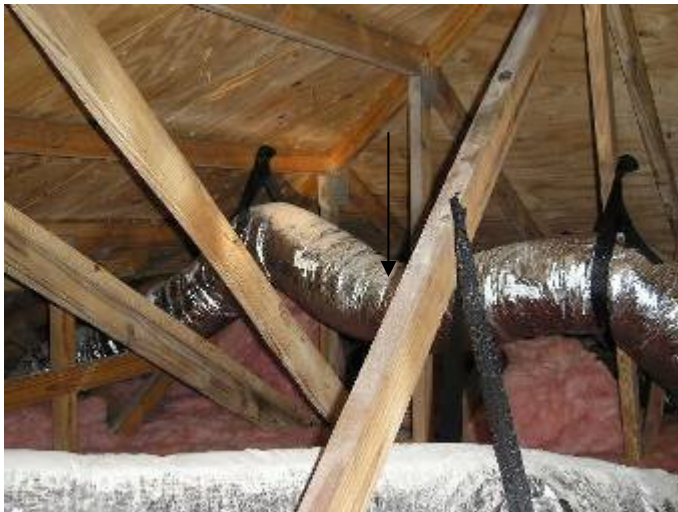
Some of the AC ductwork was sagging & not correctly supported. §13-610.1.ABC.3.3.6

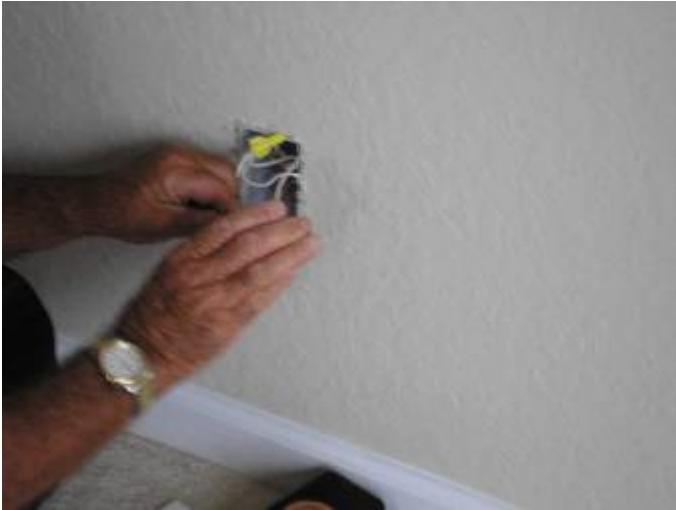
The west master bedroom receptacle tested loose or open ground. The grounding condition was repaired during the inspection.

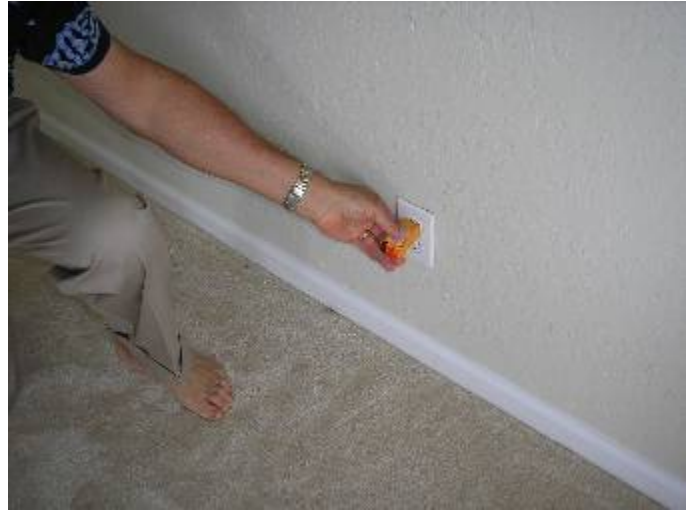
The outlets were loose in the wall after the repair was completed.

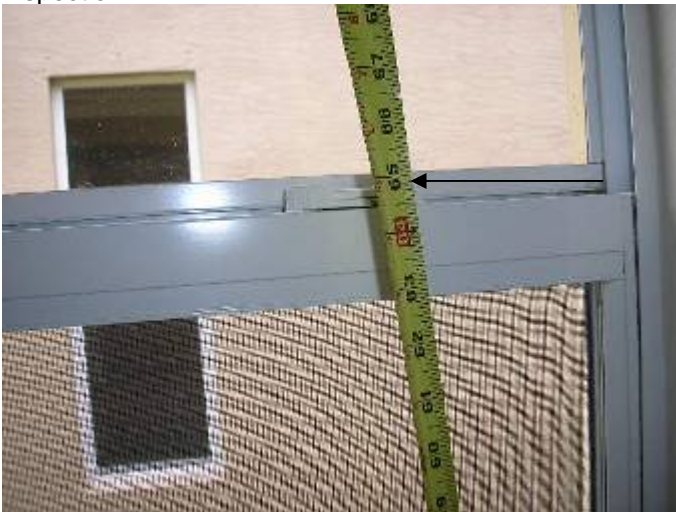
The height of the locks should not exceed 54 inches at the bedroom windows.

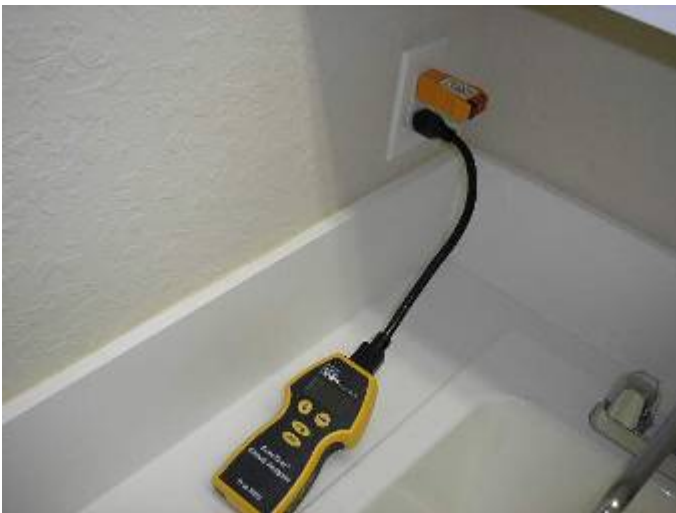
The laundry room receptacle outlet was repaired during the inspection.

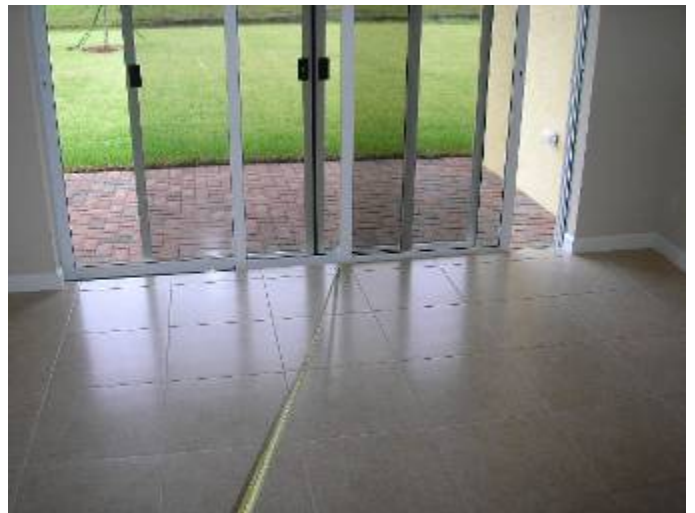
The sliding glass door was sticking in the frame.

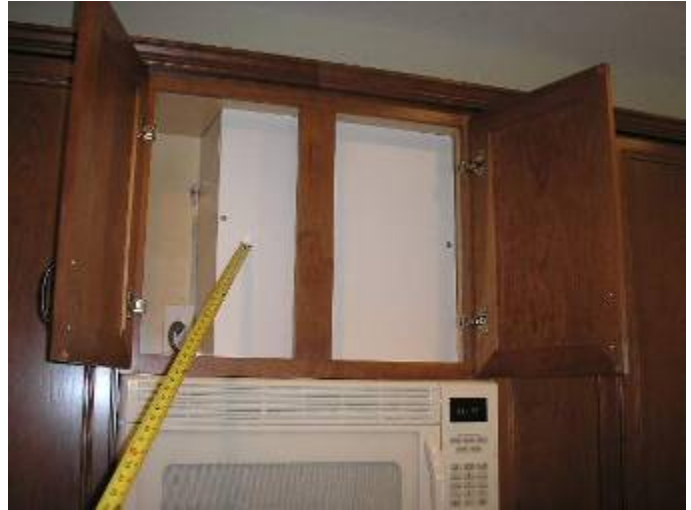
We recommend viewing the ductwork behind the panel above the microwave after closing. We were not given permission to remove the panel.

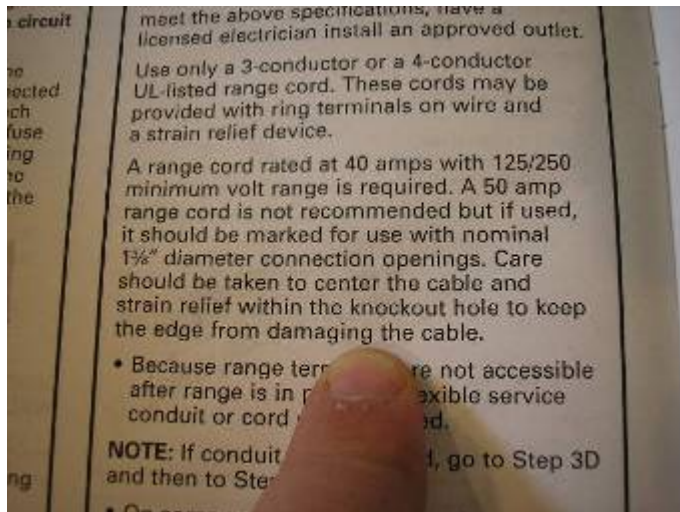
The range is installed with an electrical cord rated at 40 amps. The 50 amp overcurrent protection breaker in the main distribution panel is too big. §M304.1

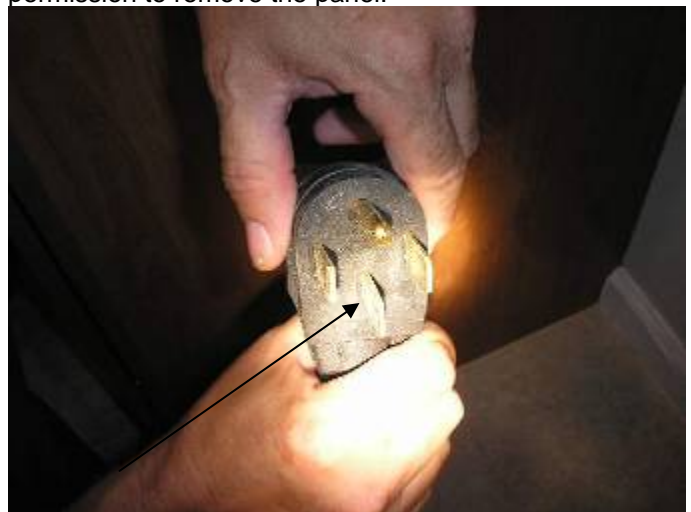
A 40 amp rated cord is used at the range & recommended by the manufacturer.

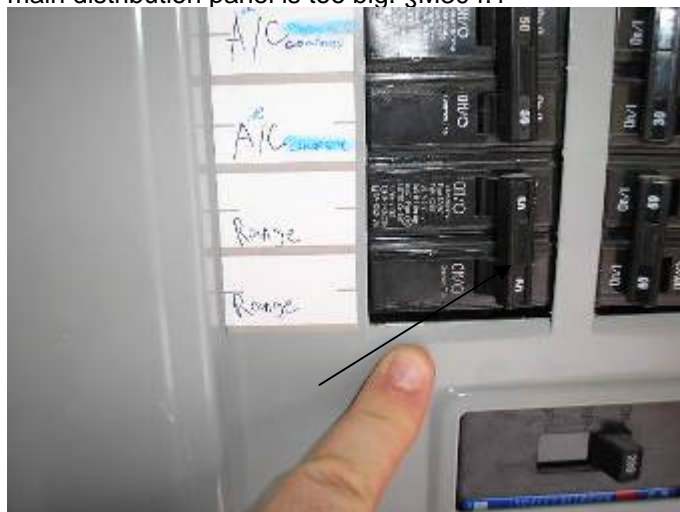
The range is installed with an electrical cord rated at 40 amps. The 50 amp overcurrent protection breaker in the main distribution panel is too big.
