Re-Inspection Report of 945 Fleming Way Stuart Florida 34997 Prepared for Dr Warren

The State of Florida requires the builder to build in compliance with the Florida Building Code.

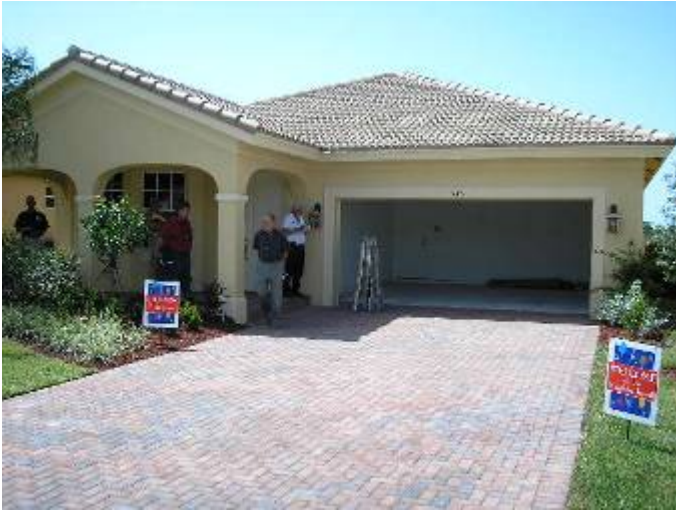
Site photo. The front of the house faces towards the south.

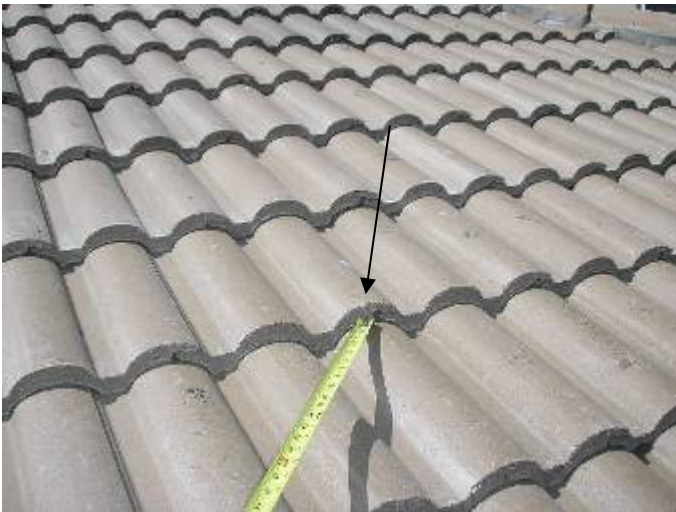
There were still some broken & incorrectly repaired roof tiles at several locations. The broken roof tiles should be removed & replaced, not "glued" back together.

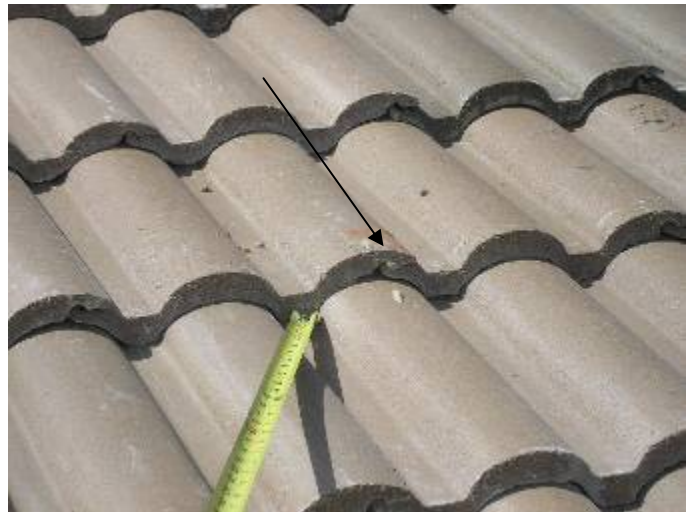
There were still some broken & incorrectly repaired roof tiles at several locations. The broken roof tiles should be removed & replaced, not "glued" back together.

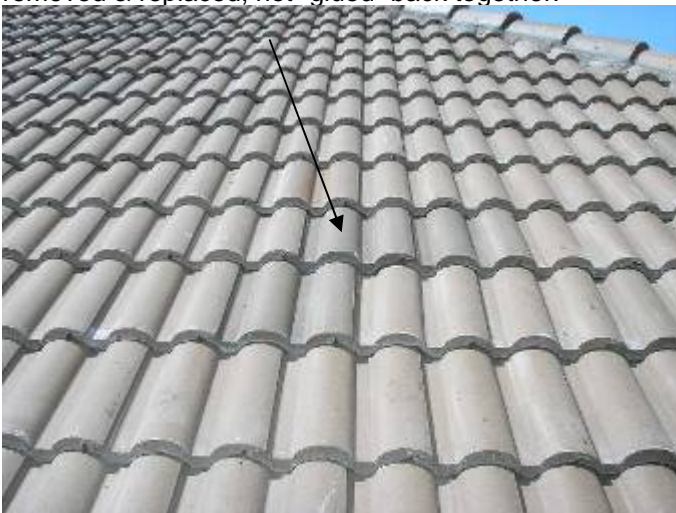
There are replacement tiles that do not match the original roof color.

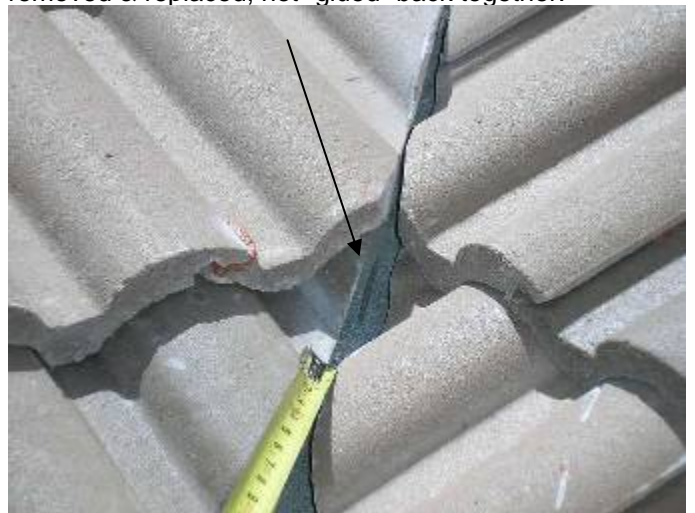
There appear to be cuts in the roof underlayment in the valleys. Any damaged roof underlayment should be correctly repaired.

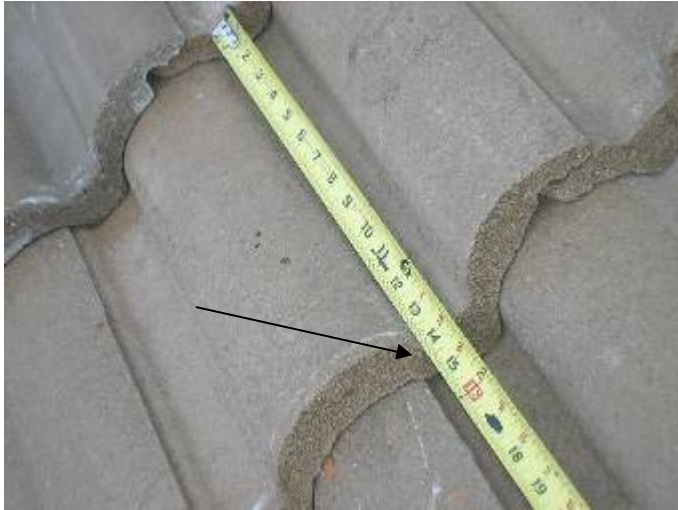
Note: The builder has documentation indicating the code section concerning headlaps is not fully applicable in the installation of these roof tiles. We did not discuss our findings or the builder's response to the report at the time of the re-inspection per client request.

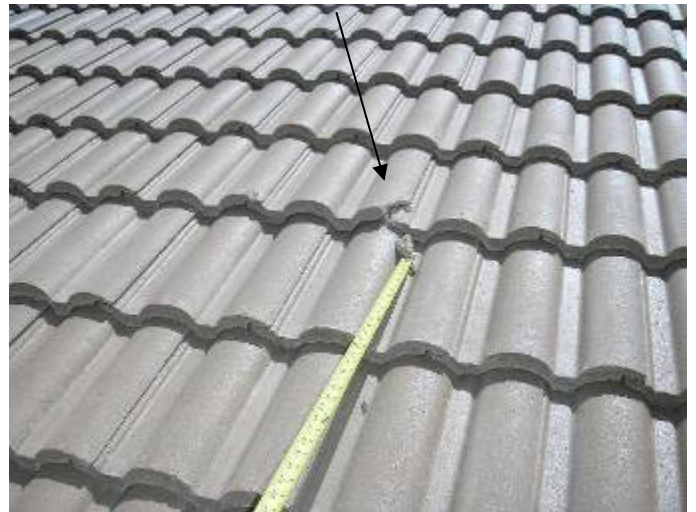
There were still some broken & incorrectly repaired roof tiles at several locations. The broken roof tiles should be removed & replaced, not "glued" back together.

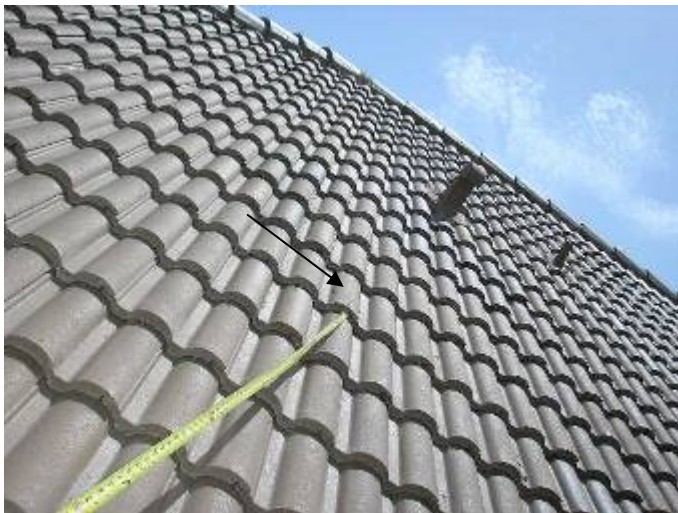
There were still some broken & incorrectly repaired roof tiles at several locations. The broken roof tiles should be removed & replaced, not "glued" back together.

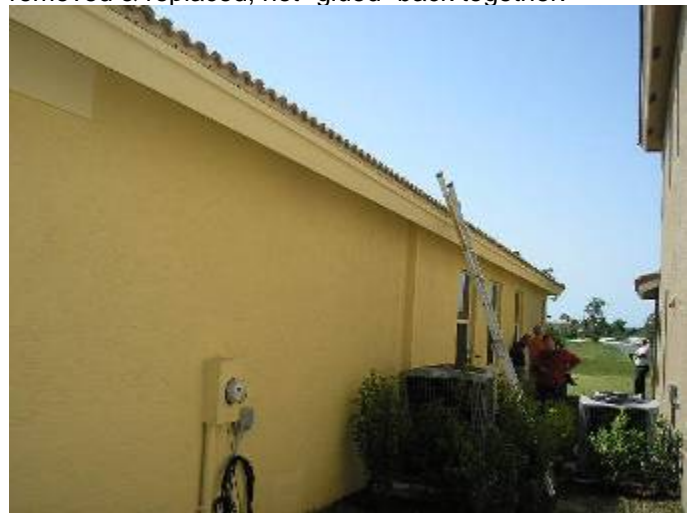
Location of the previous photo/s.

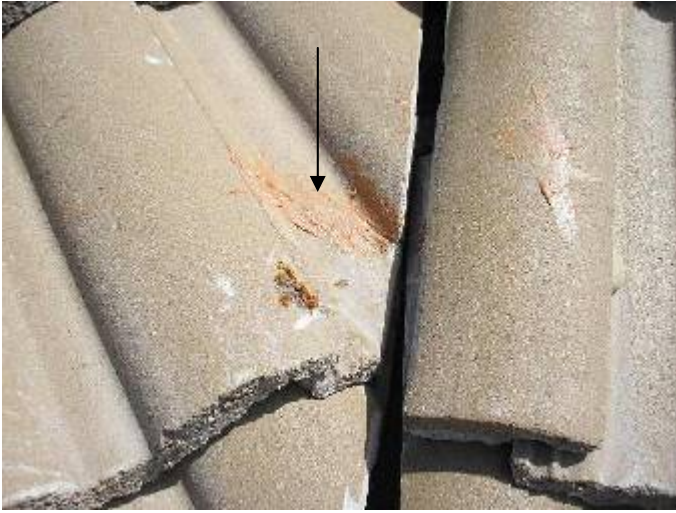
There were still some broken & incorrectly repaired roof tiles at several locations. The broken roof tiles should be removed & replaced, not "glued" back together.

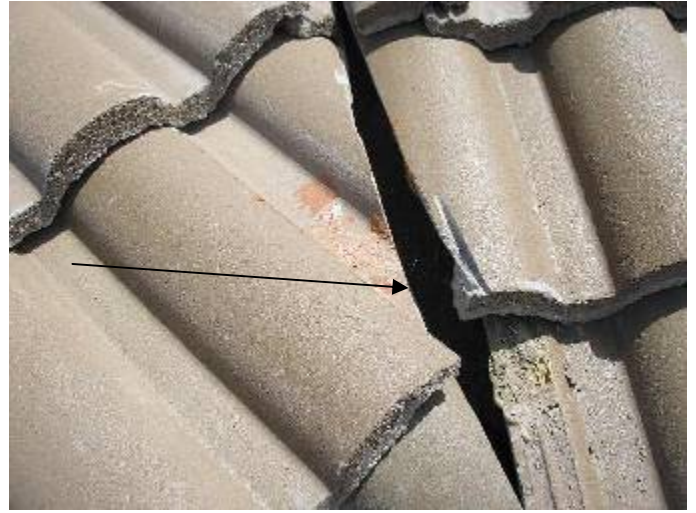
There is exposed underlayment at some of the valleys. The tiles are not mitered to meet correctly in the center of the valley. §1518.8.1, R118-3.09

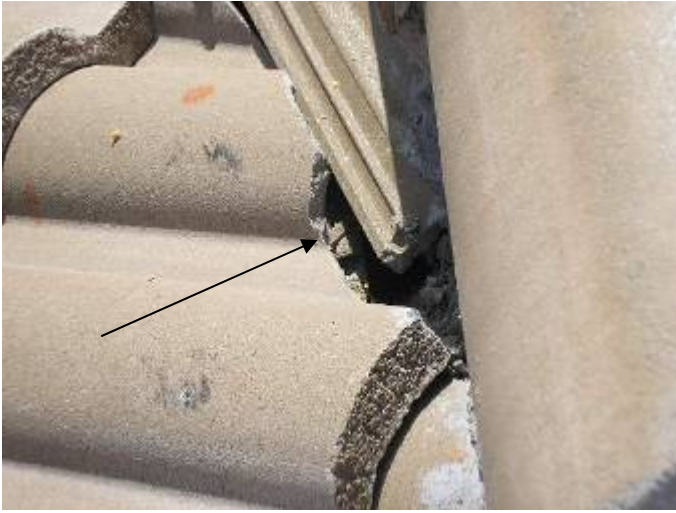
There was still some construction debris in the valleys. All debris should be removed from the roof.

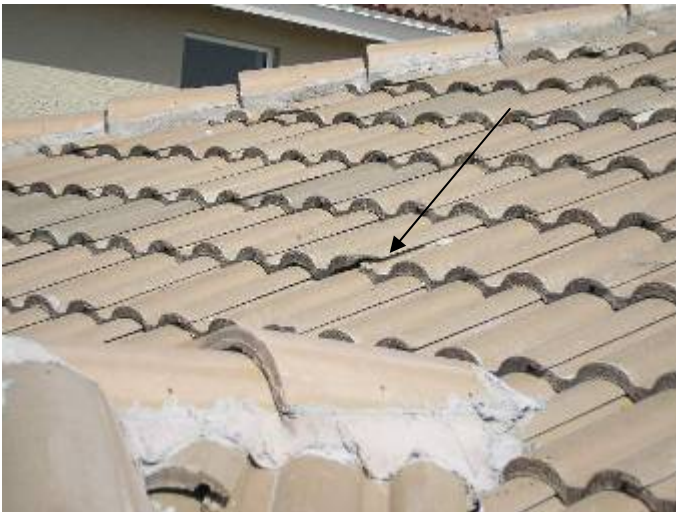
There were still some broken & incorrectly repaired roof tiles at several locations. The broken roof tiles should be removed & replaced, not "glued" back together.

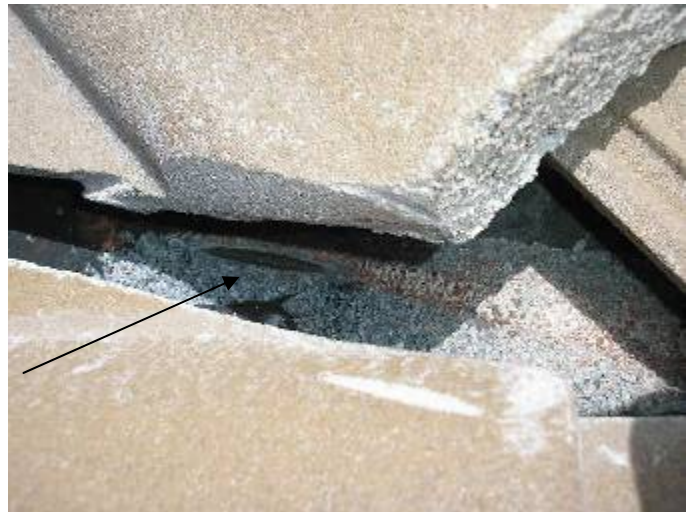
There appear to be cuts in the roof underlayment in the valleys. Any damaged roof underlayment should be correctly repaired.

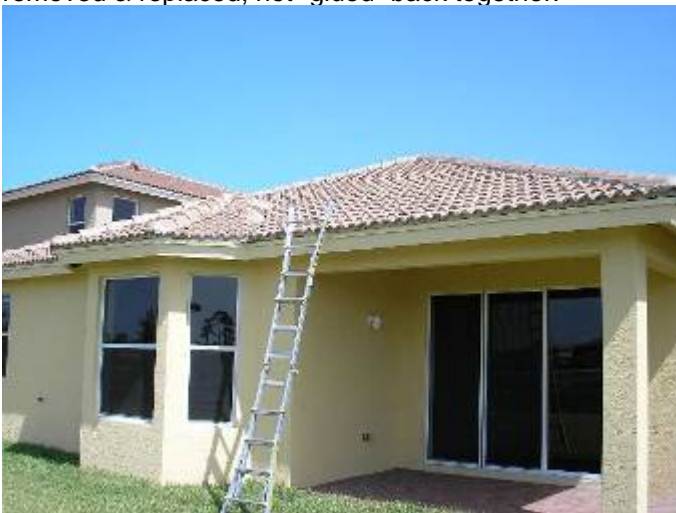
Location of the previous photo/s.

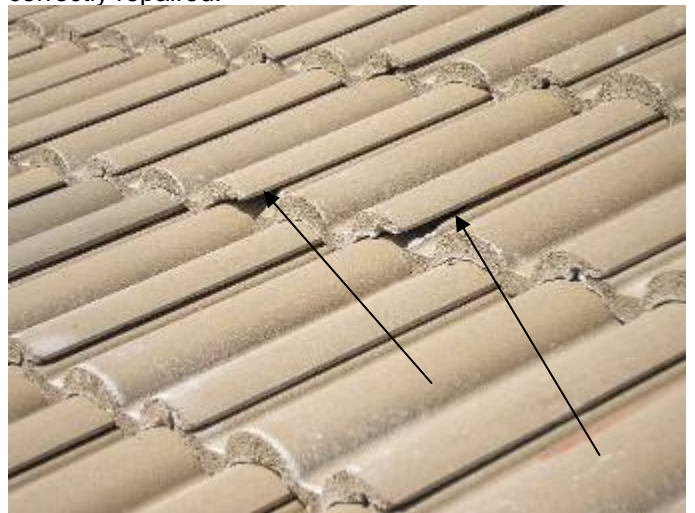
There were tiles that did not appear to be correctly set at multiple locations. We were not granted access to walk the roof to verify this condition.

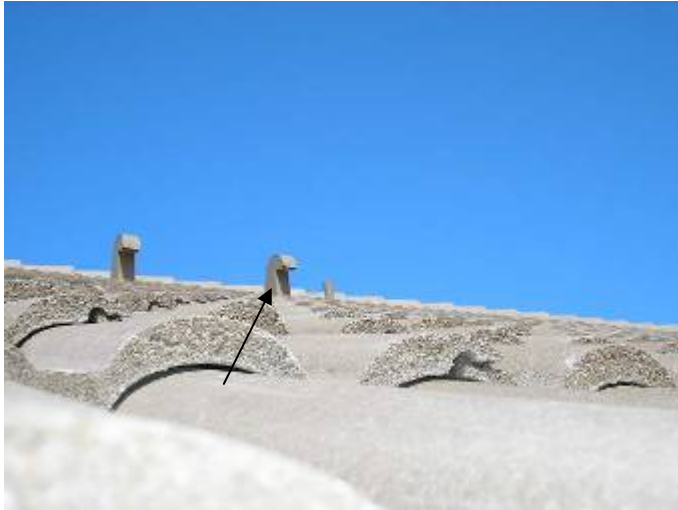
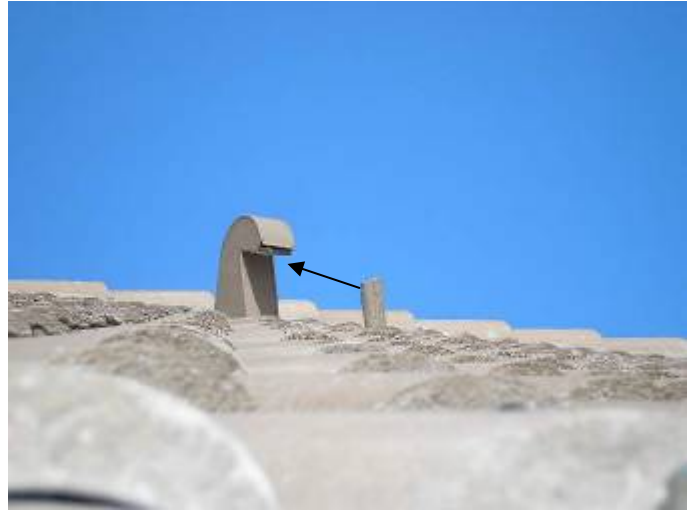
We could not verify if a screen was installed at this exhaust hood. Nor could we determine what this hood is for. If this is the make-up air intake for the AC system>>>

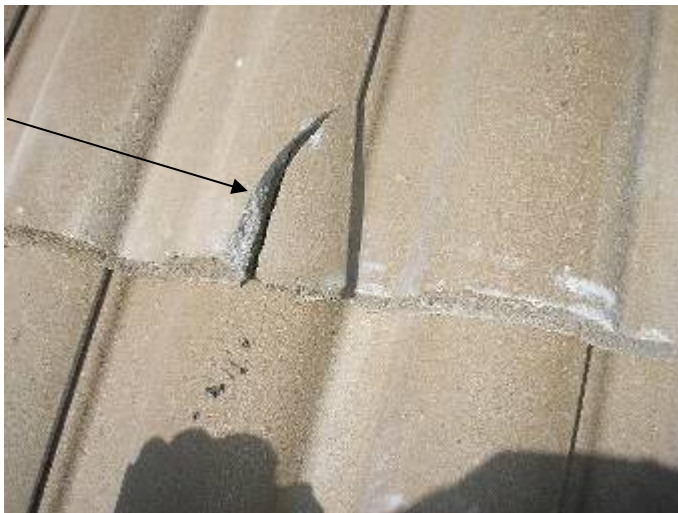
There were still some broken & incorrectly repaired roof tiles at several locations. The broken roof tiles should be removed & replaced, not "glued" back together.

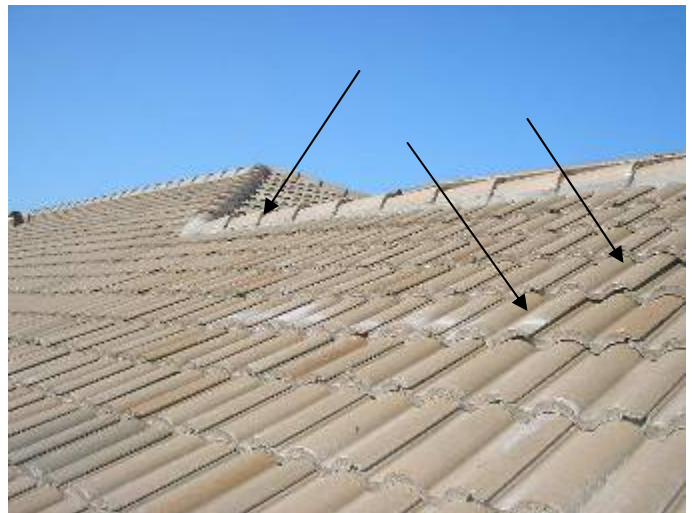
We were not able to verify the tiles were correctly secured. The builder's representative stated that someone from the building department reviewed the tile installation.

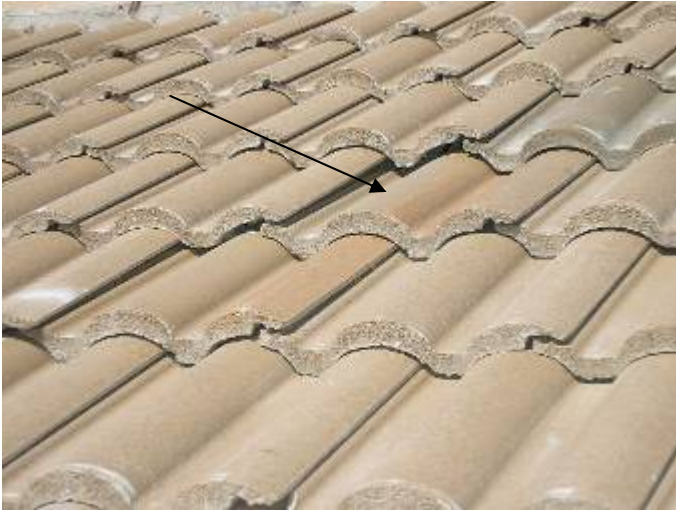
There were tiles that did not appear to be correctly set at multiple locations. We were not granted access to walk the roof to verify this condition.

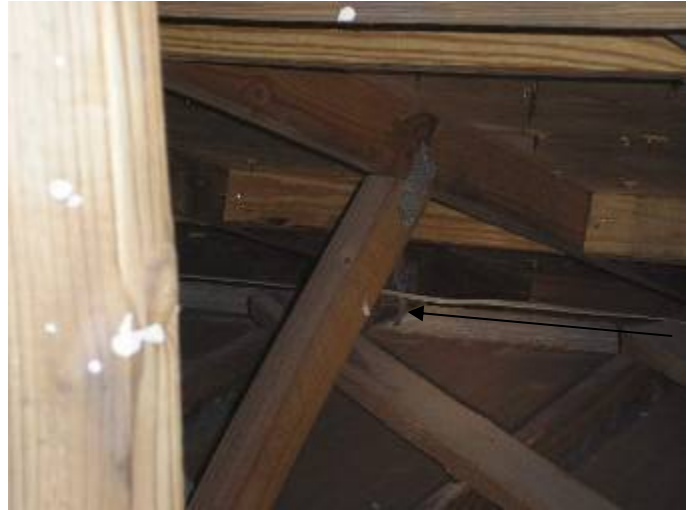
We were unable to verify all corrections in the attic as we were requested by the builder not to leave the ladder.

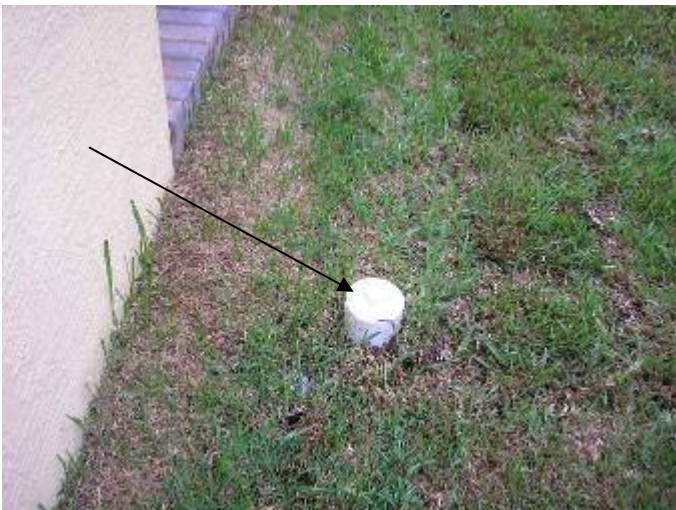
The plumbing waste line cleanout access is located in an area where pedestrian traffic is likely. The cleanout pipe is a trip hazard. §P708.2 A countersunk head should be used.
