Inspection Report of 6282 S. Military Trail, Lake Worth FL #705 Prepared for Muhammad A. & Nisreen Tina

6282 S. Unit 705 Military Trail Lake Worth FL 33463

Inspection Report of 6282 S. Military Tr. Lake Worth FL 33463 Unit 705 7.28.06

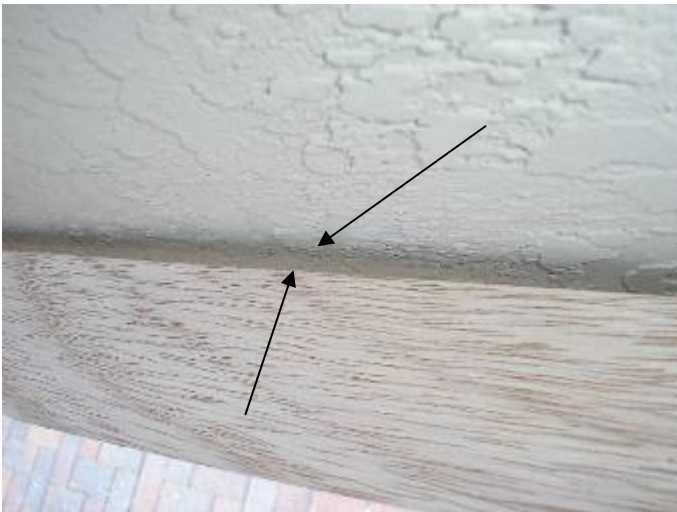
Some of the stucco work appears to be uneven, curved in & not the proper depth. ASTM C 926, §2504.2 §1403.1.3

We recommend core sampling at these locations to verify the thickness of the exterior stucco & compliance with ASTM C 926.

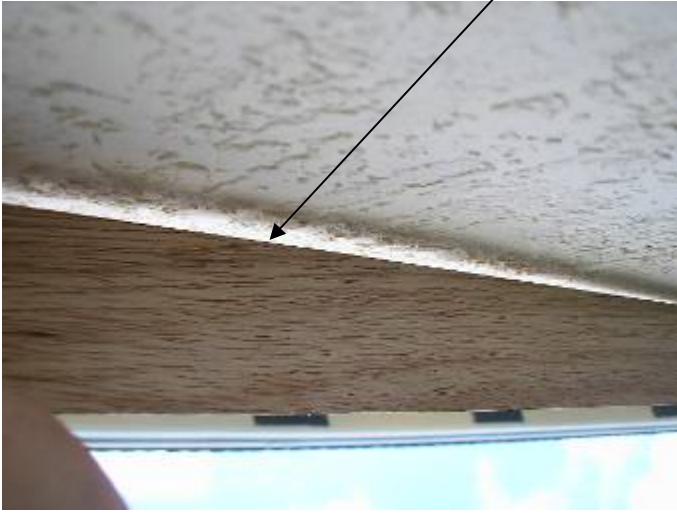
Some of the stucco work appears to be uneven, curved in/concave & not the proper depth. ASTM C 926, §2504.2 §1403.1.3

We recommend core sampling at these locations to verify the thickness of the exterior stucco & compliance with ASTM C 926.

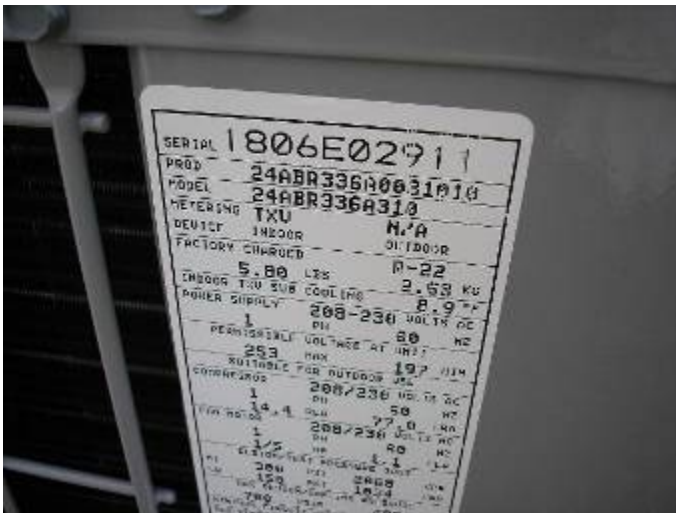
AC Info Plate: 3 ton electric compressor.

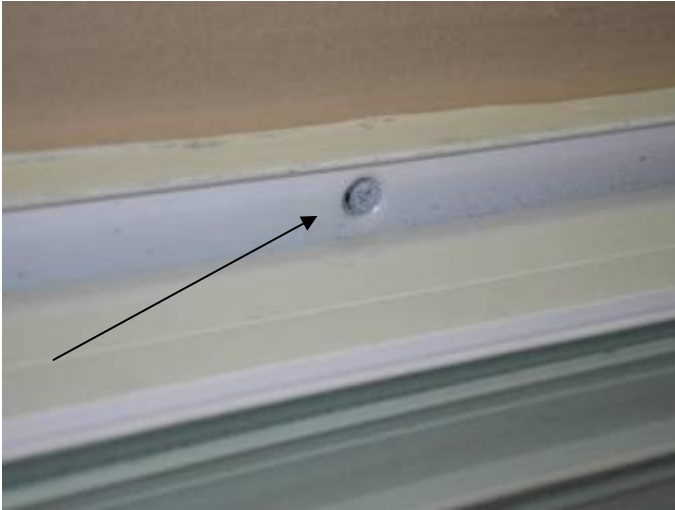
Some of the screw anchors not completely set & not sealed to prevent water & pest intrusion at the sliding glass door frame. FBC §13-606.1.ABC.1.2., §1707.4.4.1

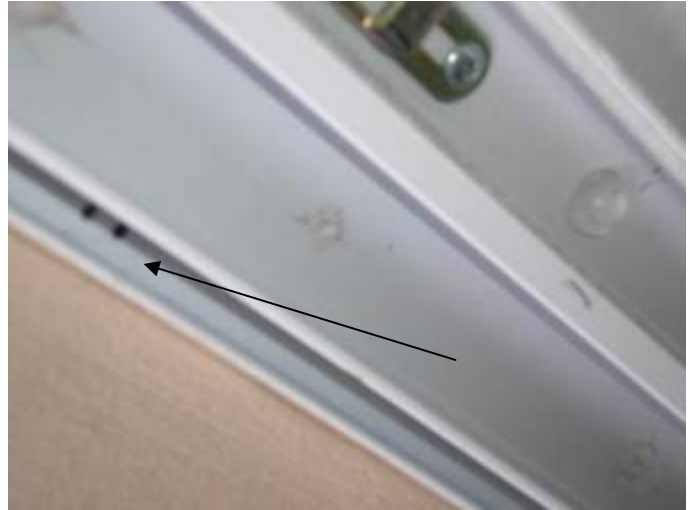
Some of the openings in the frame are not completely sealed to prevent water & pest intrusion at the sliding glass doors. FBC §13-606.1.ABC.1.2.

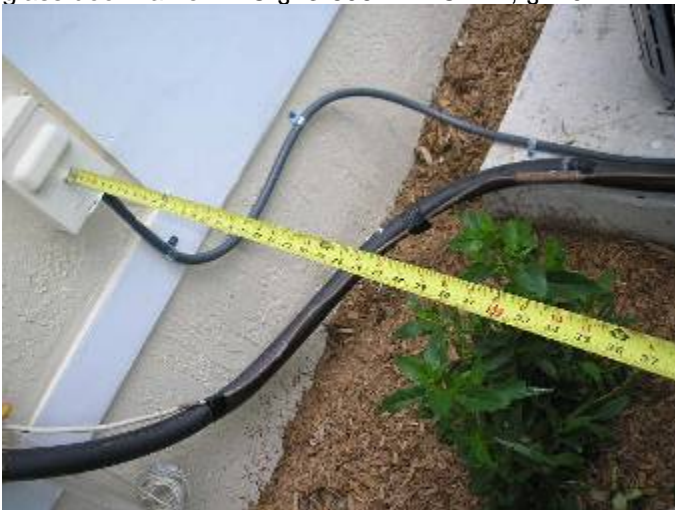
The landscape vegetation obstructs the required working space clearance at the AC disconnect electrical access cover. 36" clearance is required. 2002 NEC 110.26
2002 NEC

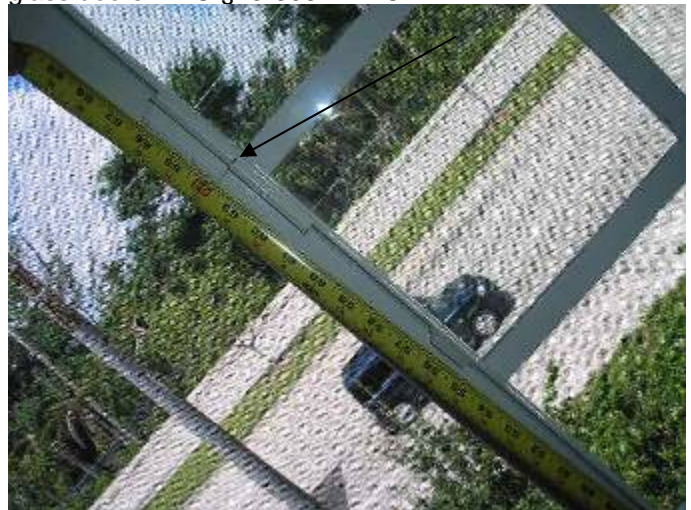
The height of the locks should not exceed 54 inches at the bedroom windows.

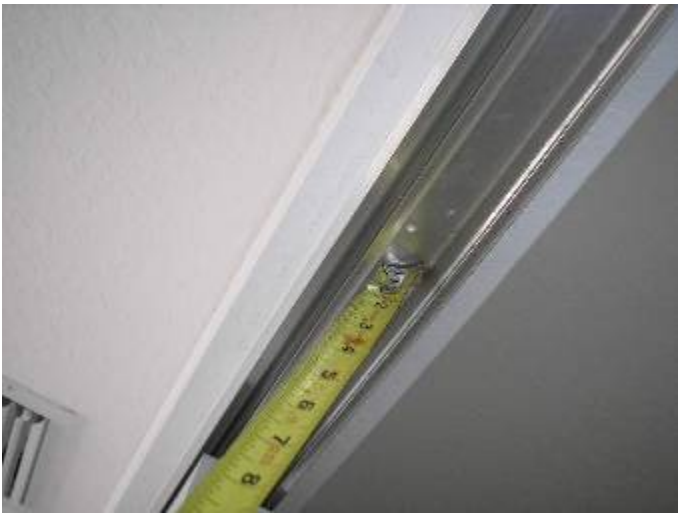
Some of the screw anchors are not installed at the bedroom closet door top tracks.

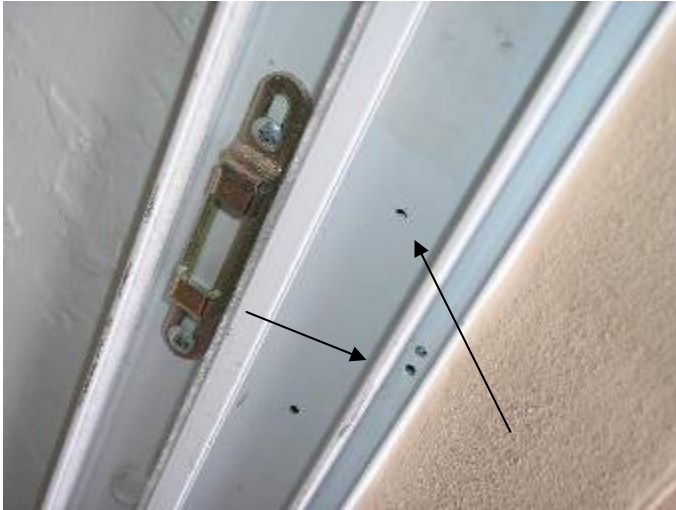
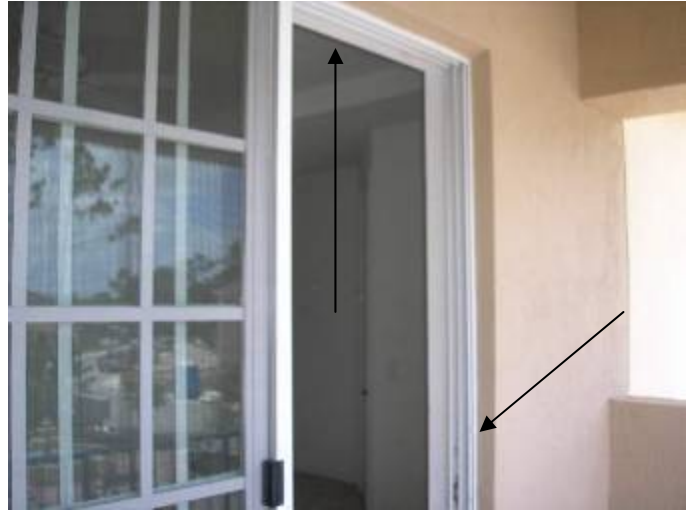
Some of the openings in the frame are not completely sealed to prevent water & pest intrusion at the sliding glass doors. FBC §13-606.1.ABC.1.2.

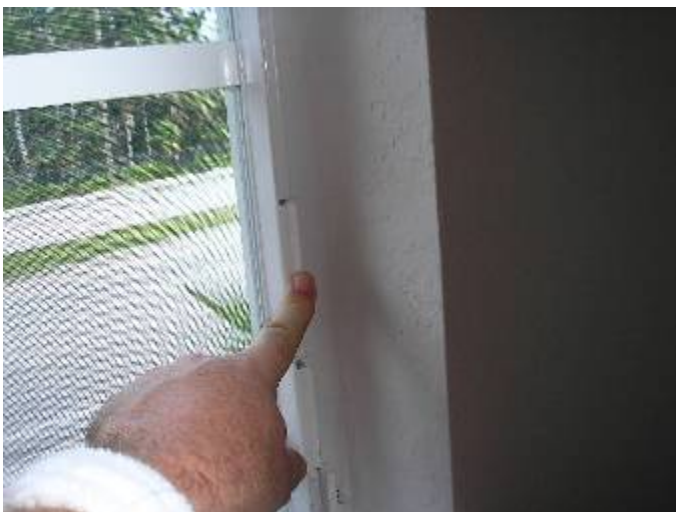
Some of the window locks stick & did not open & close correctly.

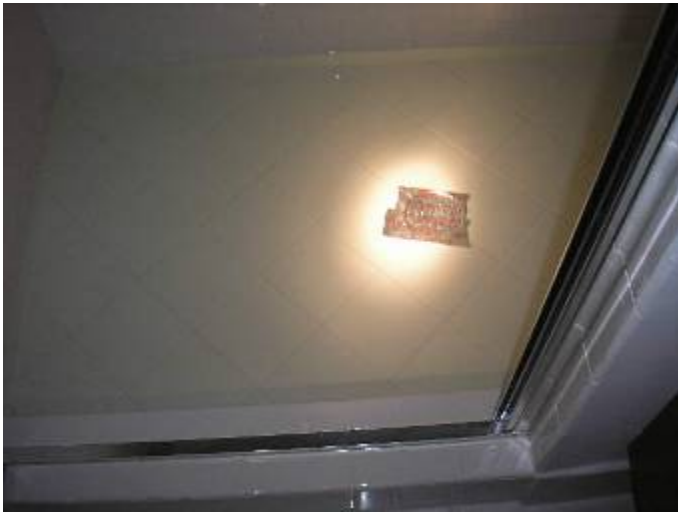
The 2nd floor drains were taped & 1 & ½ inches of water was left to stand. §P417.5.2

The tiles will need to be removed & the pan relined for a correct repair. §P417.5.2

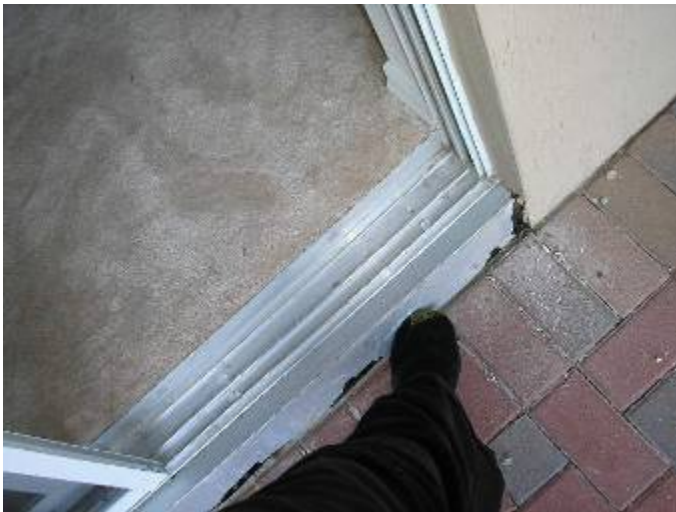
The flashing is not sealed at the bottom at the master balcony sliding glass doors.

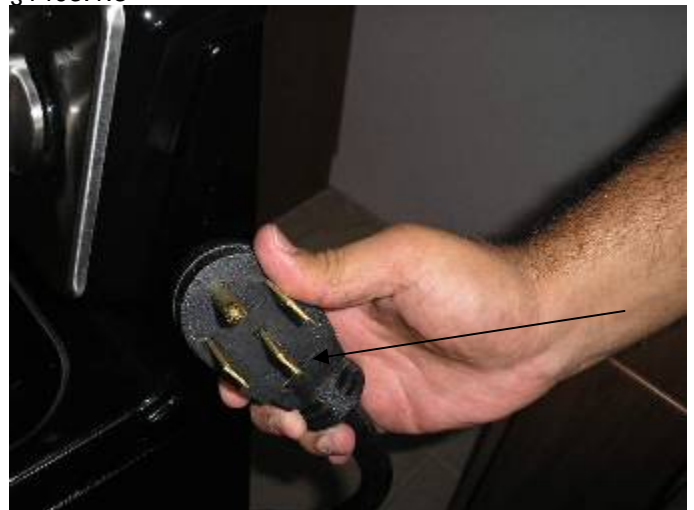
The range is installed with an electrical cord rated at 40 amps. The 50 amp overcurrent protection breaker in the main distribution panel is too big. §M304.1

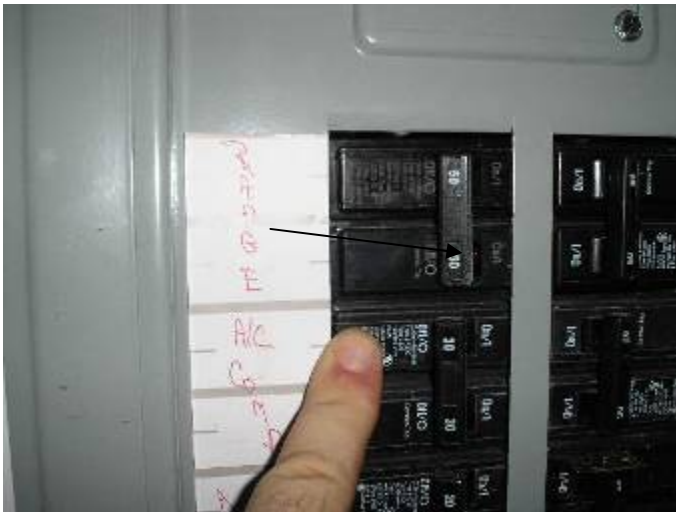
The range is installed with an electrical cord rated at 40 amps. The 50 amp overcurrent protection breaker in the main distribution panel is too big. §M304.1

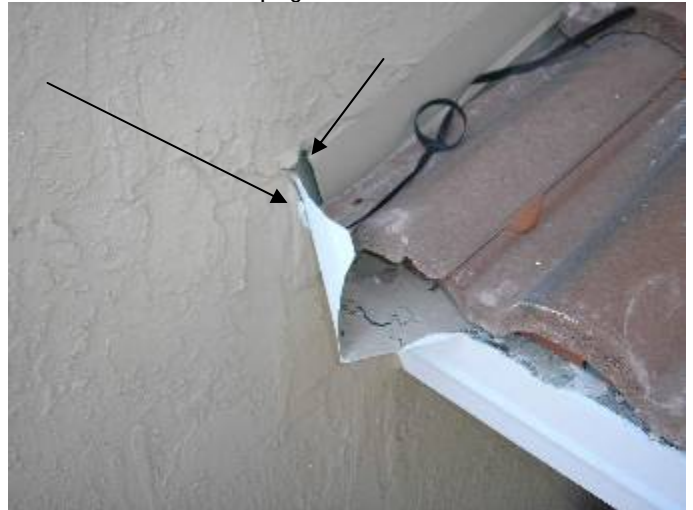
Areas around the flashing need to be completely sealed. §13-606.1.ABC.1.2, §1403.1.3

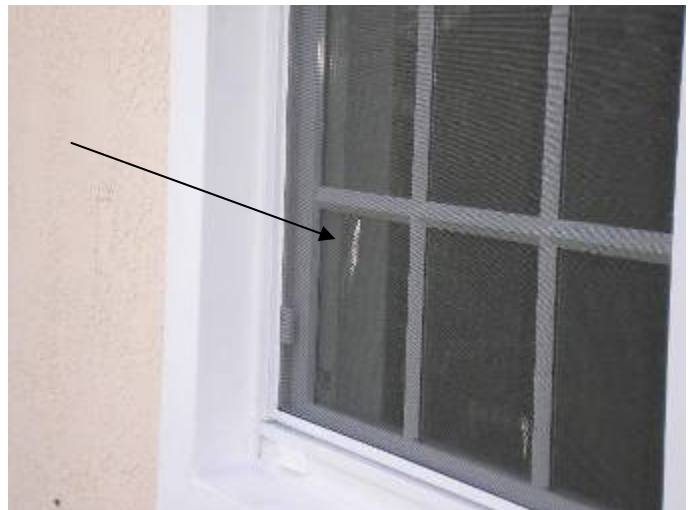
There is paint on the rear guest bedroom screen.

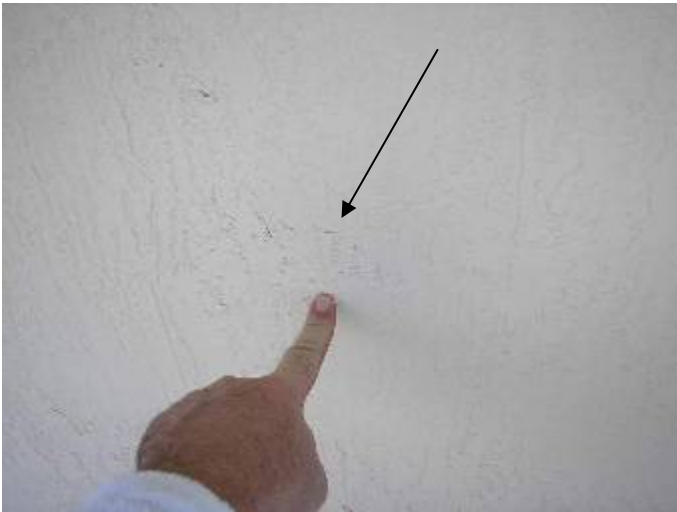
Some of the stucco is visible indicating there is not enough paint on the exterior walls.

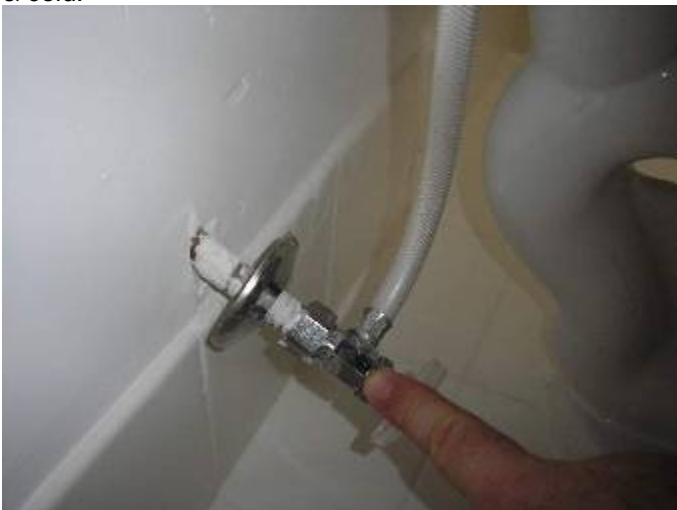
Some of the plumbing supply lines are not correctly secured behind the wall at the W.C. (toilets) & for the sink faucets. This line was bent & not level.

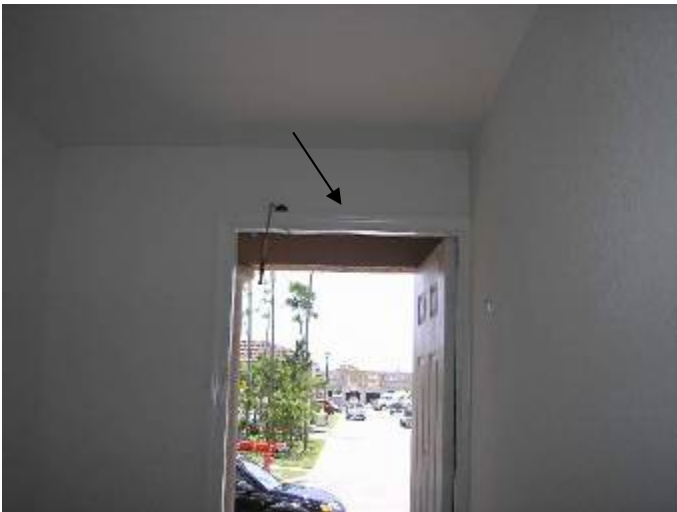
The top of the trim is not correctly sealed to prevent AC loss at the front & garage access door frames. FBC §13-606.1.ABC.1.2

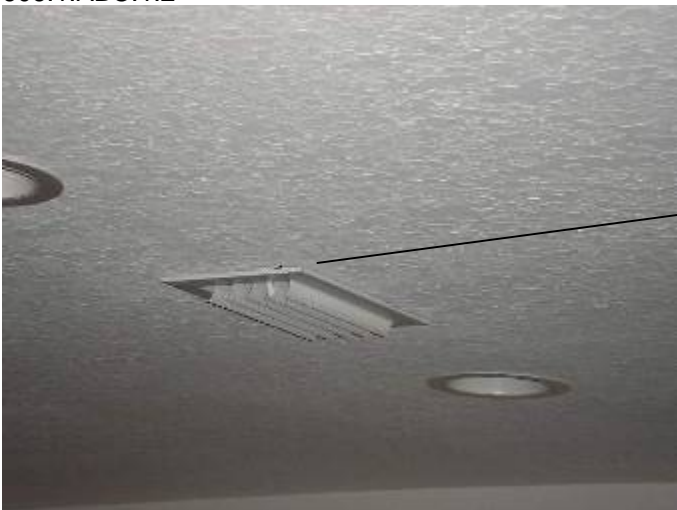
Some of the AC vent registers are not completely sealed or secured at the drywall.

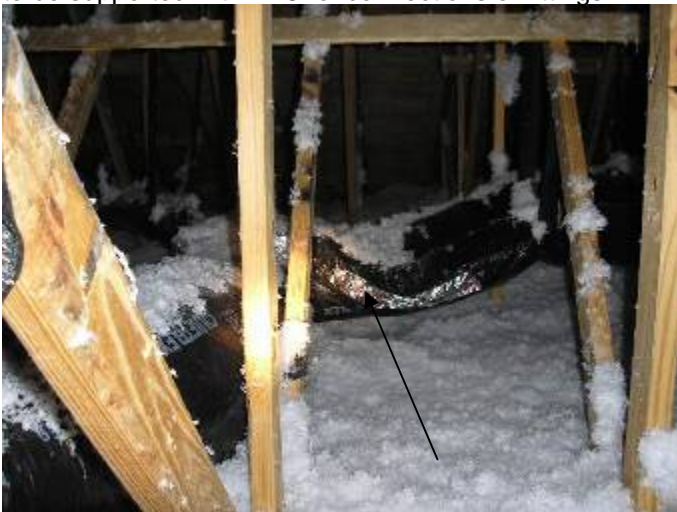
Some of the AC ductwork is not correctly installed or supported in the attic. The ducts are sagging & also need to be supported within 18" of connections or fittings.

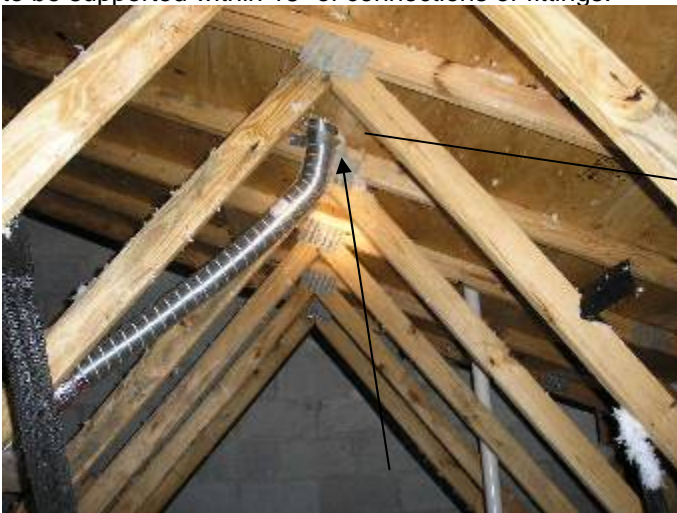
The openings in the roof sheathing/at the exhaust vents can become air intakes when the AC is operating. There is no designed make-up air provided with this AC system.

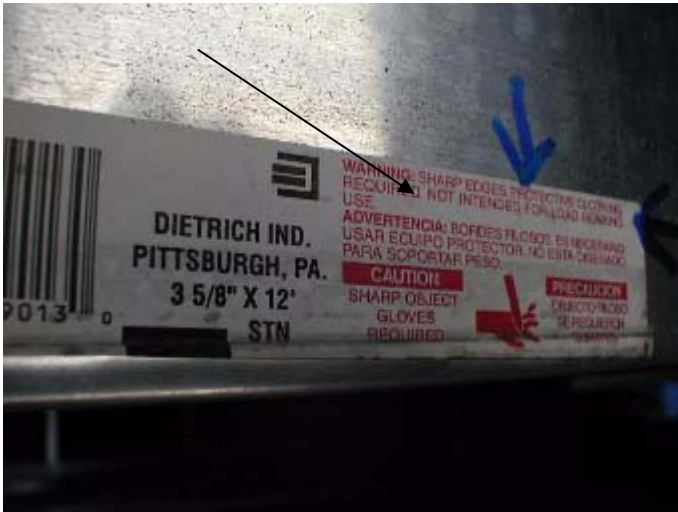
Drywall screws & light, 25 gauge metal framing studs are not designed to support persons entering an attic at the 2x4 wood blocking between the trusses. §2504.5.1

The 2x4 blocking should be secured through the trusses with 16d nails.

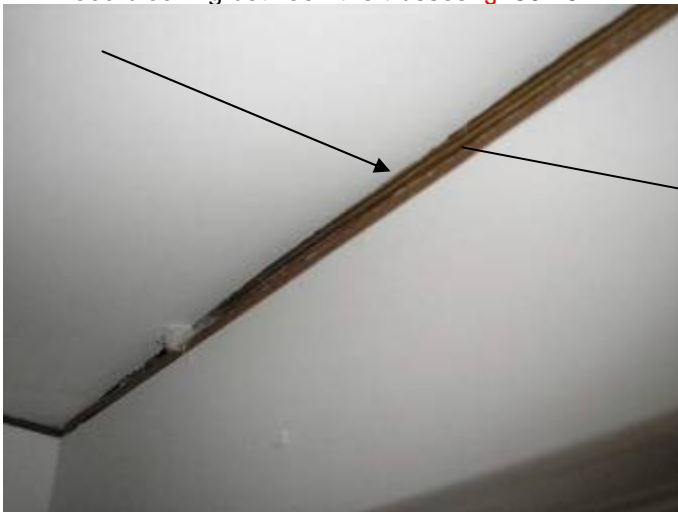
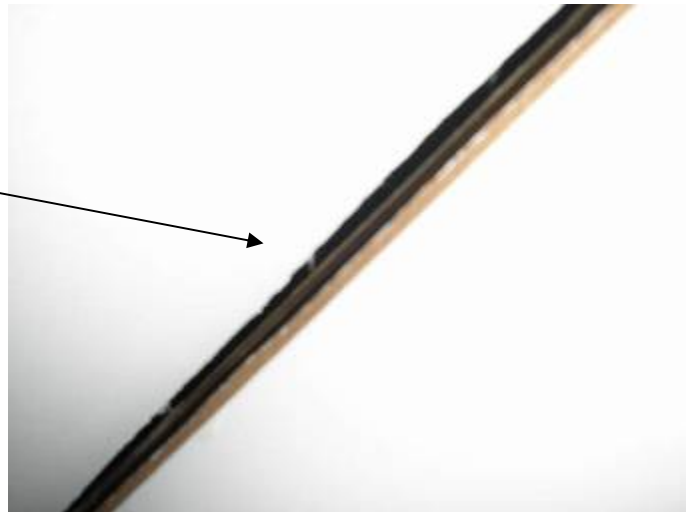
The attic access cover does not fit correctly to prevent AC loss at the hatch frame.

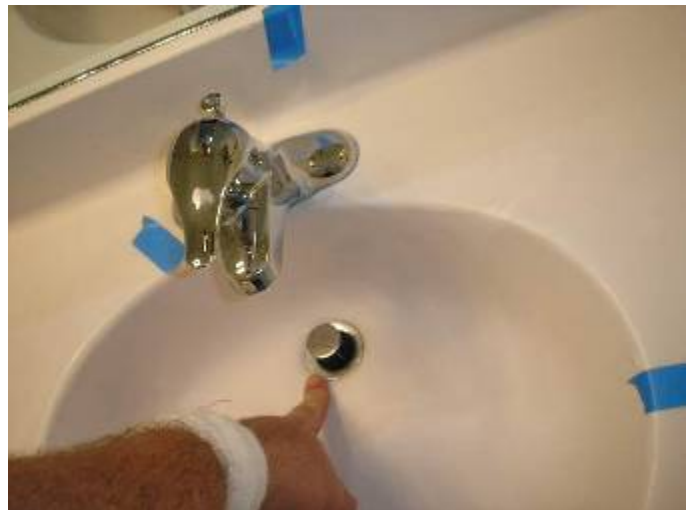
The right lavatory sink stopper did not operate correctly at the 2nd floor guest bathroom.

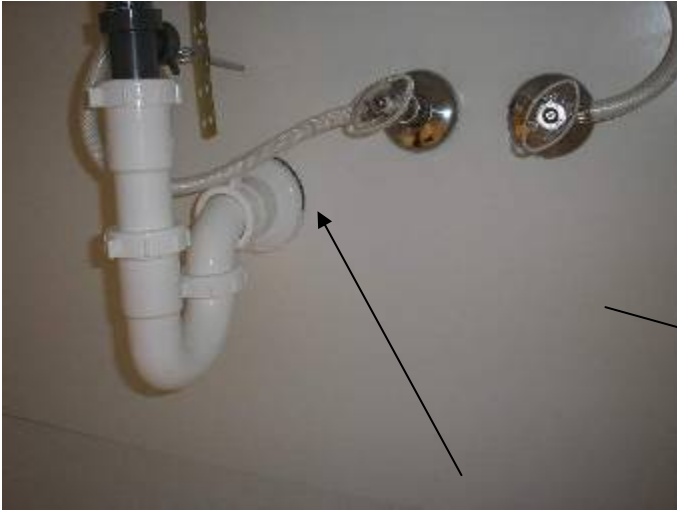
Some of the plumbing supply lines are not correctly secured or sealed at/behind the wall at the W.C. (toilets) & for the sink faucets.

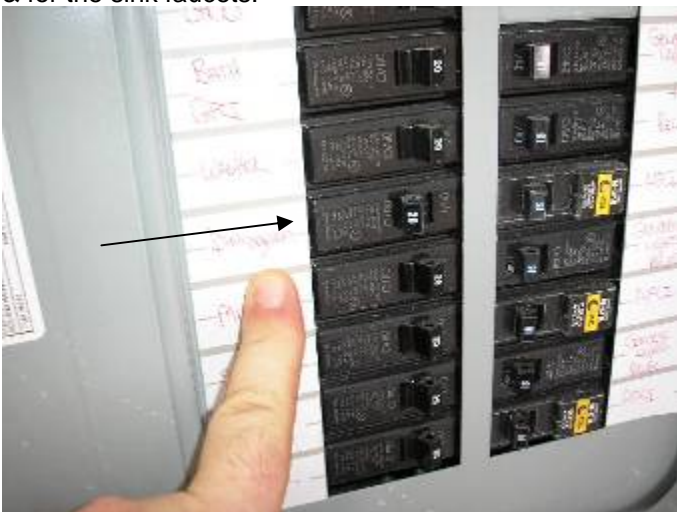
The breaker marked living room was off & we were instructed not to turn it on by the builder's representative. The panel cover was not removed per builder request.

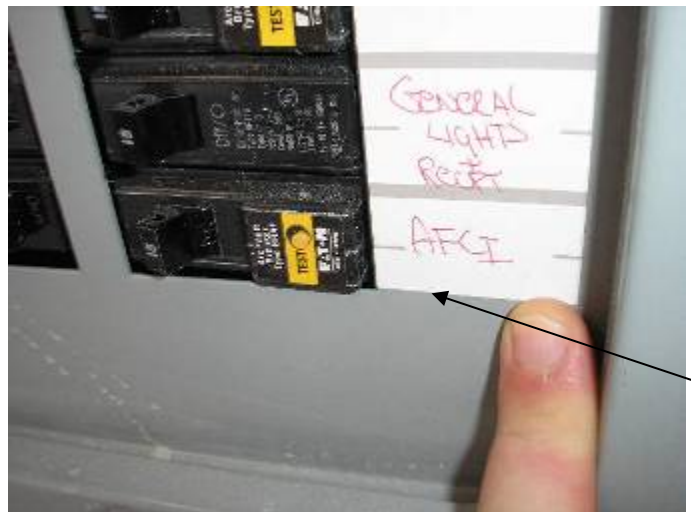
The circuits are not all completely identified to indicate the location of service.

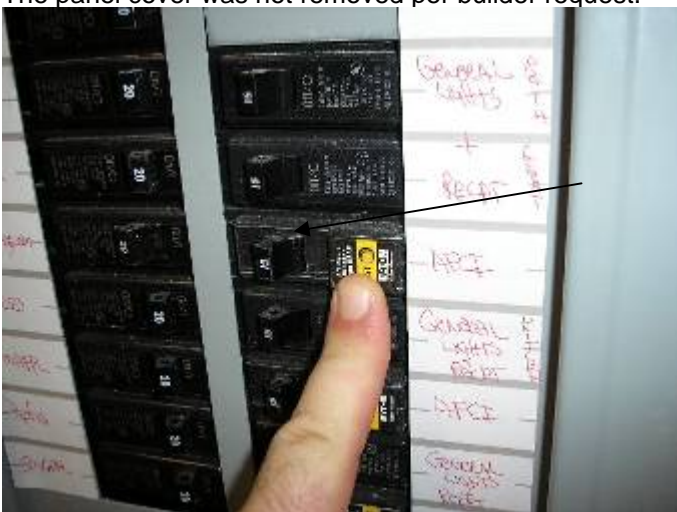
The AFCI arc fault breaker did not move to the fully tripped position when tested.

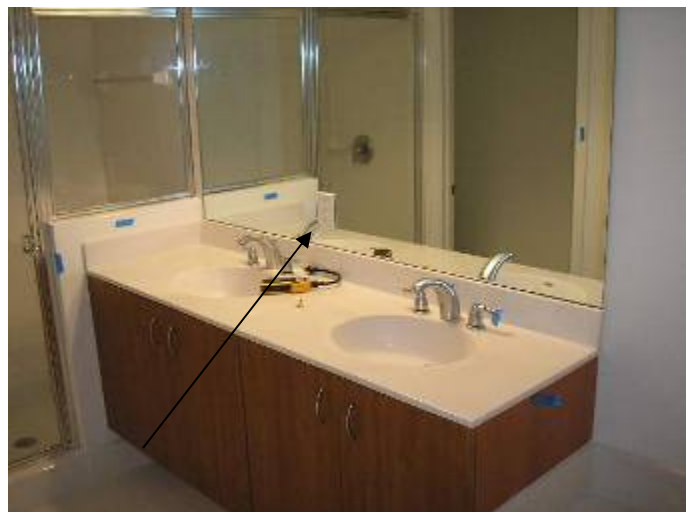
Note: There is only 1 receptacle outlet at the master bathroom lavatory sink area. Review the electrical plan to confirm there should not be 2 separate outlets.

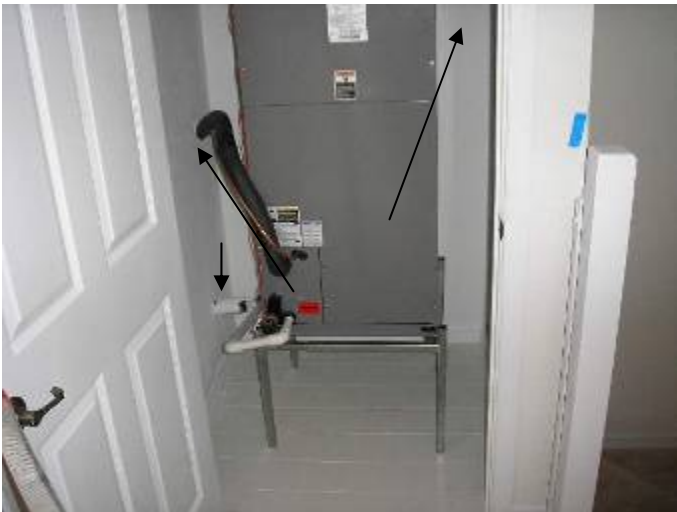
Location of the previous photo/s at the AC air handler on the 2nd floor.

§13-410.1.ABCD.3.7 Mechanical Closets. The interior surfaces of mechanical closets shall be sheathed with a continuous air barrier as specified in §13-410.1.ABCD.3.7.1 and shall be sealed to 100 percent closure with approved closure systems as specified in §13-410.1.ABCD.3.7.2. All joints shall be sealed between air barrier segments and between the air barriers of walls and those of the ceiling, floor and door framing. All penetrations of the air barrier including but not limited to those by air ducts, service lines, refrigerant lines, electrical wiring, and condensate drain lines shall be sealed to the air barrier with approved closure systems.

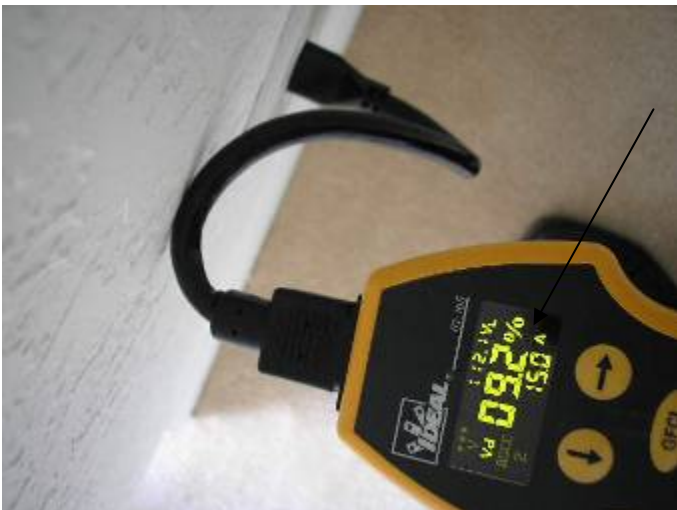
Note: Some of the receptacle outlets had voltage drops that exceed 5% 2002(NEC) 210.19 Conductors. - See Below.

See the builder's/electrical engineer's response to this item. **The voltage drops noted in the report are referenced as a suggested guideline & informational only. They are not considered a violation of the code & this condition is not enforceable.**
